## **CLEANUP PLAN**

**Municipal Auditorium  
1201 St. Peter Street  
New Orleans, Louisiana 70116**

**Prepared by:  
Leaaf Environmental LLC**

**May 2025  
LTBA-035D**

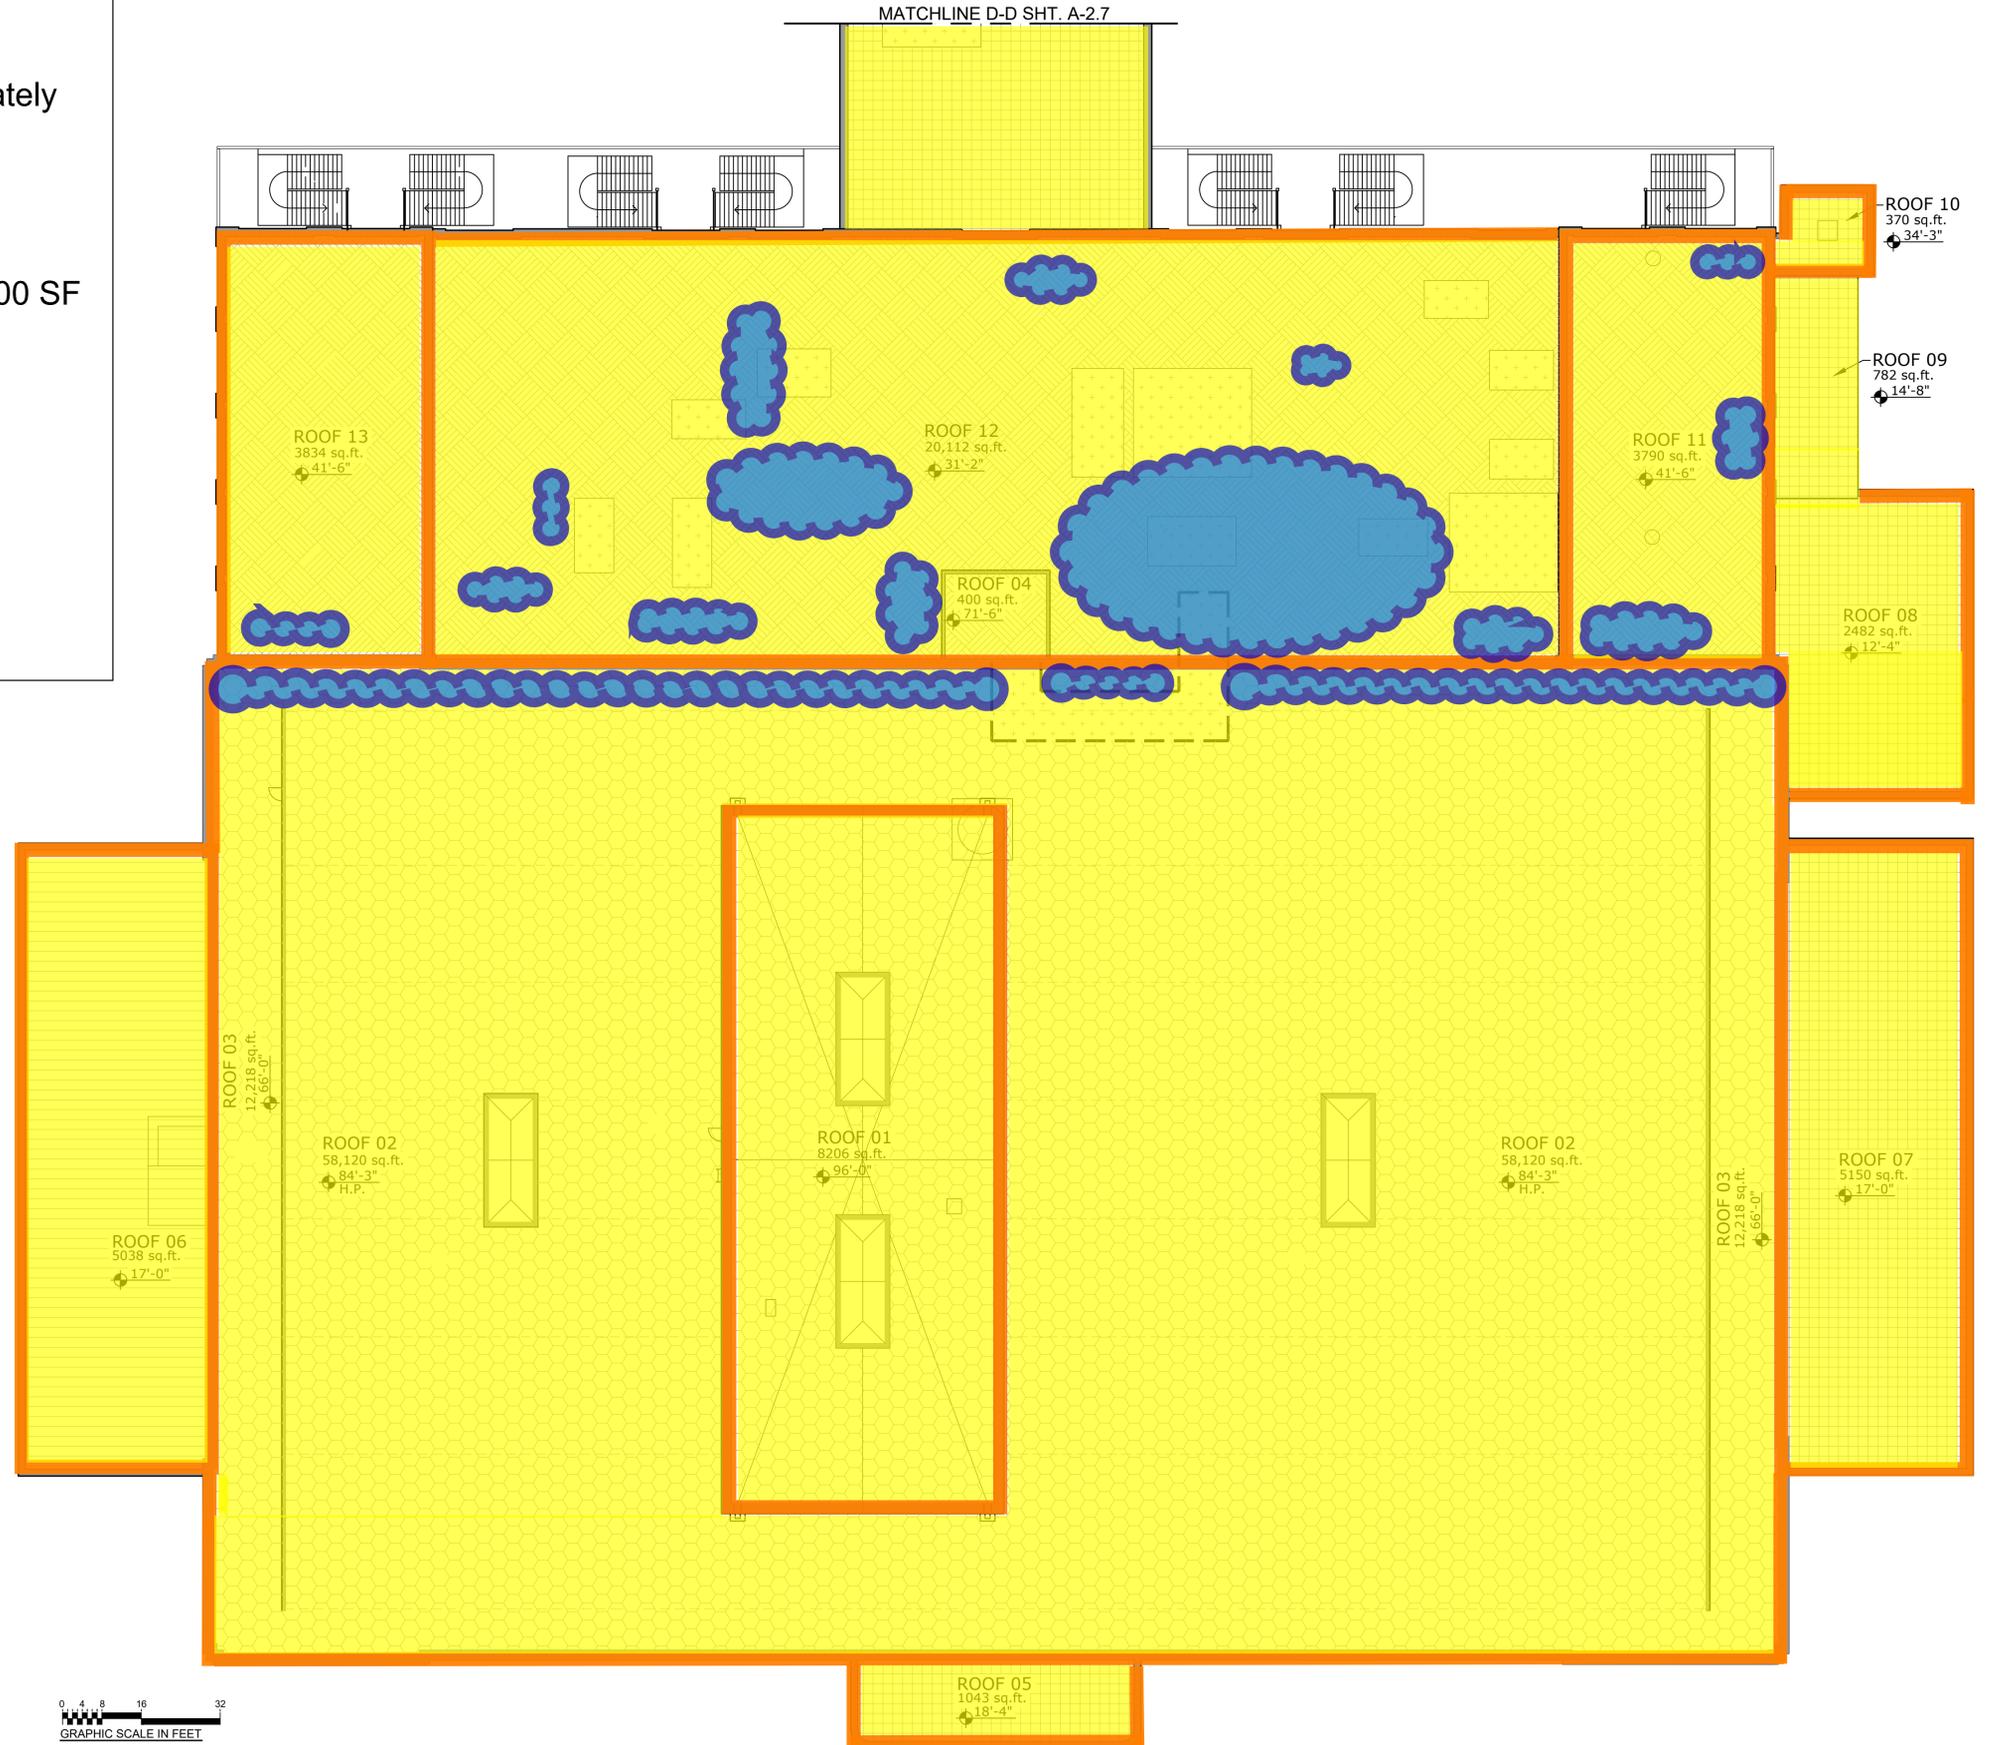
1 ROOF PLAN  
A-2.6 SCALE: 1/16" = 1'-0"

**Parapet Wall / ACM associated with Parapet Wall - approximately 3,500 LF**

- Black Felt
- Black Roofing Material

**Roof Edge ACM Roofing Components - approximately 118,000 SF**

- Black Roofing Material
- Black Roofing Material and Silver Paint

**Roof Debris - approximately 22,750 SF**

- Black Tar
- Black Tar and Silver Paint
- Black Roofing Material and Silver Paint
- Black Felt and Silver Paint

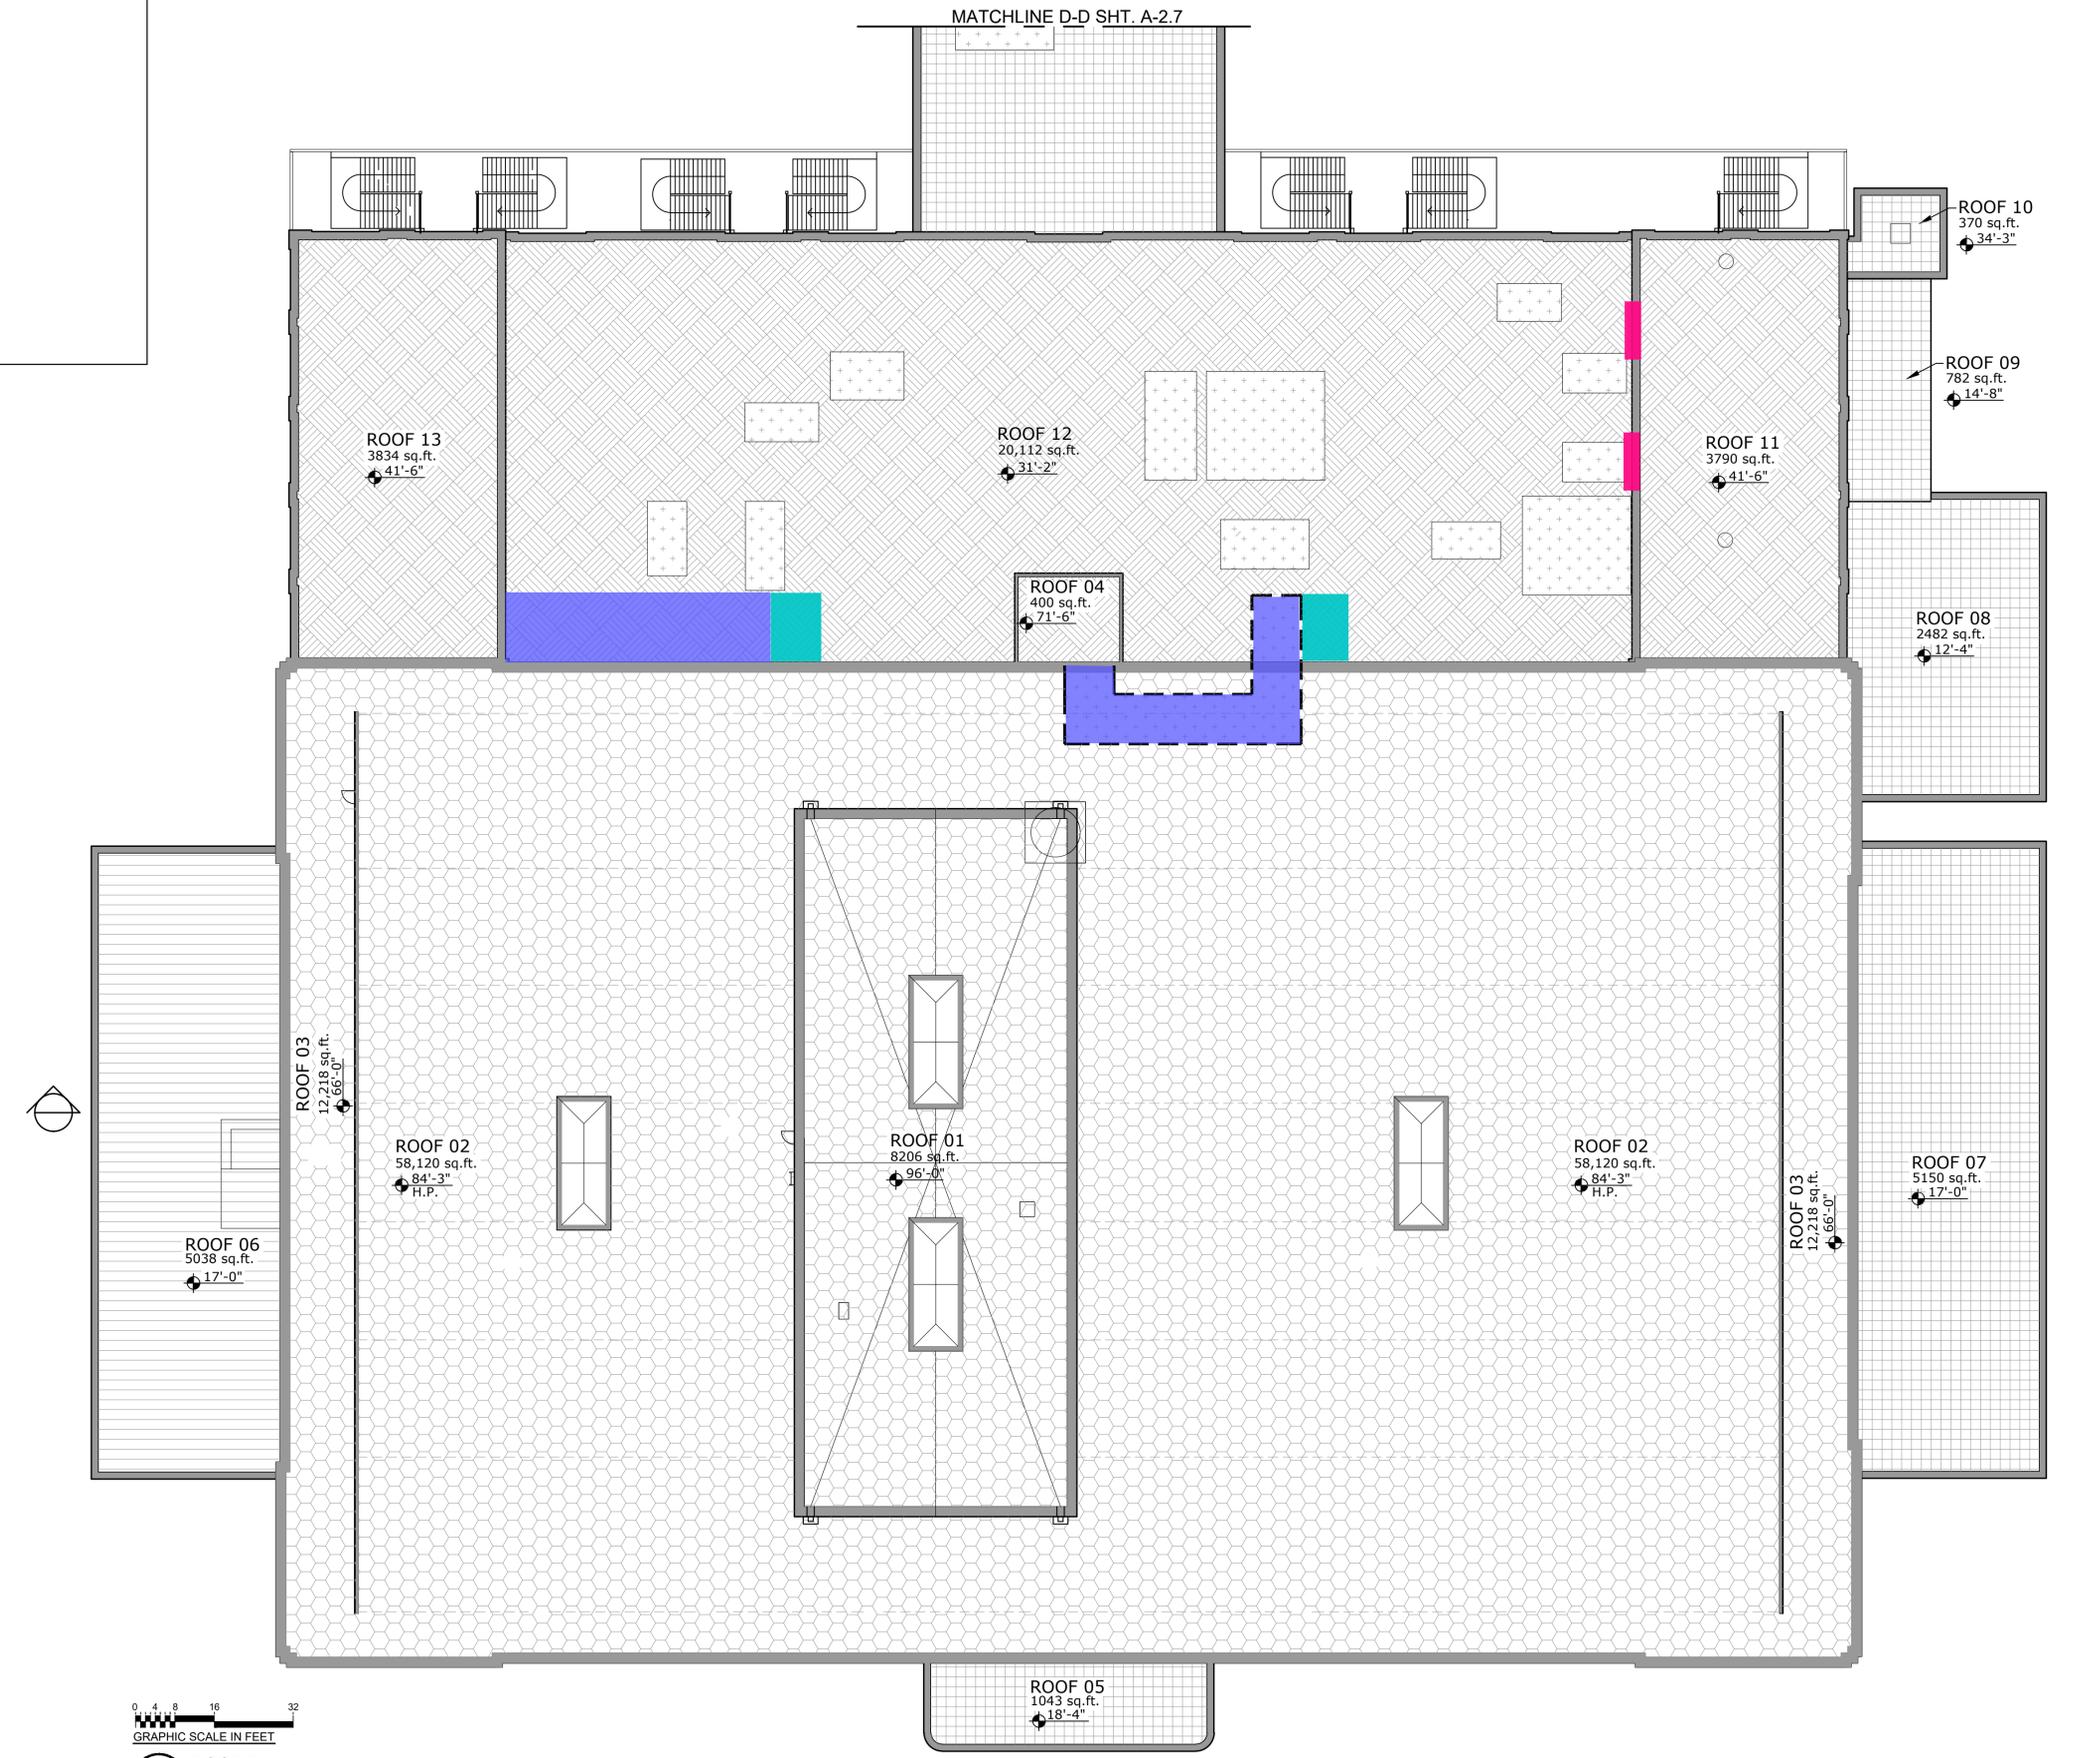
1 ROOF PLAN  
A-2.6 SCALE: 1/16" = 1'-0"

Black/Gray Wall Caulk - approximately 6 LF

Silver Duct Wrap - approximately 8,400 SF  
- Black Mastic and Silver Paint

Gray Corrugated Transite Panel - approximately 300 SF

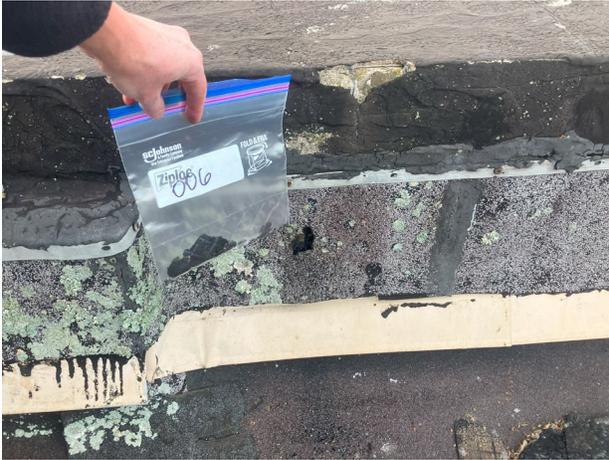
Photo of exterior building at Annex Roof 13 where asbestos-containing Parapet Wall Black Felt was sampled.

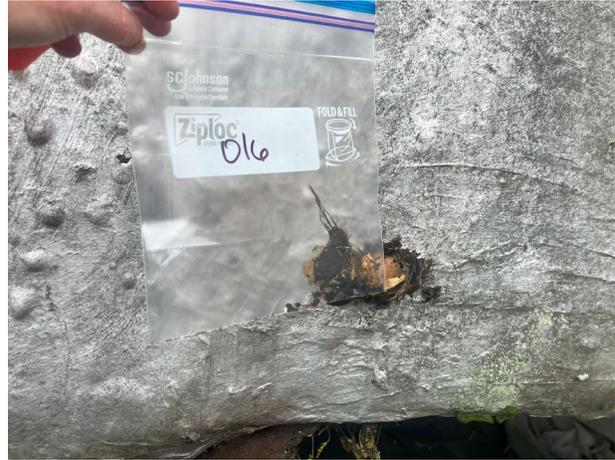
Photo of exterior building at Annex Roof 12 HVAC where asbestos-containing Silver Duct Wrap Black Mastic and Silver Paint was sampled.

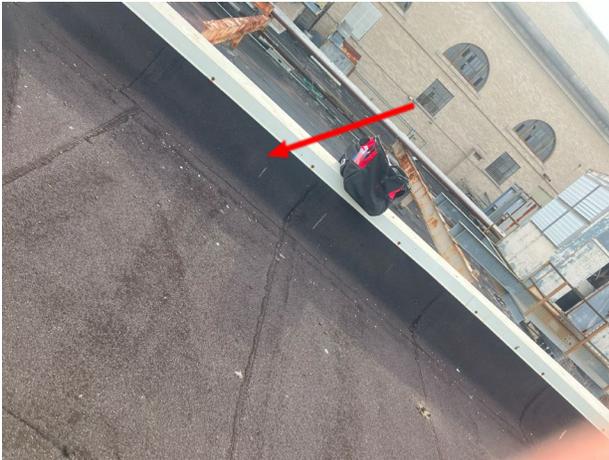
Photo of exterior building at Annex Roof 12 where asbestos-containing Parapet Wall Black Roofing Material is located.

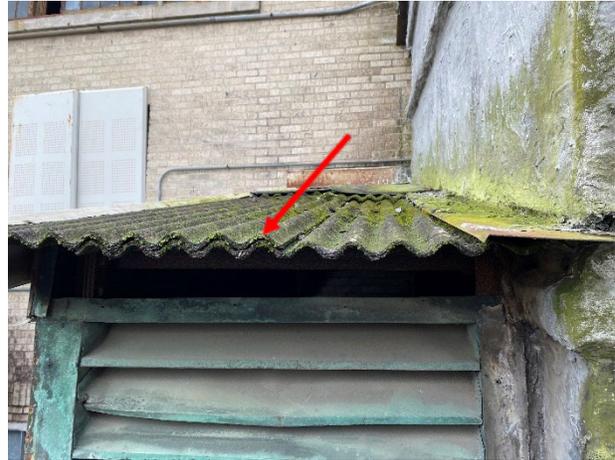
Photo of exterior building at Annex Roof 12 where asbestos-containing Gray Corrugated Transite Panel is located.

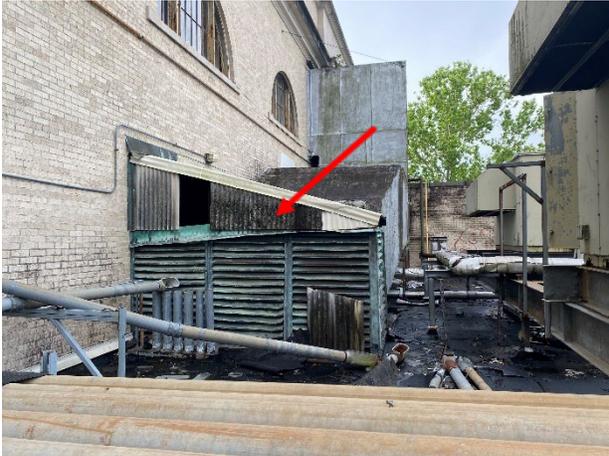
Photo of exterior building at Annex Roof 12 where asbestos-containing Gray Corrugated Transite Panel is located.

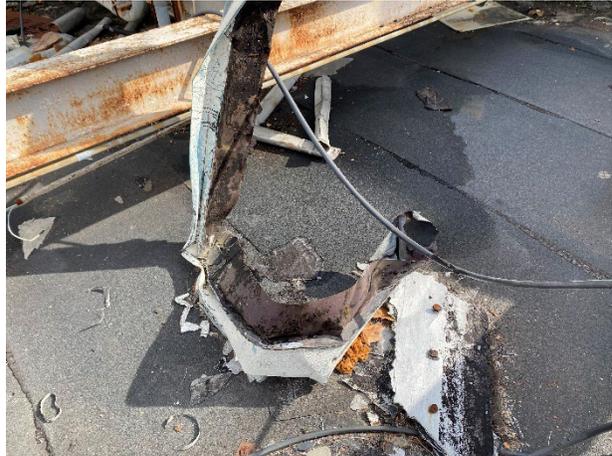
Photo of exterior building at Annex Roof 12 where asbestos-containing Black Felt and Silver Paint was sampled in debris and on copper flashing.

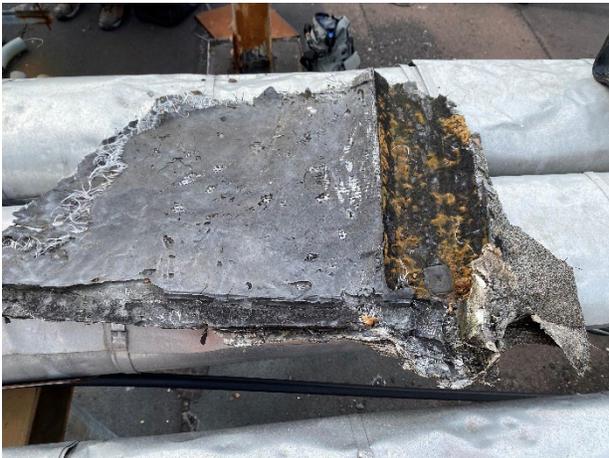
Photo of exterior building at Annex Roof 12 where asbestos-containing Roof Debris Black Tar and Black Roofing Material with Silver Paint was sampled.

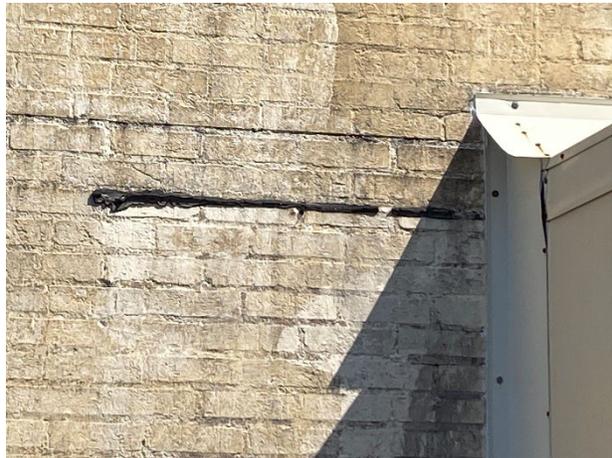
Photo of exterior building at Annex Roof 11 where asbestos-containing Black/Gray Wall Caulk was sampled.

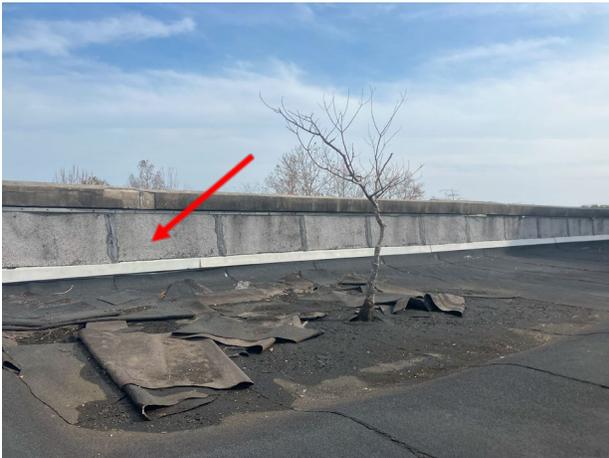
Photo of exterior building at Annex Roof 11 where asbestos-containing Parapet Wall Black Felt is located.

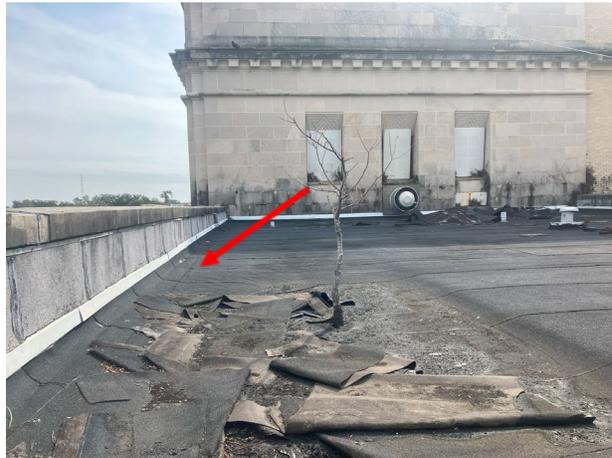
Photo of exterior building at Annex Roof 11 where asbestos-containing Roof Edge Black Roofing Material is located.

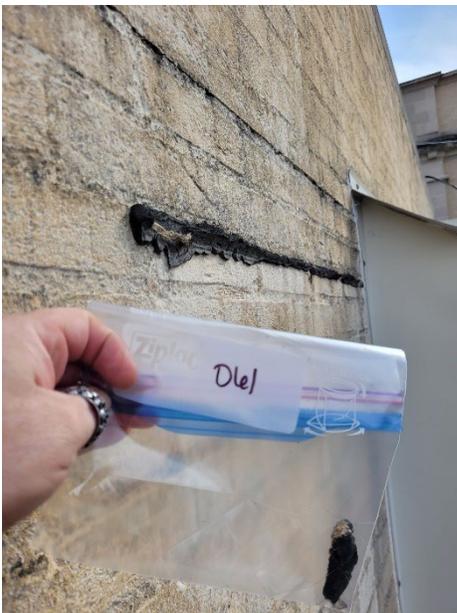
Photo of exterior building at Annex Roof 11 where asbestos-containing Black/Gray Wall Caulk was sampled.

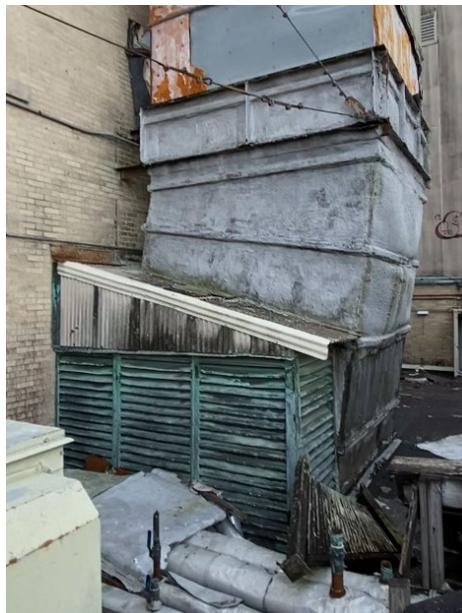
Photo of exterior building at Annex Roof 12 where asbestos-containing Silver Duct Wrap Black Mastic and Silver Paint is located.

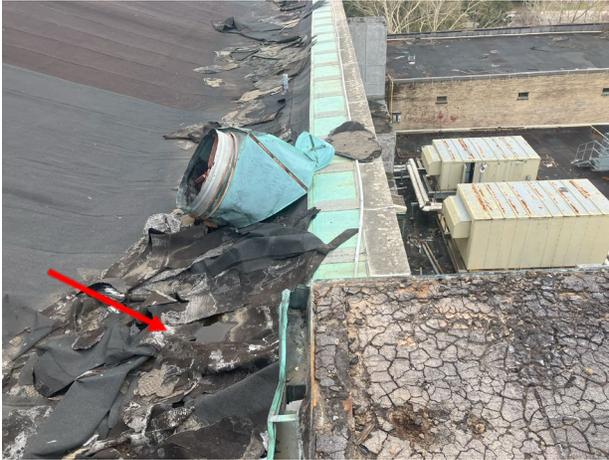
Photo of exterior building at Auditorium Roof 2 where asbestos-containing Roof Debris is located.

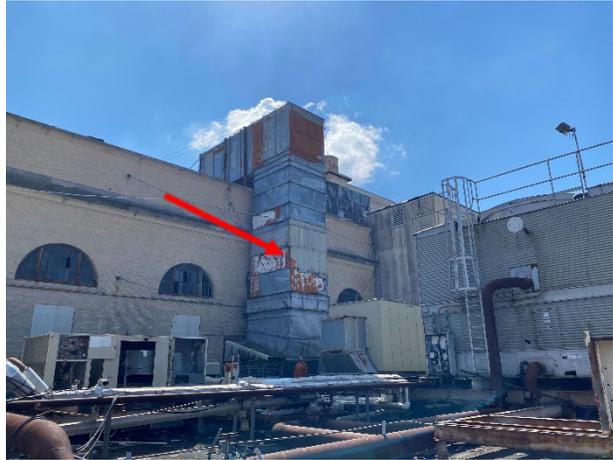
Photo of exterior building at Annex Roof 12 where asbestos-containing Silver Duct Wrap Black Mastic and Silver Paint is located.

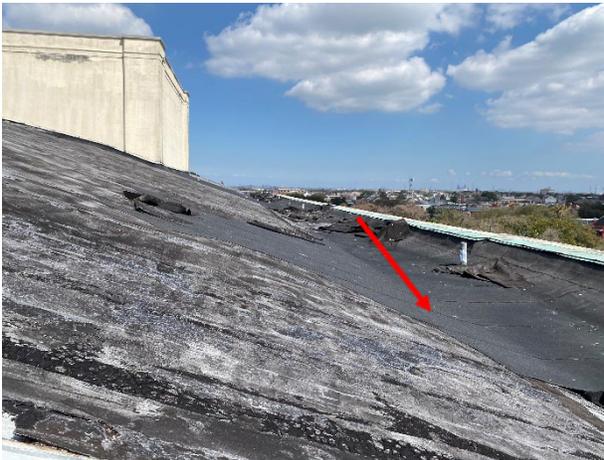
Photo of exterior building at Auditorium Roof 2 where asbestos-containing Roof Edge Black Roofing Material and Silver Paint is located.
