LINCOLN BEACH SITE ASSESSMENT REPORT

PREPARED FOR THE CITY OF NEW ORLEANS
Department of Public Works

DIGITAL ENGINEERING & IMAGING, INC.

April 2021

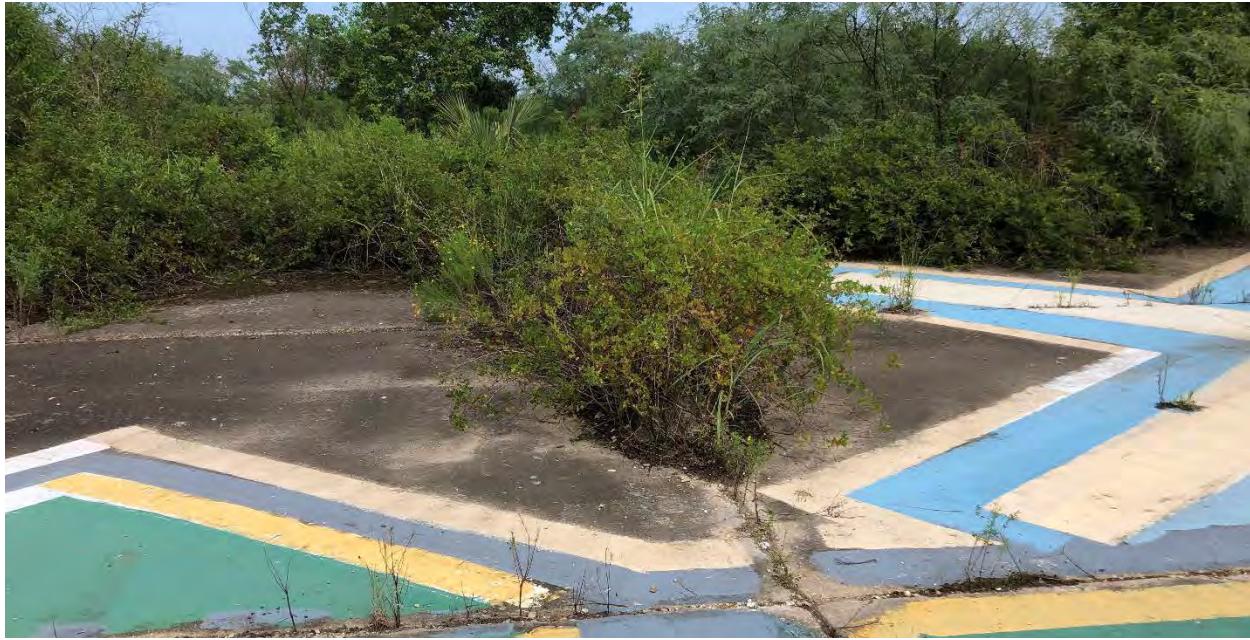
Figure 10: Severe overgrown in concrete joint, likely causing damage to the adjoining panels

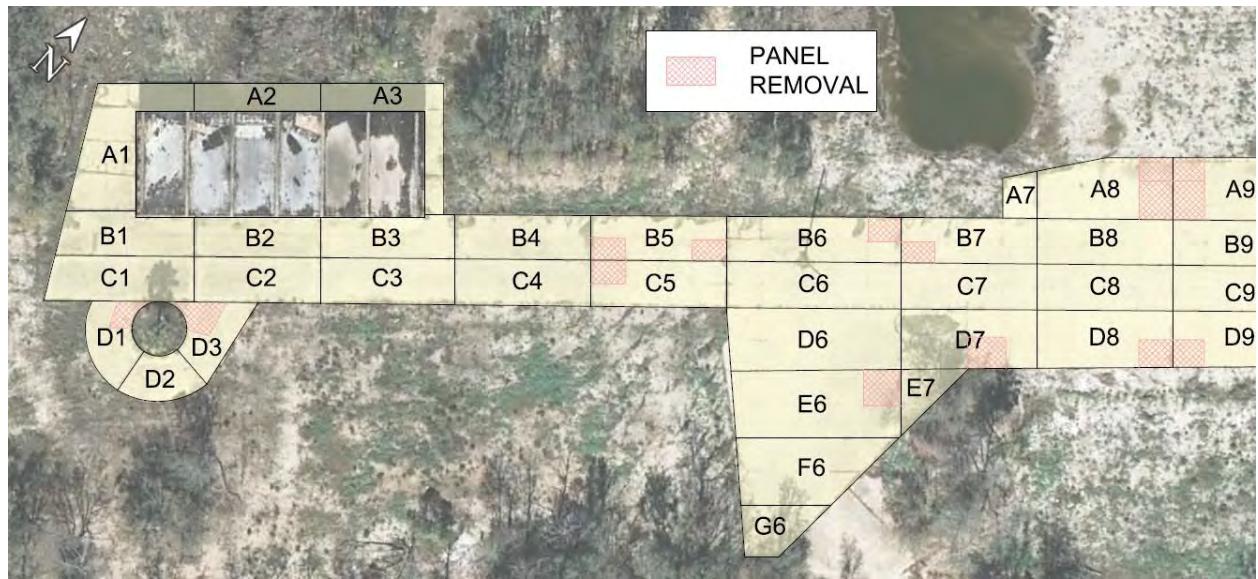
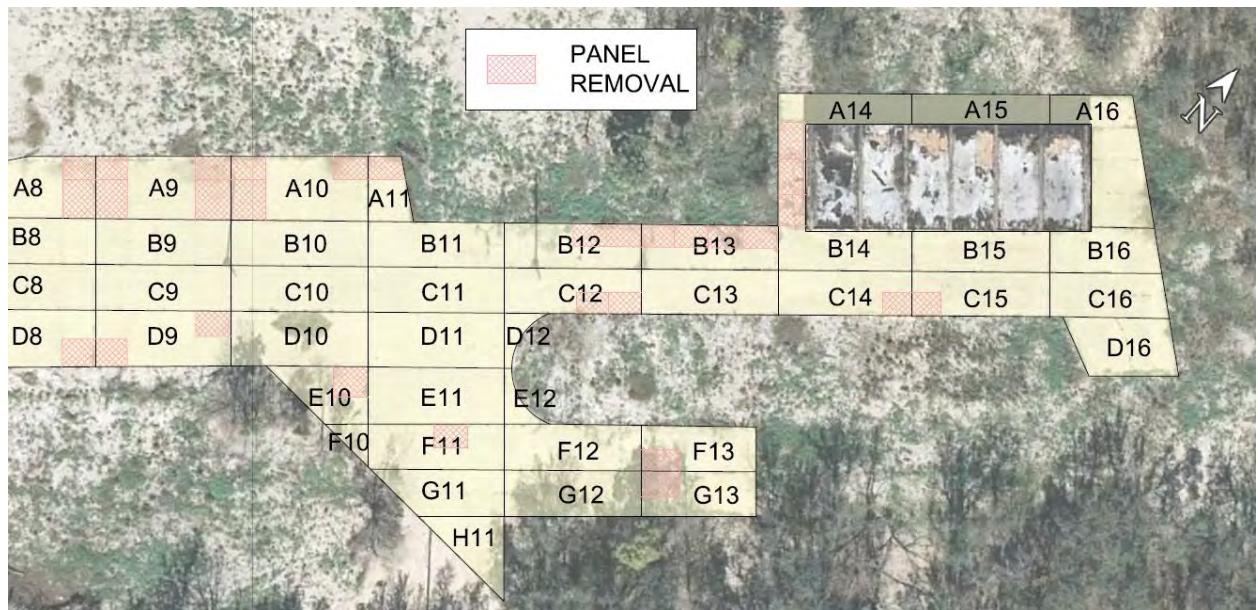
There are instances of panels showing excessive cracking/damage that is beyond repair. These 10'x14' panels (shown in Figures 11 & 12) will need to be removed and replaced at a cost of approximately \$125 per square yard. In total there are 40 panels (approx. 622 square yards) that will need to be removed and replaced due to excessive cracking, settlement, and/or non ADA-compliant slope. Existing concrete will be pressure washed to allow it to match the new concrete panels more closely at a cost of \$2.25 per square yard. However, depending on future use of the park, some of these panels may only need to be removed and not replaced. The lack of access for large vehicles such as a concrete truck, or equipment needed to break up and remove damaged concrete panels creates a challenge for the rehabilitation of the property. Large equipment may need to be brought to the site on a barge, and any demolished material may need to be removed from the site by barge. Due to time restraints related to when concrete is batched and when it can be poured, the concrete may need to be mixed on site rather than being mixed at an off-site concrete plant. This would increase the cost of all work relating to new concrete on the site.

Figure 11: Western half of the property's pavement, broken down into 2x4 panel segments

Figure 12: Eastern half of the property's pavement, broken down into 2x4 panel segments

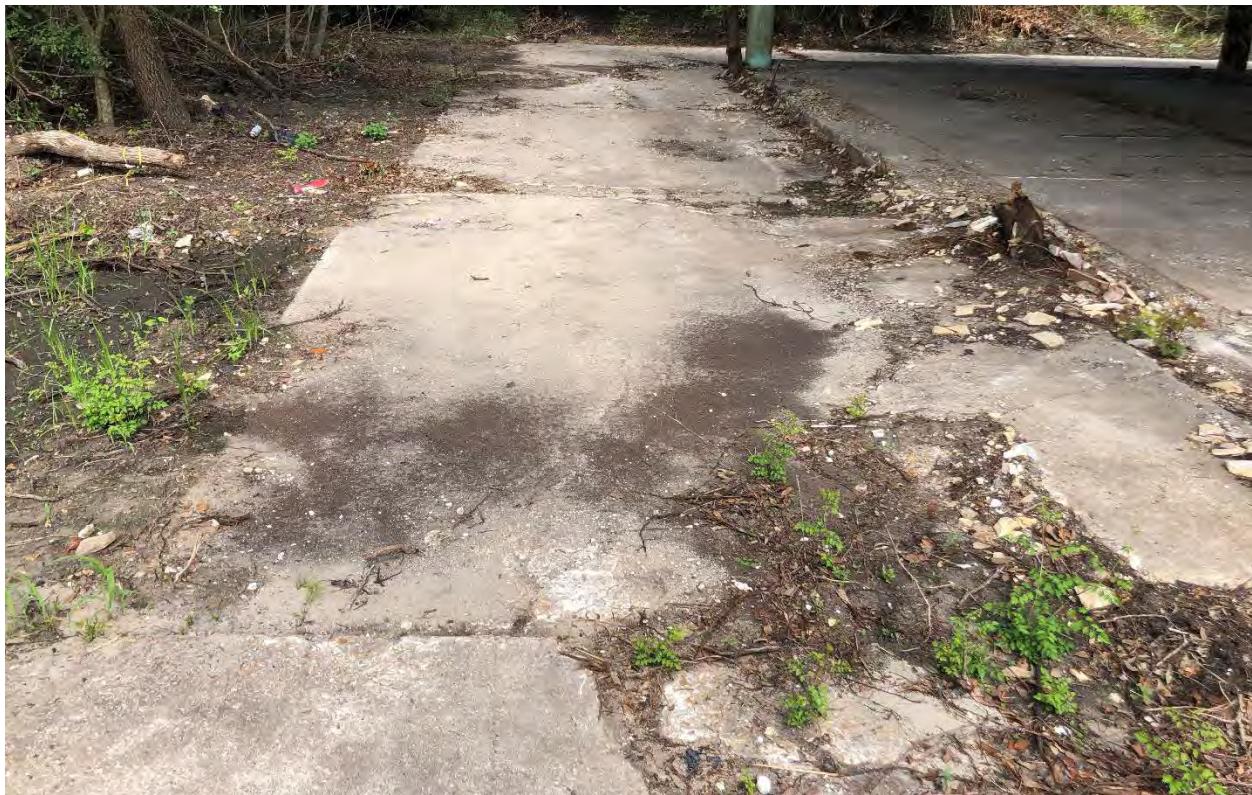
Figure 13: Excessive cracking in Segment A14.

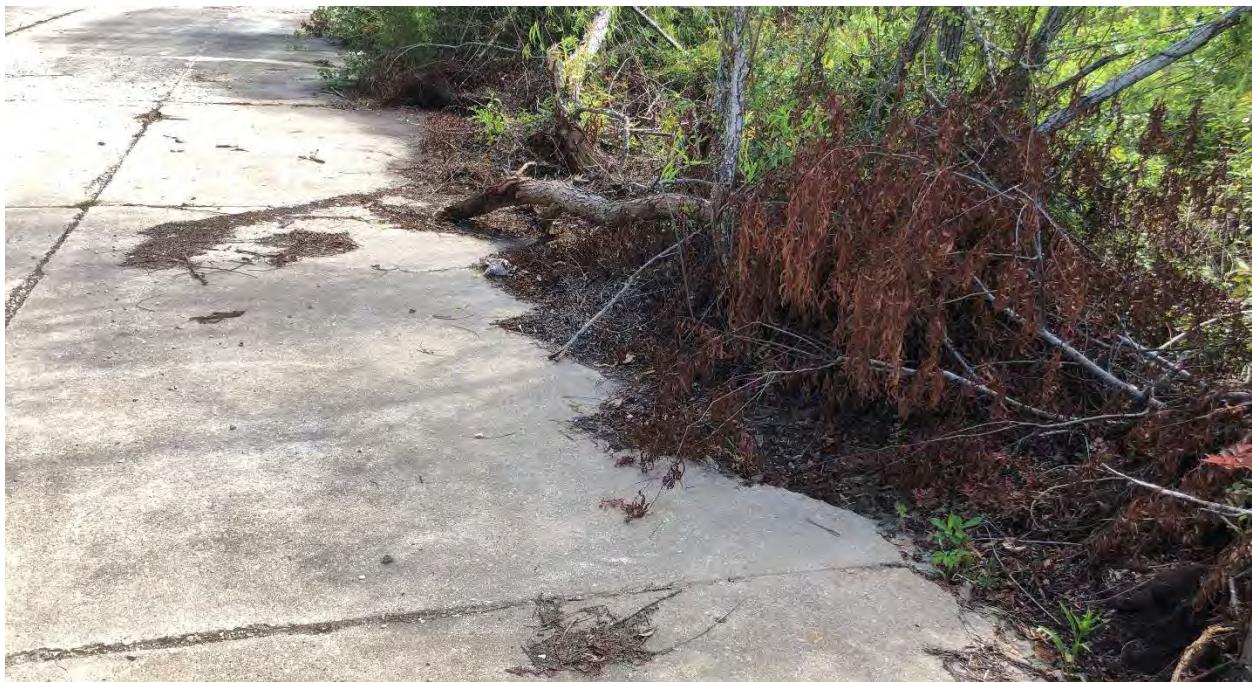
Figure 14: Half of panel cracked and missing in Segment C12.

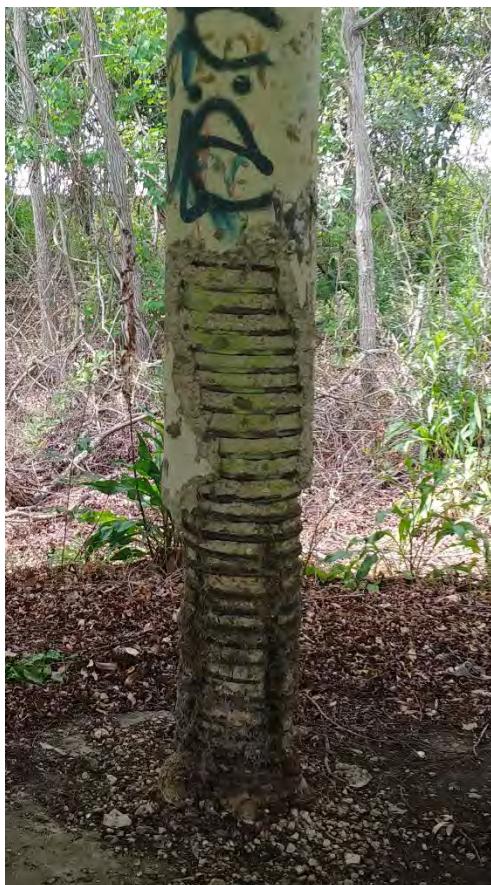
Figure 17: Column A5 showing significant damage before being repaired

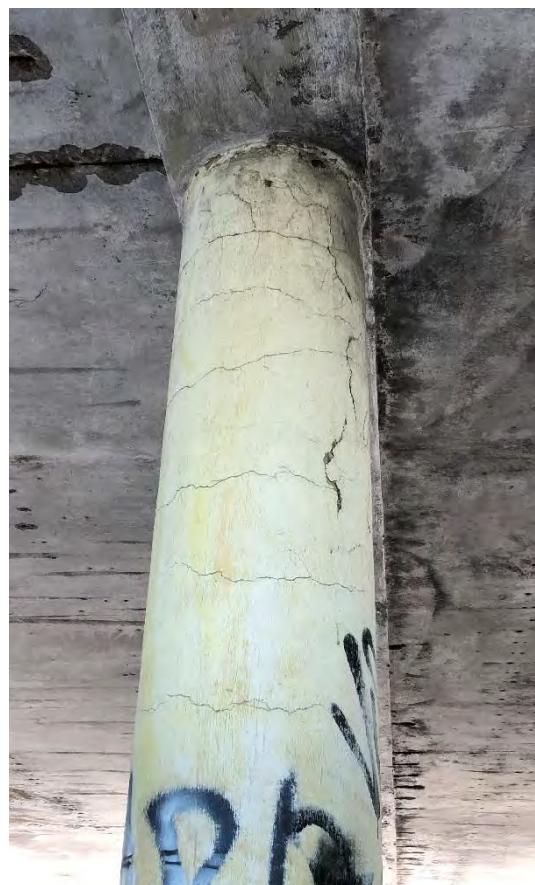
The rectangular columns appeared to be structurally sound, though some slight cosmetic cracking was present. The circular columns displayed visual damage. There is spalling of concrete on the bottoms of columns A1, A2, A6, and A7 revealing the reinforcement. Column A5 had significant spalling revealing the bottom 4' of reinforcement and had been repaired prior to the second site visit. On the north side at the top of all columns, except the repaired A5, there is cracking caused by the columns flexing inward due to the weight of the roof. There is some minor cracking on each of the roof panels, and some exposed rebar on the ceiling due to the rebar not being placed properly when the structure was built. The original tar and gravel coating on the roof is in poor condition and needs to be replaced.

Figure 18: The tops of all columns of the west and east pavilion exhibited this cracking

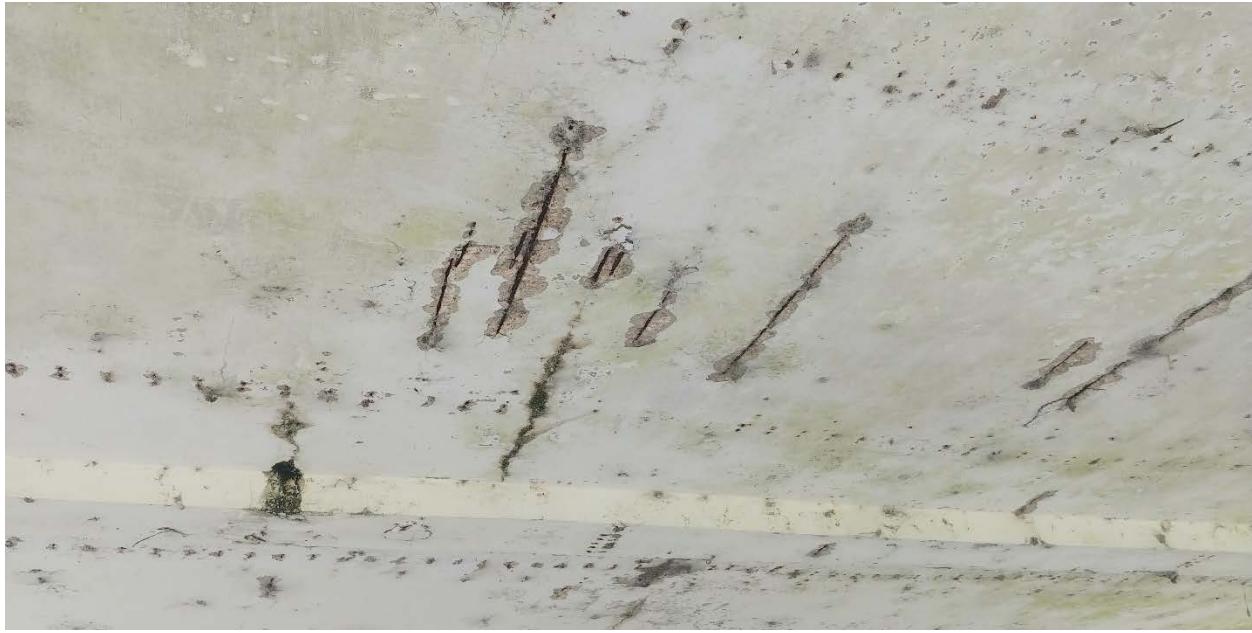
Figure 19: Visible concrete reinforcement caused by incorrect placement of the rebar at the time of the pavilion's construction

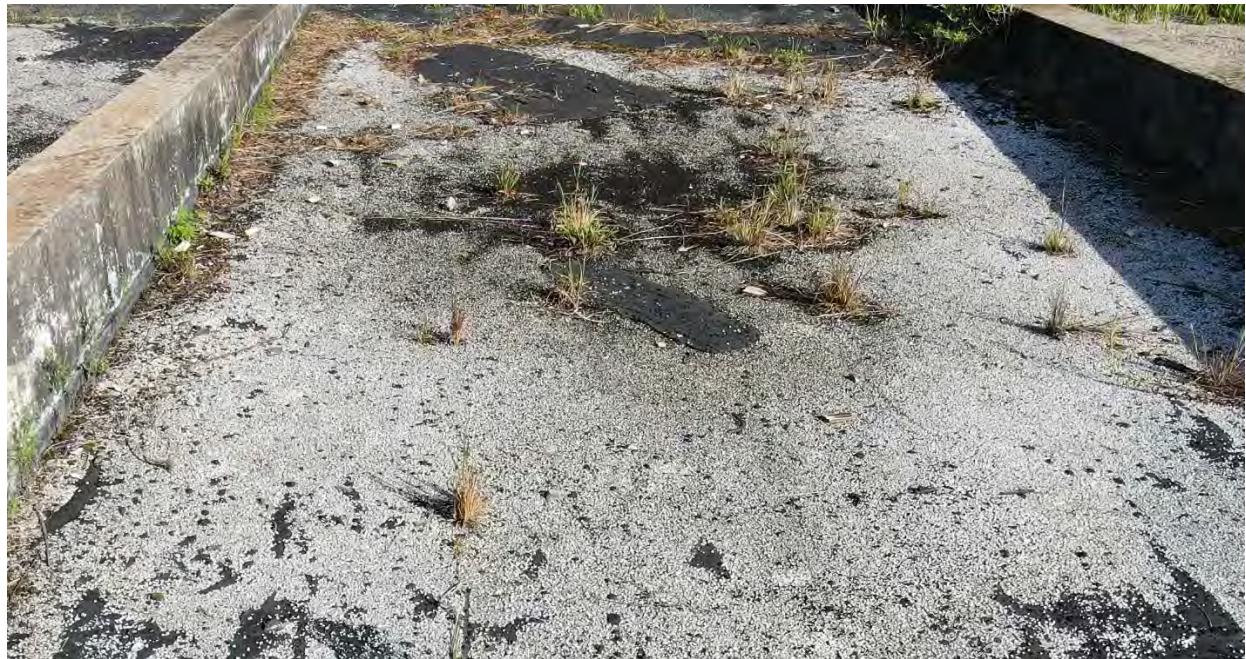
Figure 20: Tar and gravel roof in poor condition

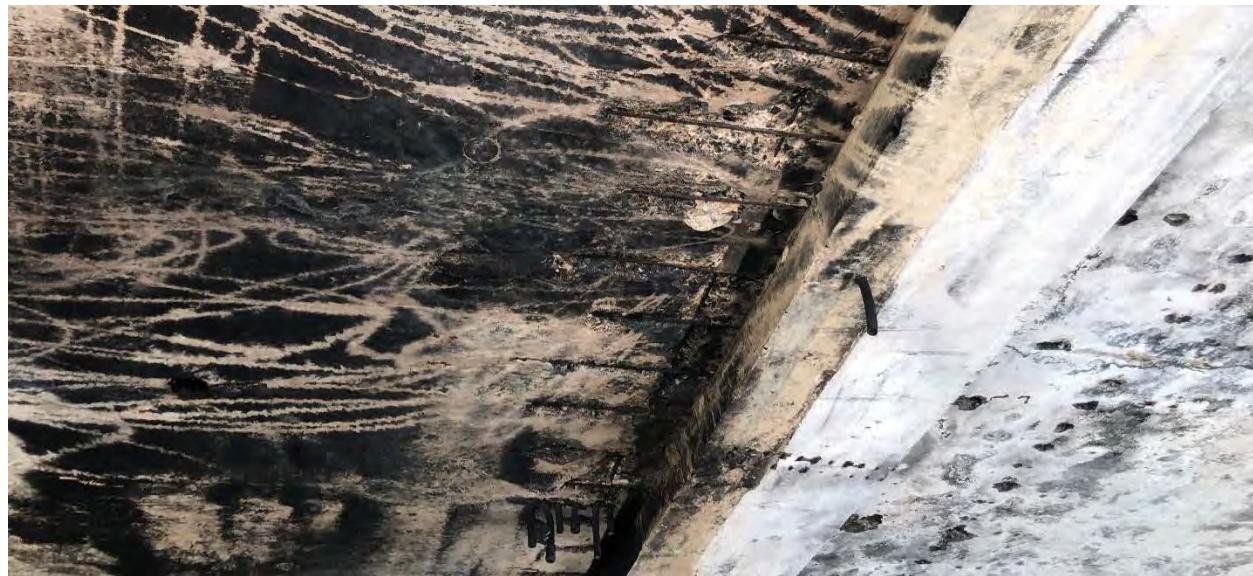
A1 and A3 are spalling at the mid height of the columns. Roof panel 1 is in poor condition due to repeated fires created under that portion of the ceiling by encampments. Heat from the fires has caused excessive spalling and deformation of reinforcement within the concrete. Roof panel 5 has significant cracking that originates from column A6, showing that the roof panel has failed.

Figure 22: Roof panel 1 with exposed rebar caused by the spalling of concrete under the heat of encampment fires

replaced, then the roof structure would have to be shored during repairs to ensure that it does not collapse. On the east pavilion, at least two (2) of the roof panels (1 & 5) would likely need to be removed and replaced completely if they are determined to have "substantial structural damage." This will also require shoring of the entire roof structure. Once the exiting roof panels are removed, new panels matching the existing dimensions of the old panels would need to be constructed with reinforcement adhering to current codes and be tied into existing roof supports. The cost of the new roof panels would be approximately \$80/square foot. Upgrading the roof panels to current coding could require more rebar, increasing the weight on existing supports. If this increased weight is too much for the existing supports, then the existing supports would need to be improved as well to carry this weight.

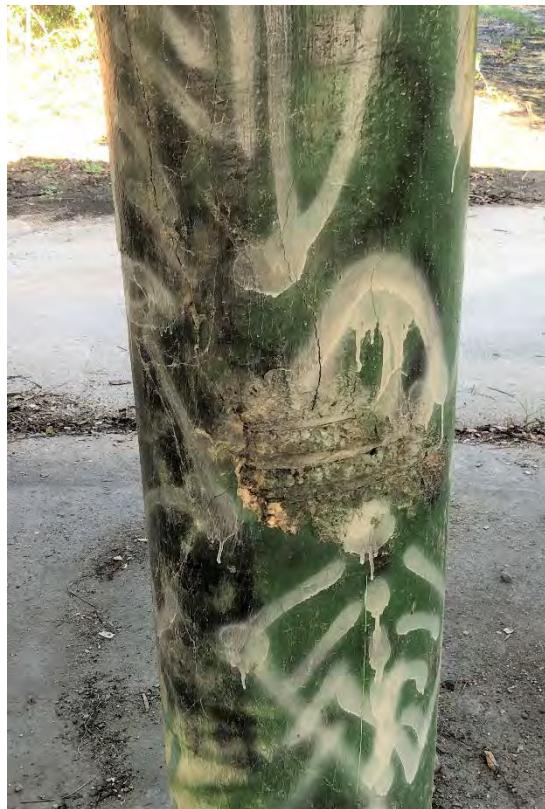
Figure 23: Mid-height spalling at column A3.

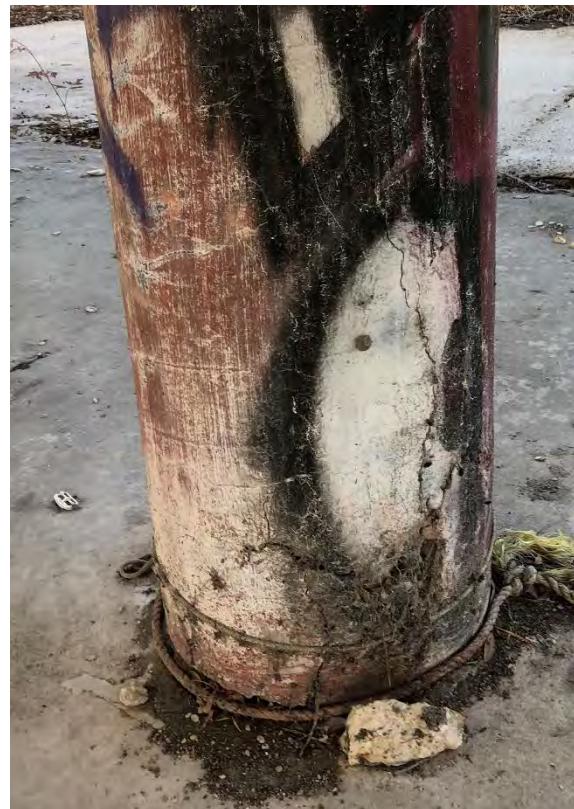
The rectangular columns appeared to have the same small cosmetic cracking as the west pavilion and appear structurally sound. Similar to the west pavilion, all of the circular columns have stress cracking on the north side of the columns caused by the roof load. Columns A2, A5, and A7 have spalling near the bottom of the columns revealing reinforcement, while columns

Figure 24: Spalling at bottom of column A5

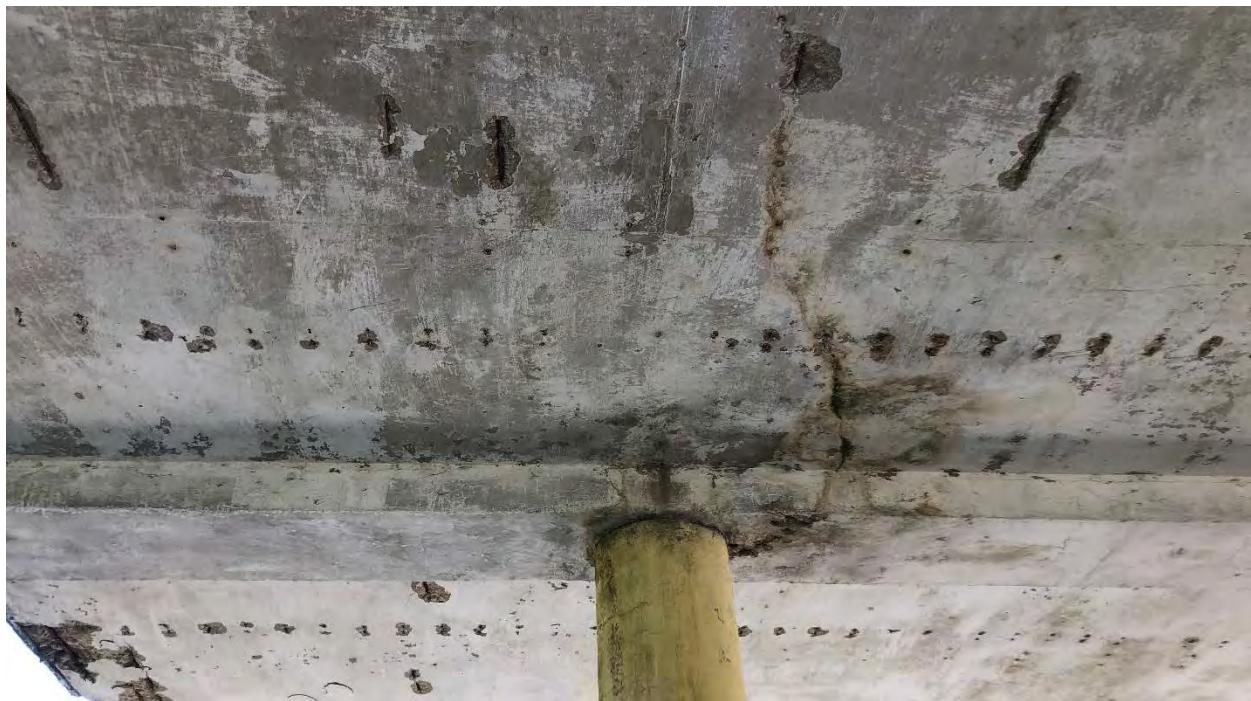
Figure 25: Crack running through roof panel 5 that originates at column A6.

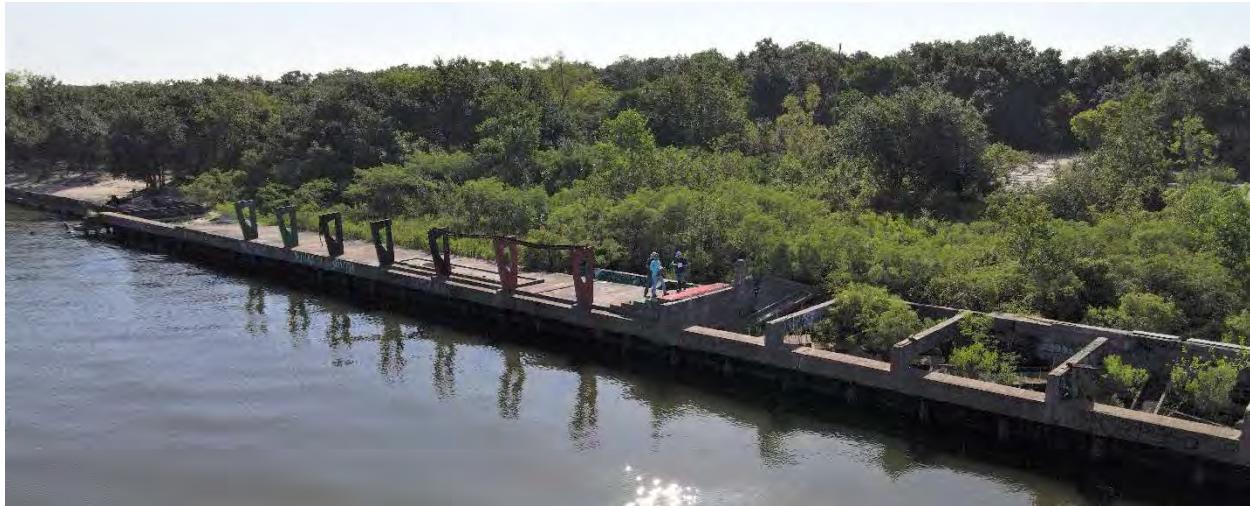
Figure 26: Current condition of the pool deck

As stated previously, the pool deck area along the beach bulkhead had an original total length of approximately 400 feet, but there is currently only 150 feet of deck still intact. It appears 250 feet of the deck was destroyed by storm surge, leaving only the deck supports behind. The canopy that ran along the deck is also missing, with only seven (7) canopy supports remaining on the 150 foot portion of deck still standing. The canopy supports had visual damage where the canopy was ripped away; leaving exposed rebar that has been damaged by corrosion from years of exposure. The 150 feet of deck remaining is lower than the missing portion, with a set of stairs leading up to the missing portion. The portion of deck still standing appears to be in good condition, but the support system of the deck was unobservable and there are no record drawings of the support system. The support beams for the portion of deck that has washed away appear to be in poor condition. Structural analysis can be completed for the deck supports to determine the classification of the supports as "dangerous" or having experienced "substantial structural damage," but after a base visual inspection of the damaged deck supports it appears that they are unusable. There is severe cracking and spalling occurring on most of the beams revealing the rebar, with apparent deformation of the rebar. Additionally, a geotechnical inspection will be required to determine soil conditions and existing pile tip locations to ensure that the load capacity of the existing deck is adequate to support the rehabilitated pool deck. However, if the desire to keep the Lincoln Beach property as close to the original design and reuse original structures for historical purposes is paramount, then the following repairs could be made:

1. The support beams (18) for the deck would need to undergo a stress test to determine the current capacity for the supports and determining if they have "substantial structural damage". If those supports meet current strength guidelines, they may only require minor grout repairs to fix cracking and provide cover to exposed rebar. However, if the beams have "substantial structural damage" then the existing beams must be encapsulated by new stirrups, longitudinal bars, and concrete according to current code requirements. This repair would cost

approximately \$6,000/support. The material chosen for the new deck would be determined by future design choices; however the original deck was made of concrete panels.

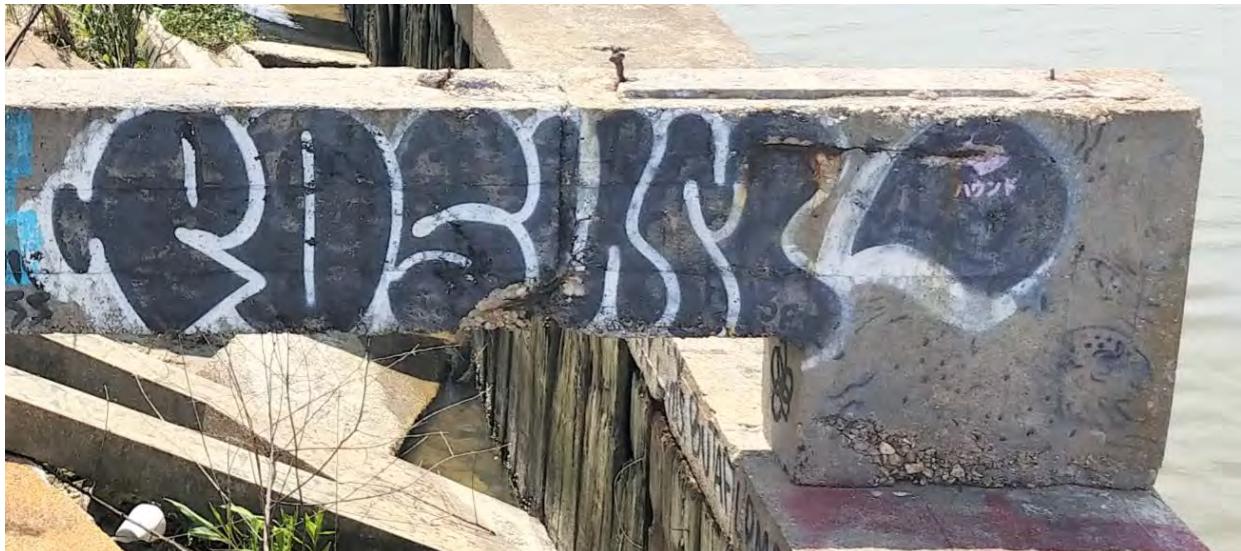
Figure 27: Visual crack through the entire section of the existing deck support

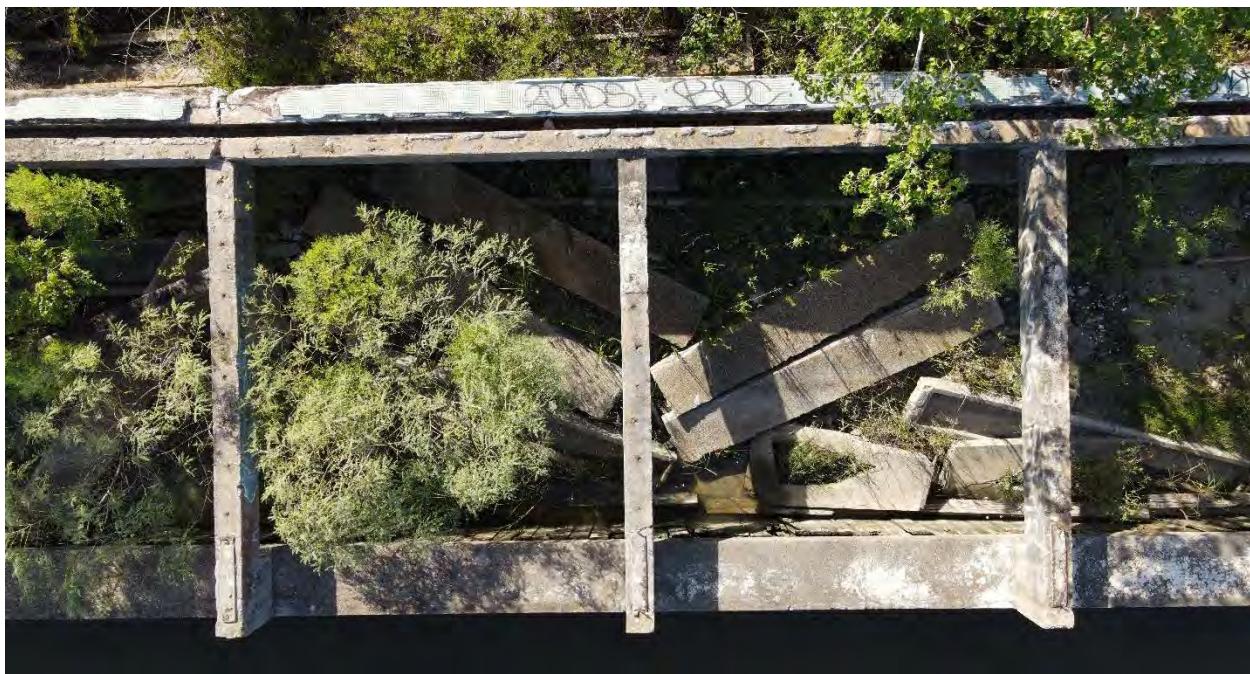
Figure 28: Aerial view of existing deck supports and the washed away concrete decking

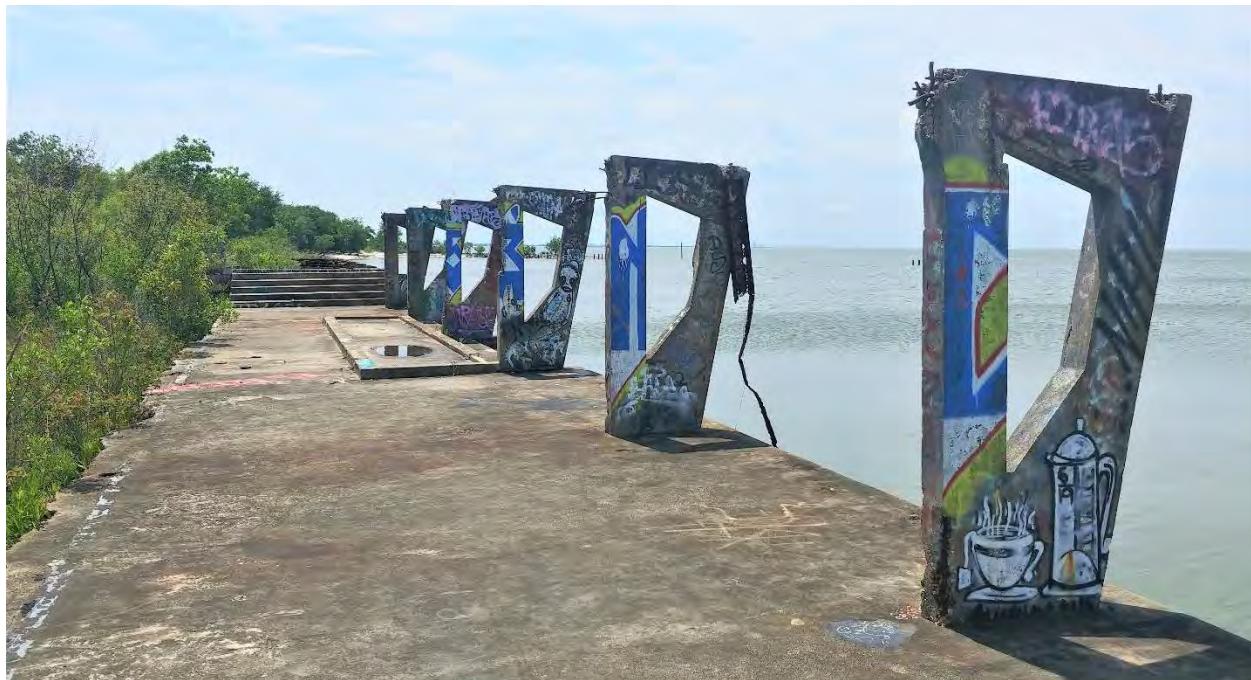
Figure 29: The remaining pool canopy supports remaining on the portion of deck still standing

2. The few pool canopy supports that remain could be salvaged and used as a reference for a potential new pool canopy. The existing supports would need minor crack repairs with grouting, and the exposed rebar where the canopy connected to the supports would need to be removed. A new canopy could be connected to the existing supports. The remaining pool canopy supports could also be salvaged for

\$20,000 each and moved to a different location on site to be utilized as supports for future Lincoln Beach elements to be determined by the property owner.

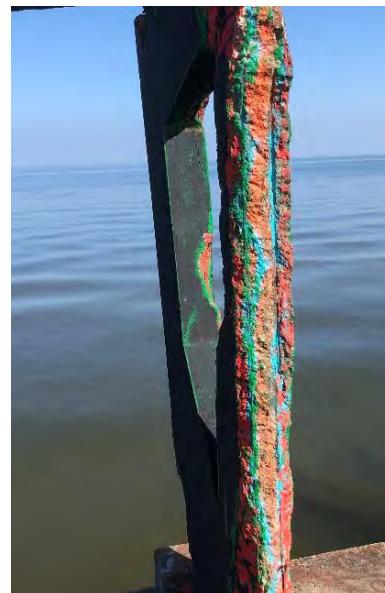
Figure 31: Canopy support with all rebar exposed due to spalling

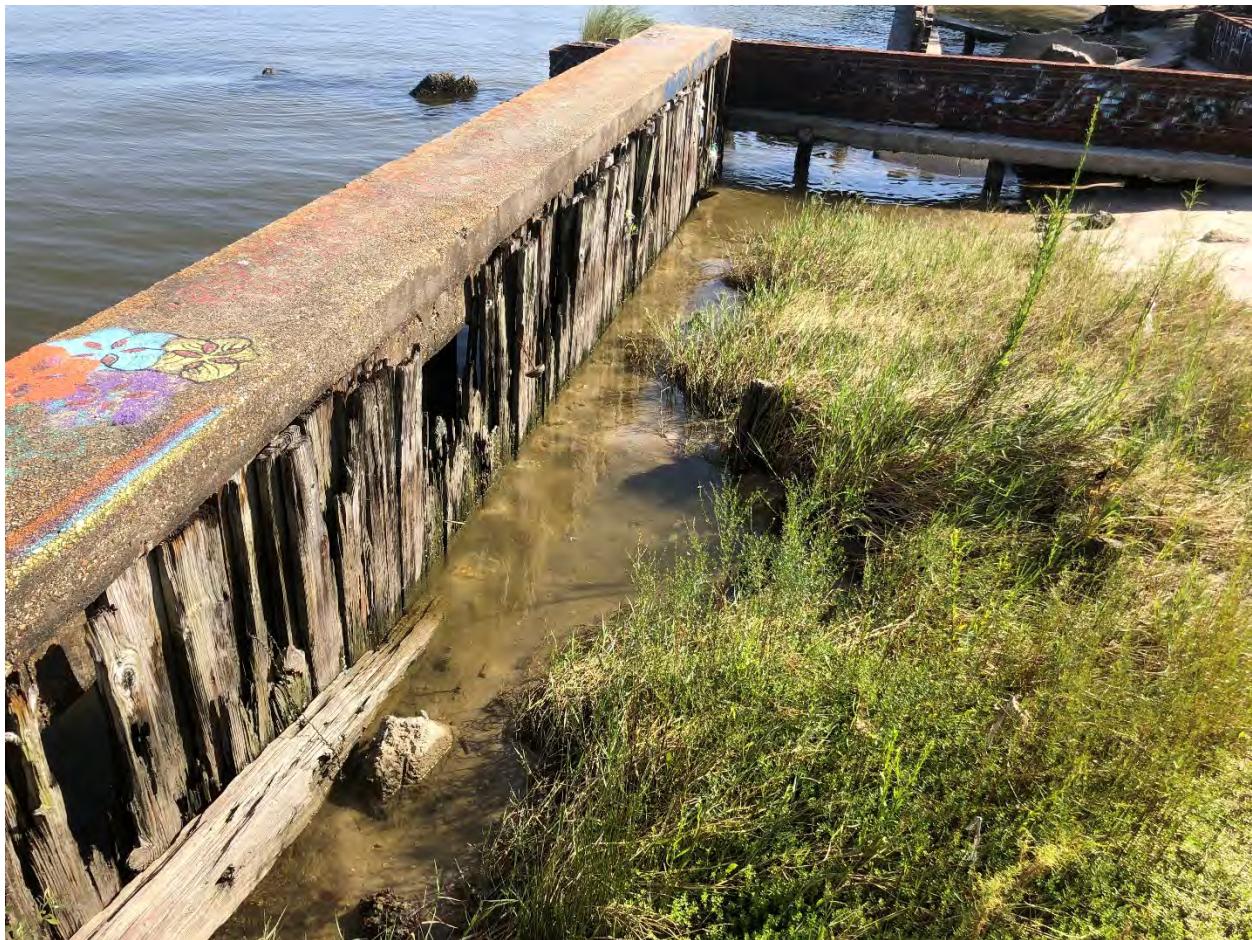
Figure 32: Portion of bulkhead exhibiting damage and erosion of sand

The 12 inch diameter wood piles (approx. 130) will need to be encapsulated and poured with grout around the deteriorated wood to ensure that the piles are structurally sound. Most of the wood panels comprising the retaining wall would need to be replaced with new wood panels or potentially synthetic or metal panels instead.

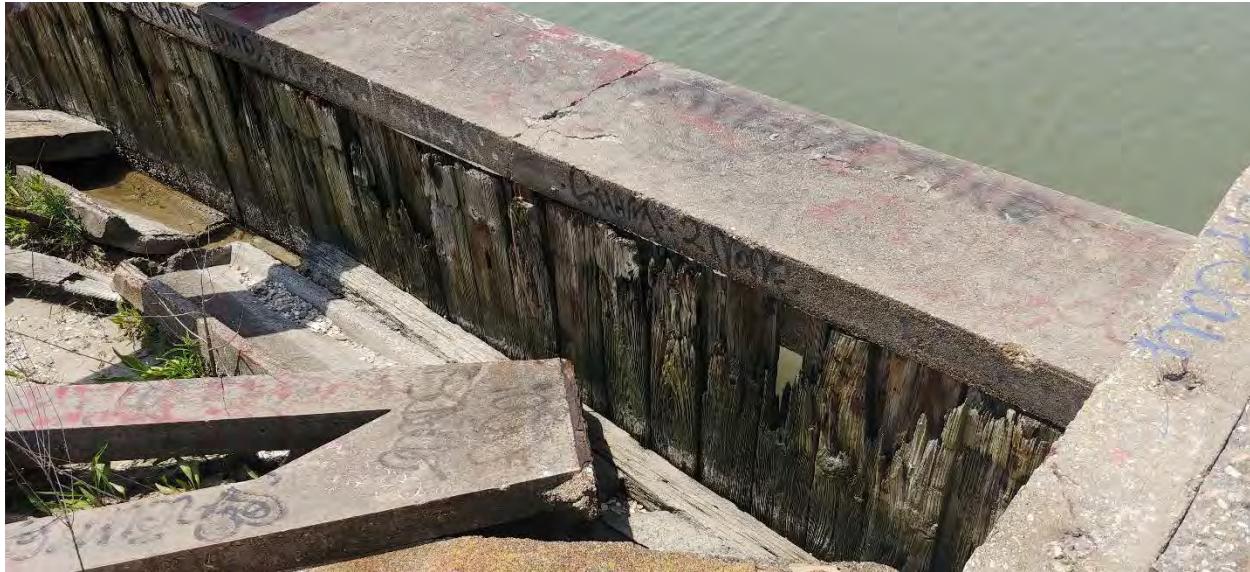
Figure 33: Damaged bulkhead beneath the pool deck supports

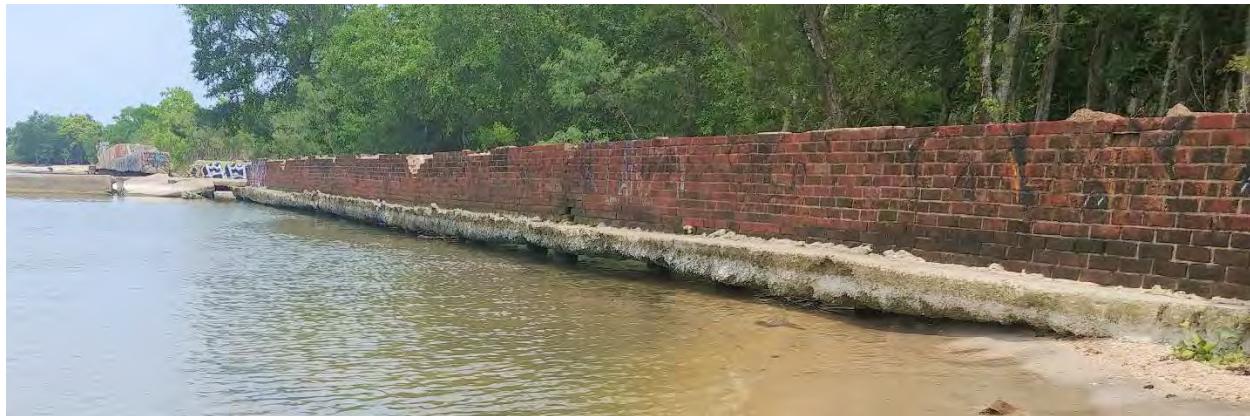
Figure 34: Erosion exposing the underneath of the bulkhead

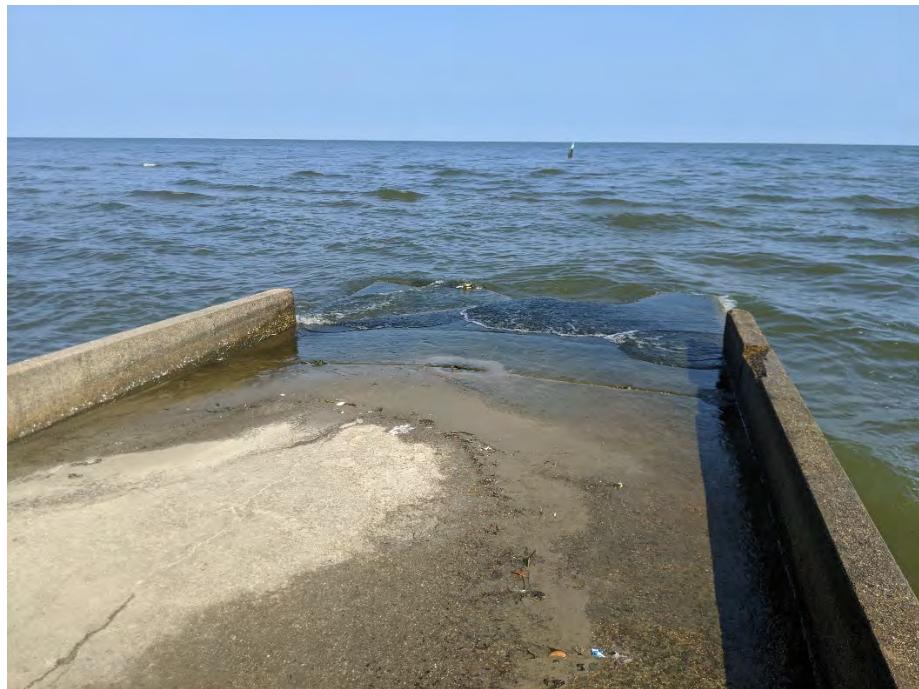
The existing concrete pad in Figure 1 is all that remains from the old pier that used to be at Lincoln Beach and will need to be removed from the site to upgrade the beach. A new timber dock can be constructed for approximately \$120 per square foot of dock. For boats to be able to access the dock it is recommended for the dock to extend to the -4.5 foot contour line. Constructing a dock of similar size to the previous pier that used to exist will cost approximately \$477,500. This cost includes access dredging for a barge to reach the site since the equipment used to construct the dock will not be able to access the site from Hayne Blvd through the tunnel.

Figure 35 – Concrete Pad to be Removed

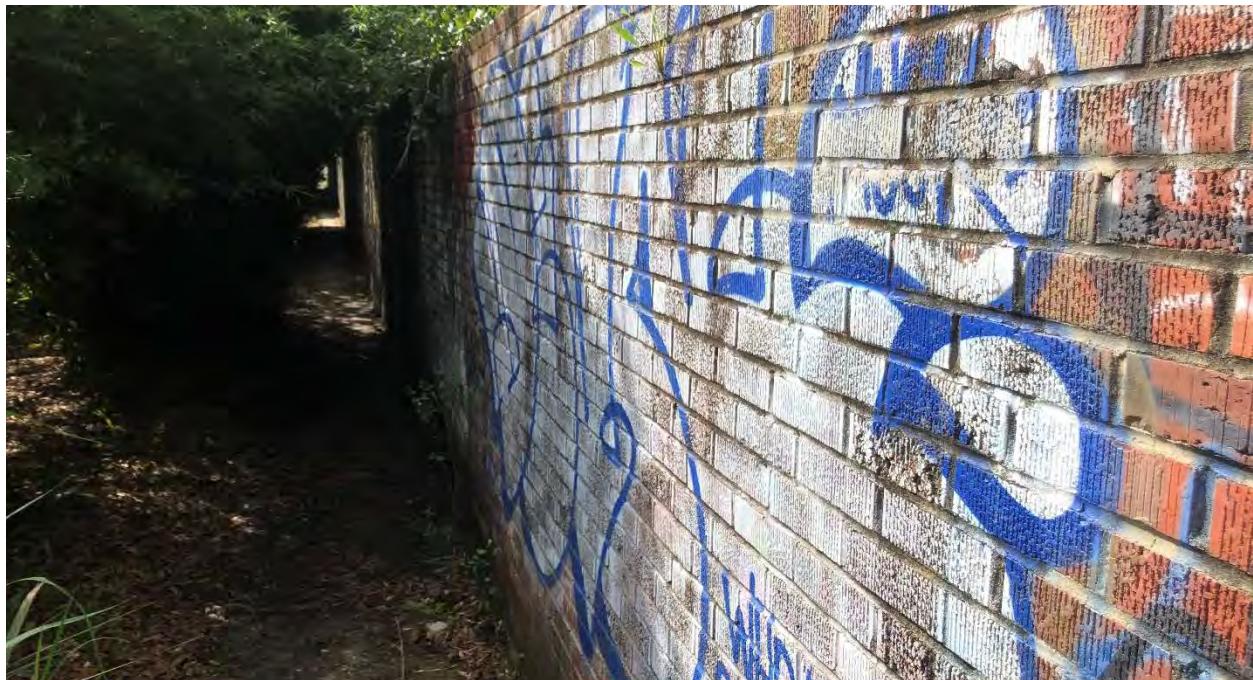
Figure 38: Portion of brick fence covered in graffiti but in good condition

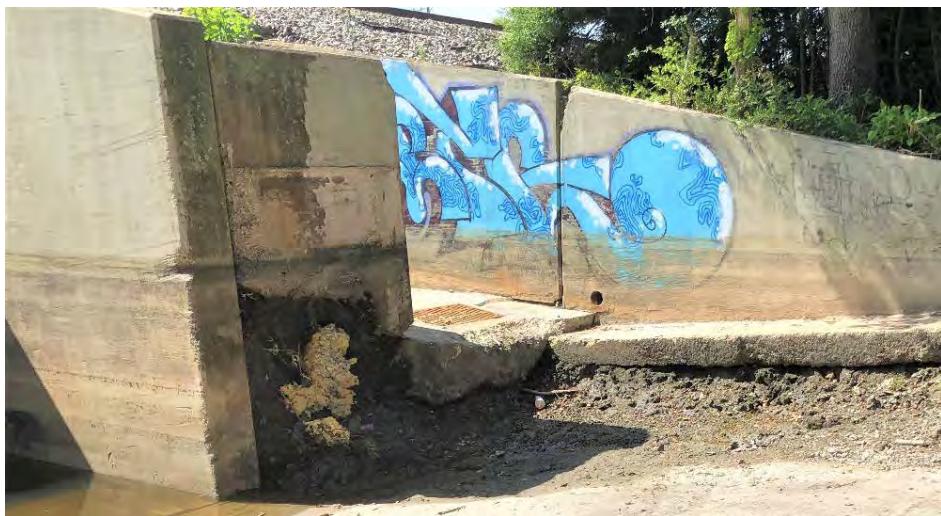
Structurally the three access tunnels appear to be in good condition. The only issue with the access tunnels is the western tunnel on the north side has the bottom half of the concrete retaining wall missing. This has caused earth behind the wall and beneath the train tracks to erode. If this is left unattended, the earth beneath the train track will eventually erode completely, threatening the integrity of the tracks. It is recommended that the owner of the retaining to repair it as soon as possible to prevent further erosion beneath the train tracks. The tunnels will also need new drainage, as the tunnels currently hold multiple feet of water. Alternatives for tunnel drainage is provided in the Utilities Technical Memorandum.

Figure 39: The bottom of the retaining wall is missing, revealing earth beneath the train tracks

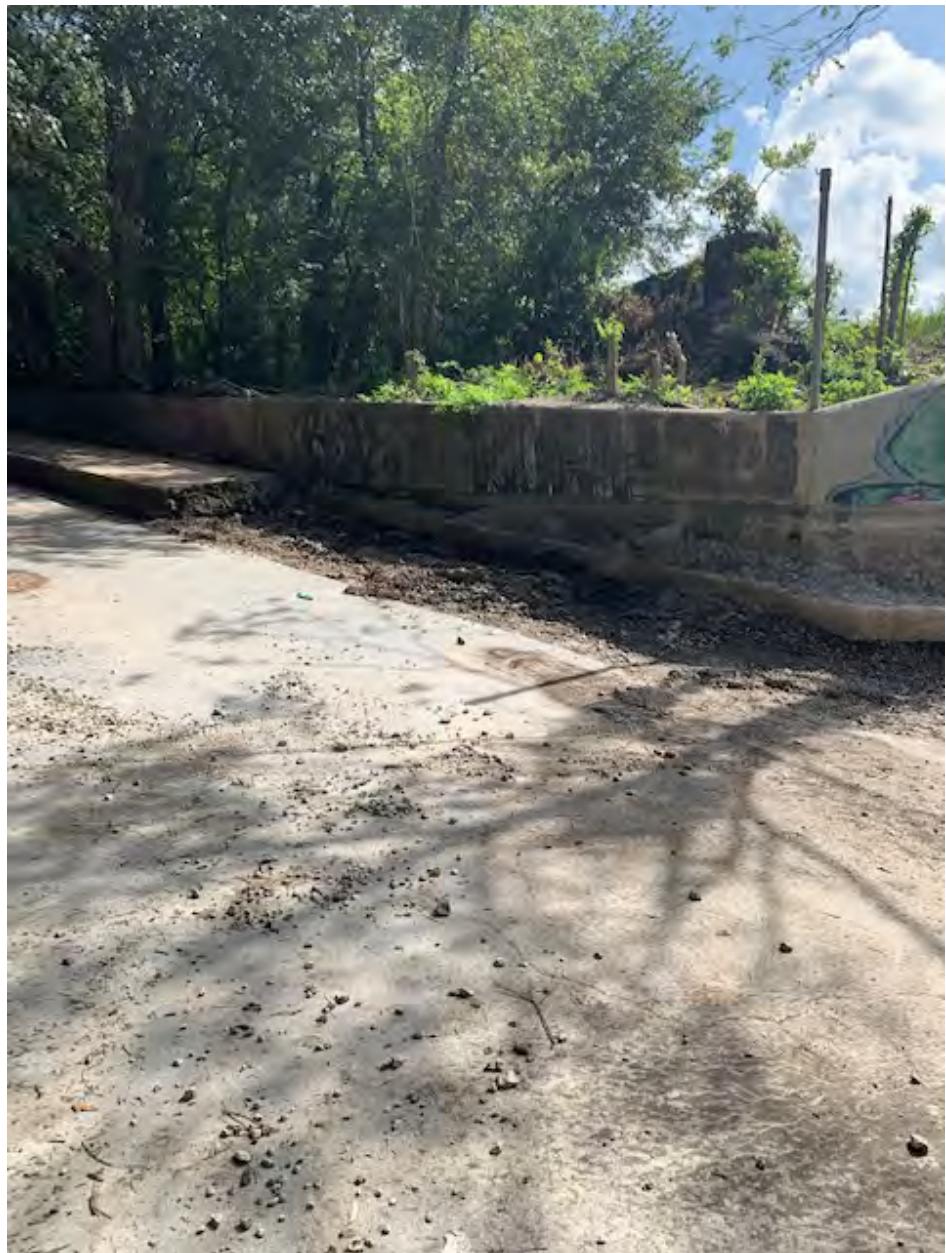
Figure 46: Missing 50'x8' Concrete Walk on East side of Horseshoe Driveway

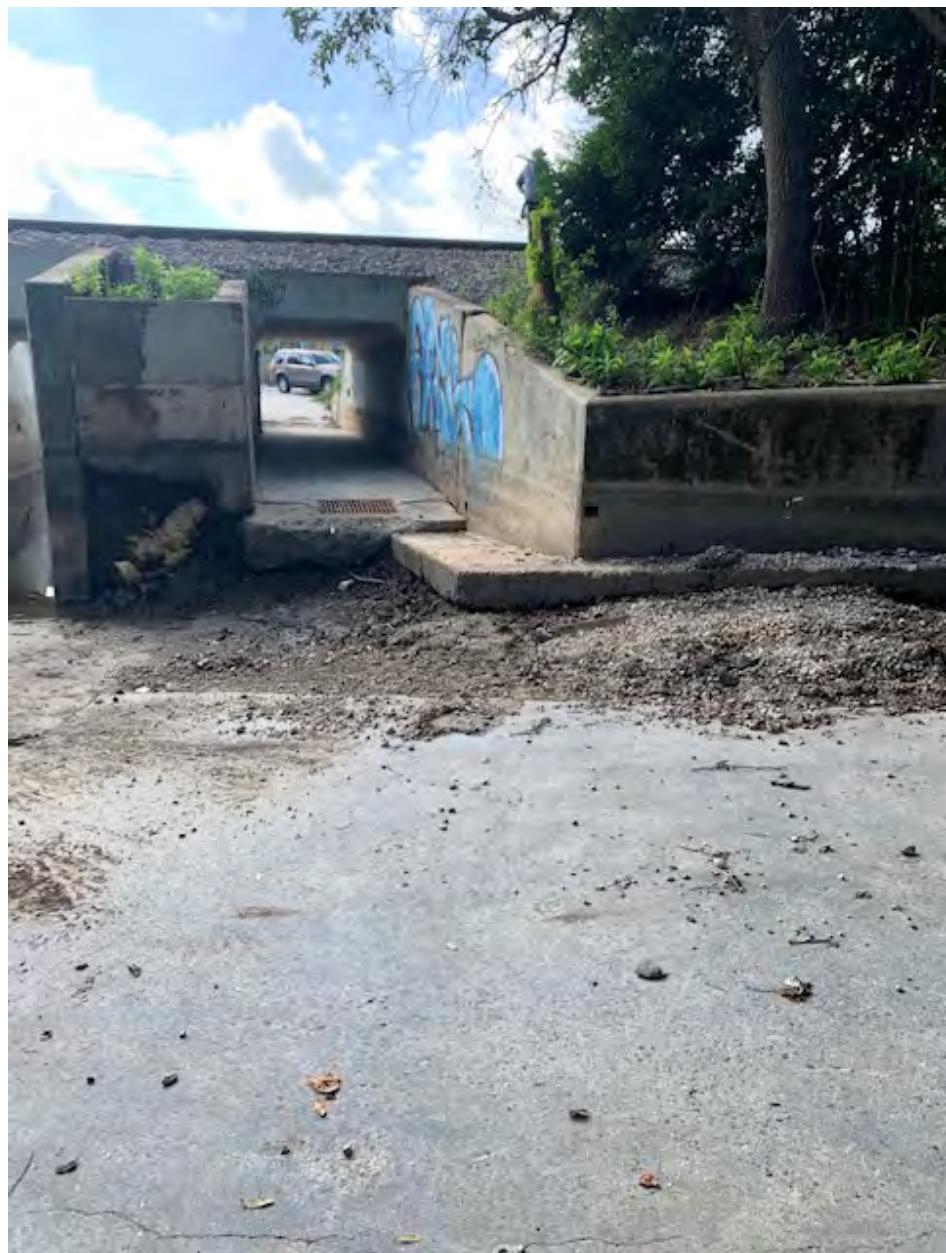
Figure 47: Missing 30'x8' Concrete Walk on West side of Horseshoe Driveway
