CITY OF NEW ORLEANS

Historic District Landmarks Commission

Guidelines for Roofing

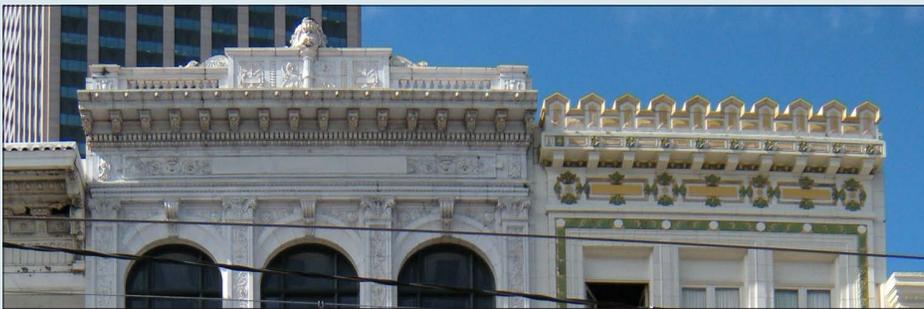
This commercial building row has decorative cornices and parapets at the front elevation with lower flat roofs behind. Retain all historic cornices and parapets.

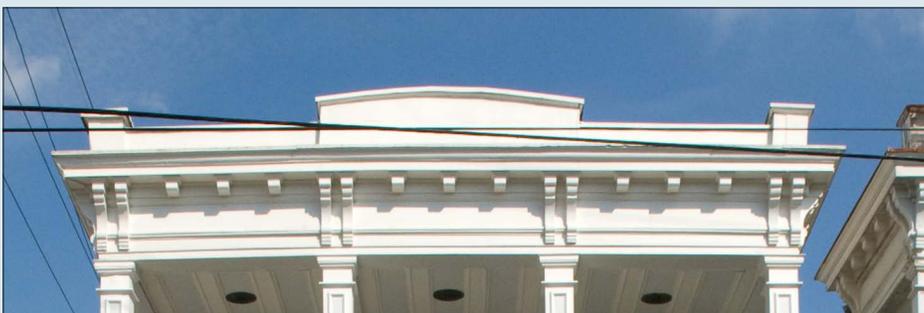
The parapet on this residential gallery features a central arch and conceals the low sloped gable roof beyond. The paired brackets at the cornice are typical of the Italianate style.

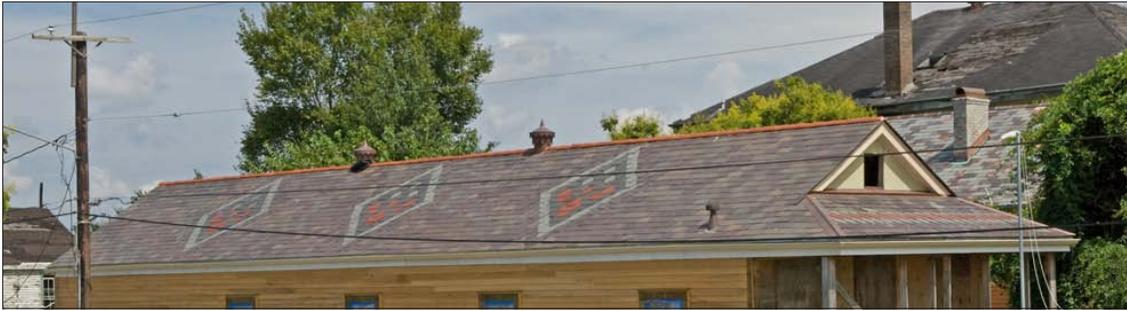
This distinctive slate roof with diamond patterns, terra cotta ridge caps, and Chinese caps are being retained as part of the rehabilitation project.

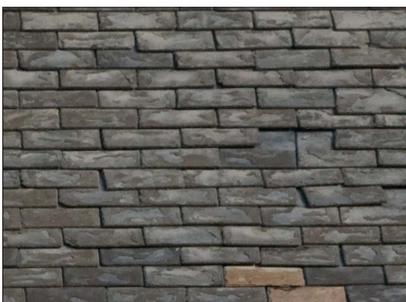
Individual missing or damaged slates can often be replaced, extending the serviceable life of the roof and postponing costly replacement.

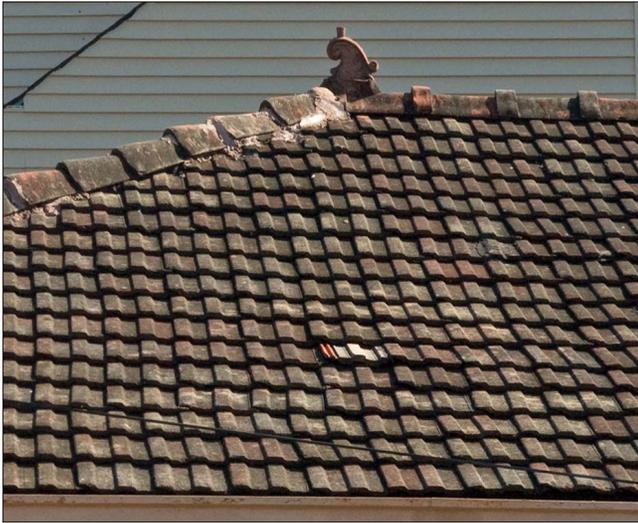
This concrete tile roof includes a finial and terra cotta ridge caps at the top of the main roof and along the roof hip.

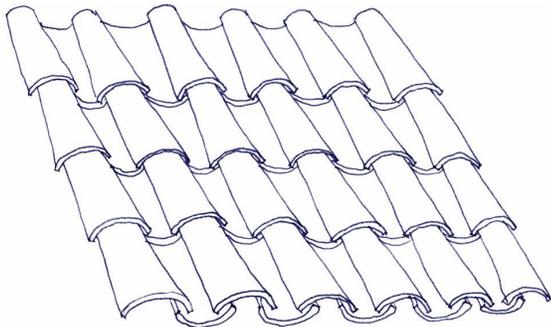
Terra cotta tile provides a durable, fire resistant and distinctive roof finish. Spanish tiles are rounded and installed in an overlapping pattern.

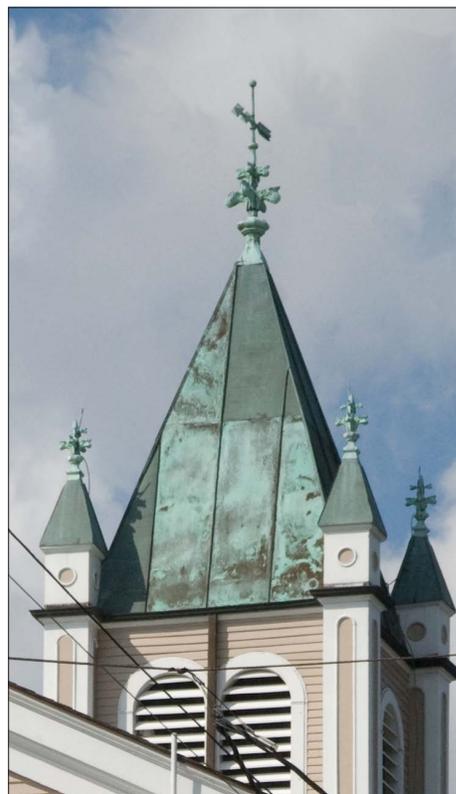
The top of this church tower includes a standing seam copper roof, copper finials and a weathervane. Copper roofing is known for its longevity with relatively little required maintenance.

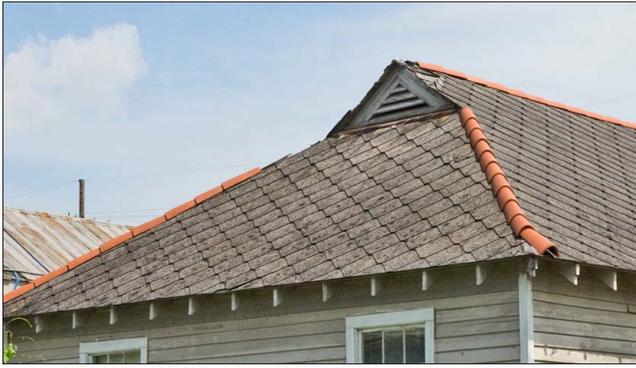
The asbestos shingle roof has terra cotta caps on the ridge and hips and a triangular louvered vent at the front gable. The ridge caps and louvered vents should be retained. Gutter installation is recommended.

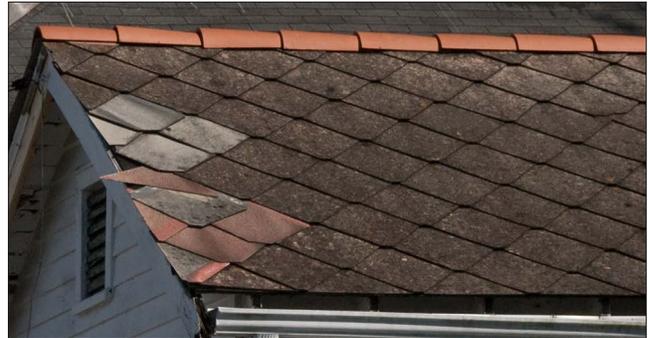
The asbestos roof has some non-asbestos replacement shingles of a similar size and shape as the existing roofing.

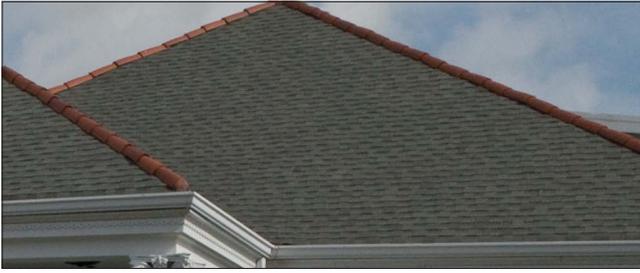
This dimensional asphalt shingle hipped roof features ridge tiles at the hips and a perimeter gutter.

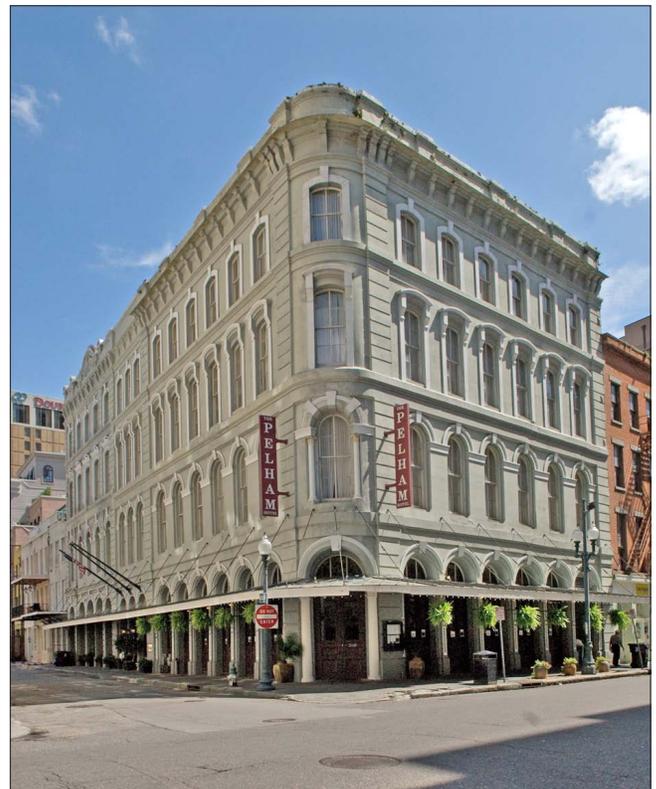
A flat or low-sloped roof is located behind the parapet and bracketed cornice.

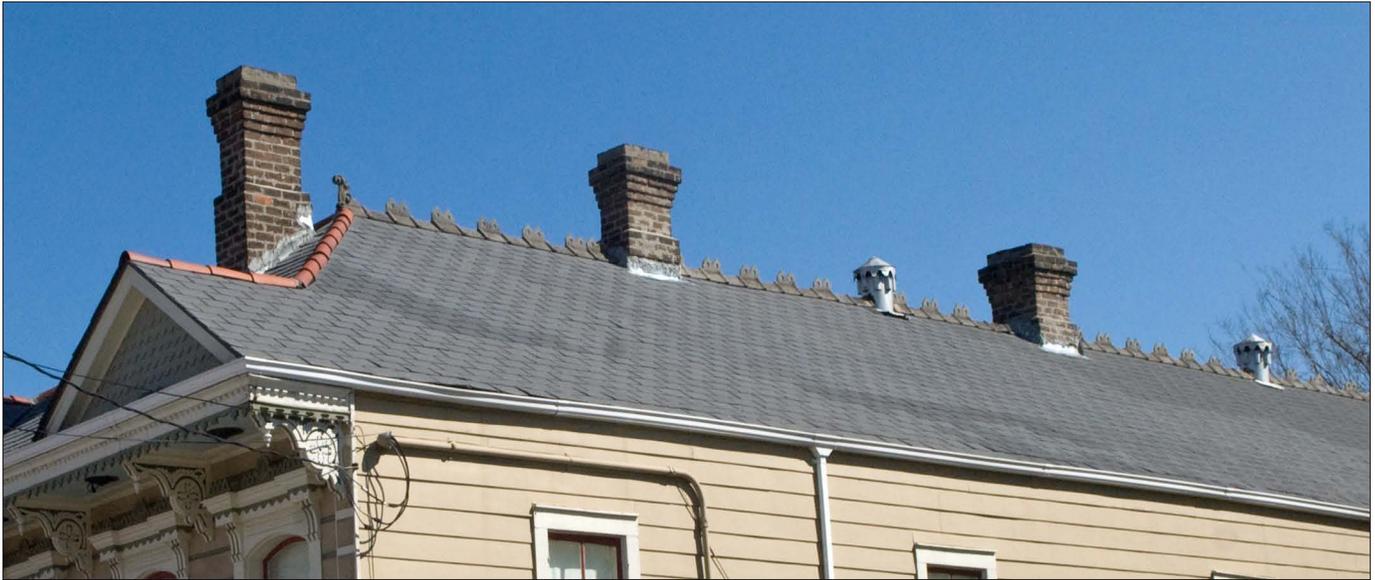
Ridge caps are located along the roof hips, cresting is along the top ridge and a finial is found at the end of the main roof gable. Chimney placement reflects the internal organization of the residence and Chinese caps provide roof ventilation.

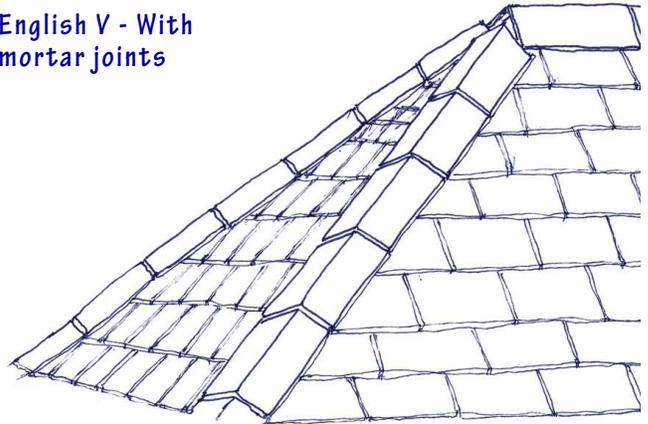
English V - With mortar joints

Ridge tiles in New Orleans are often in an English-V profile with mortar between adjoining tiles as seen in the top drawing or in overlapping Spanish tiles as seen below.

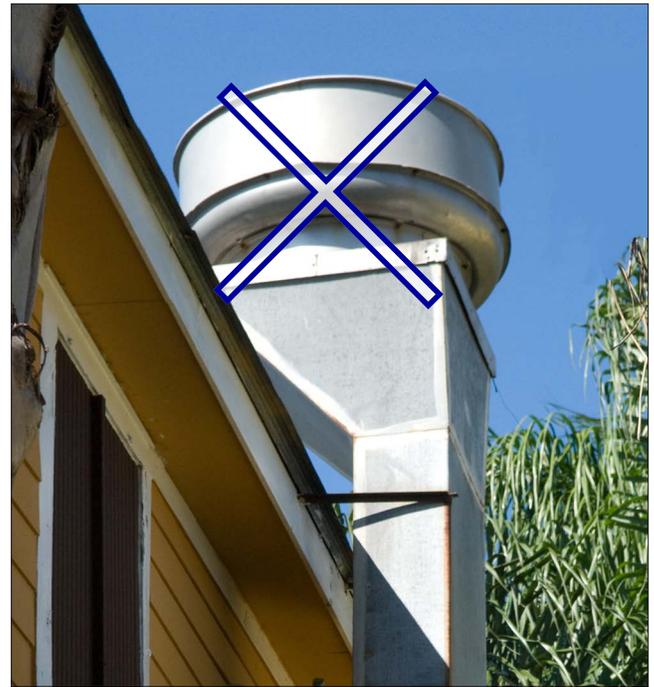
Restaurant vents and exhausts should be installed within the building envelope and in a location where they are not visible from the street.

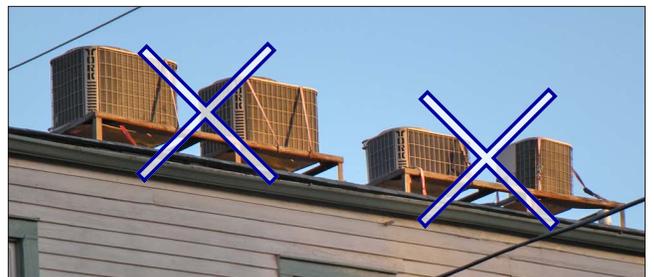
Rooftop equipment shall not be installed in a visually obtrusive manner.

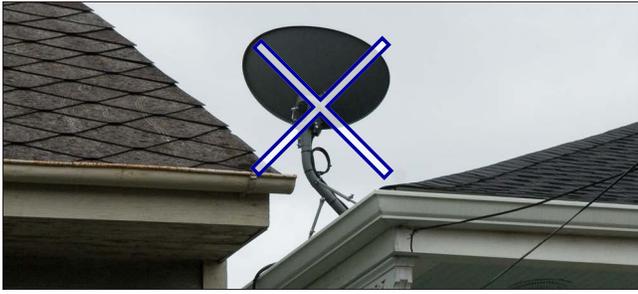
Satellite dishes should be installed towards the rear of the building so they are minimally visible from the street.

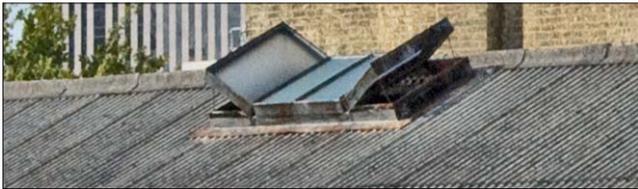
Some skylights were historically located in warehouse and commercial buildings, providing natural interior light and ventilation. The visibility of new skylights should be minimized.

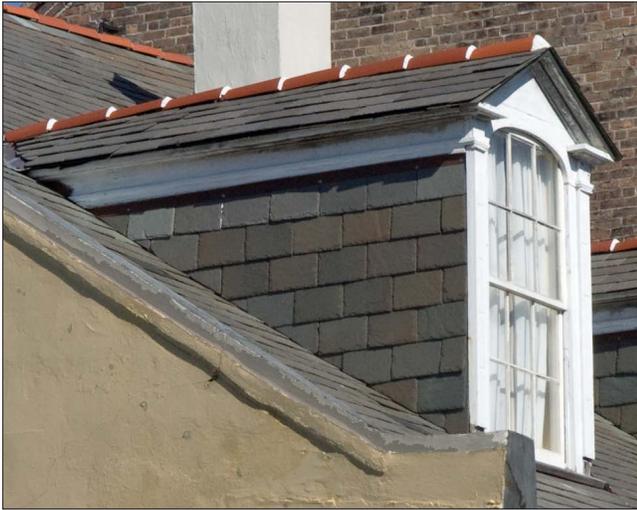
These gable roof dormers are appropriately located, proportioned and detailed for the building and include slate cheek walls. Spanish tile ridge caps should be retained.

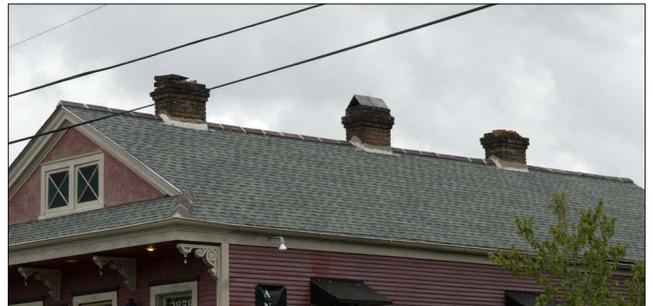
This row of three chimneys suggests the division of rooms on the interior of the building. The central chimney includes an inverted “V” cap and English V ridge tiles with mortared joints marking the top of the roof.

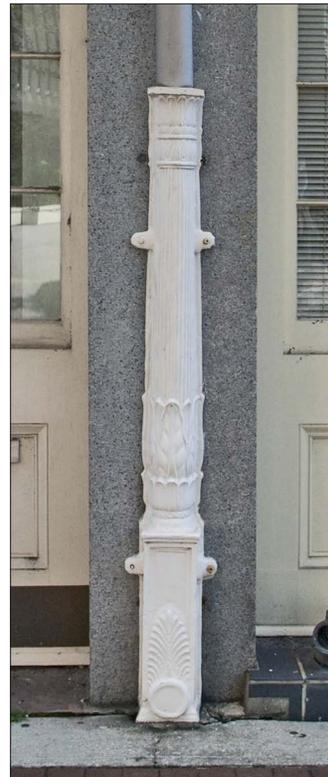
Decorative cast iron boots should be retained.
