Working with Trees in New Orleans

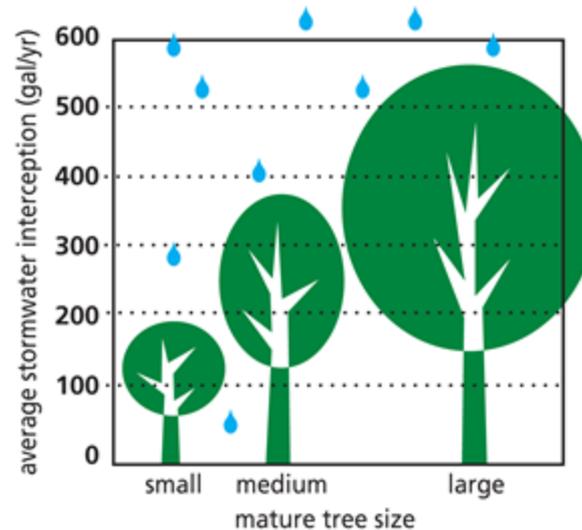
The larger the tree, the more stormwater it can manage.

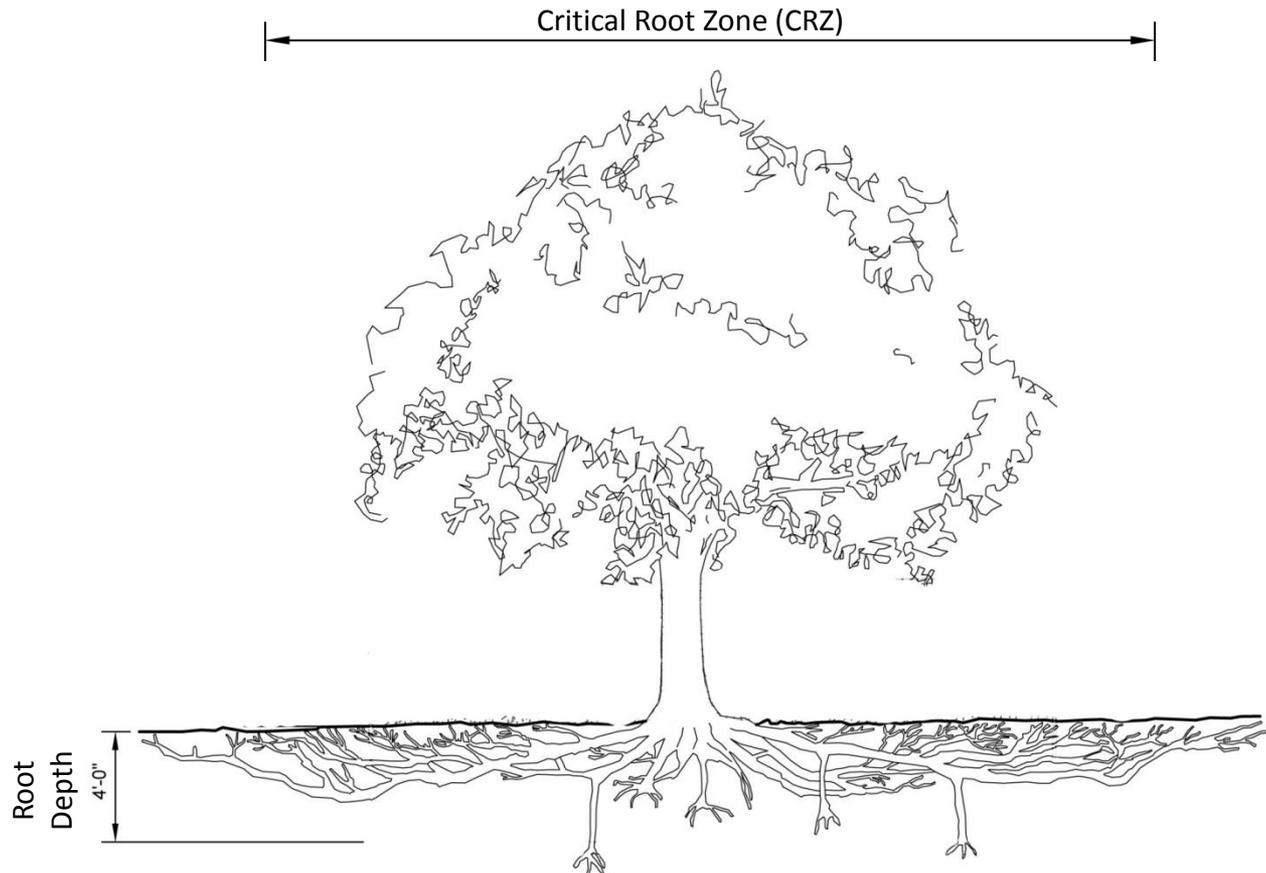
- Roots provide trees with nutrients and prevent trees from falling over.
- The critical root zone (CRZ) is the area directly under the canopy dripline.
- Digging or cutting roots within the CRZ can cause toppling of the tree or a gradual death over a period of up to 10 years.
- *Trees often die so slowly that people do not make the connection between construction damage and decline of the tree.*
- The tree root system extends beyond the canopy and to a depth of about 4 feet. 95% of the roots are in the top 2 feet of soil.

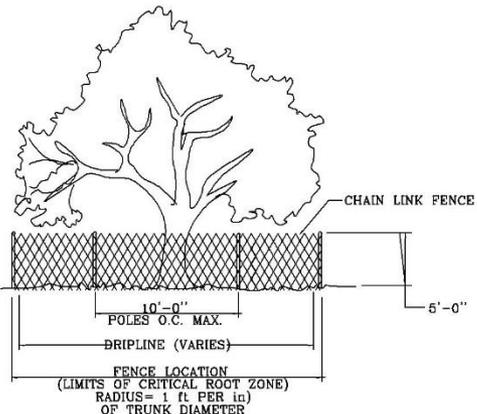
TREE PROTECTION FENCING
CHAIN LINK FENCE
N. T. S.

- NOTICE IS TO BE POSTED ON FENCING - 15' O.C. - AND SHALL READ " <<<WARNING>> PROTECTIVE TREE FENCING. DO NOT ENTER, MOVE OR REMOVE"

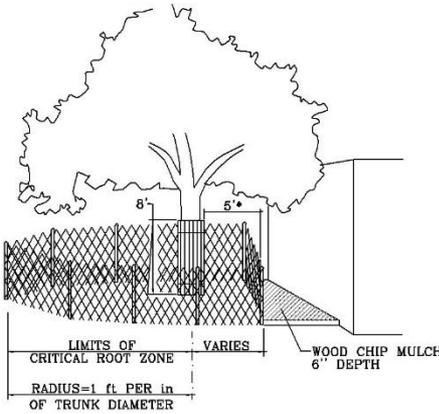
MODIFIED TREE PROTECTION FENCING
CHAIN LINK FENCE
N. T. S.
*AS NEEDED TO PROVIDE MINIMUM NECESSARY WORK SPACE. IF LESS THAN 5', THEN ADD BOARDS STRAPPED TO TRUNK.

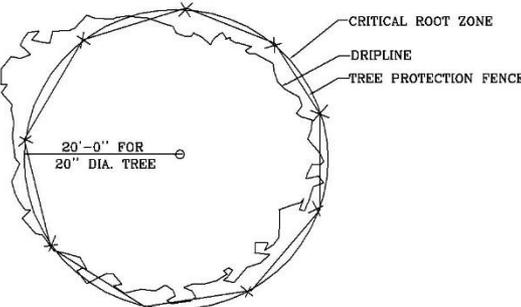
TREE PROTECTION FENCING
CHAIN LINK FENCE
N. T. S.

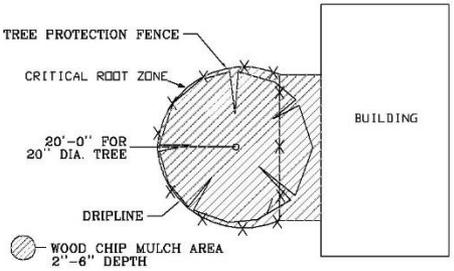
MODIFIED TREE PROTECTION FENCING
CHAIN LINK FENCE
N. T. S.

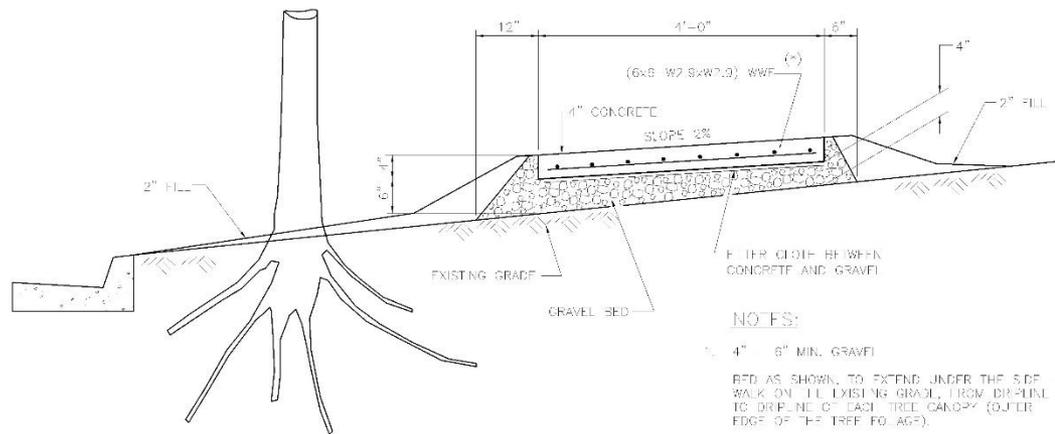
SIDEWALK GRAVEL BED

1. 4" - 6" MIN. GRAVEL BED AS SHOWN, TO EXTEND UNDER THE SIDEWALK ON THE EXISTING GRAVEL, FROM DRAIN TO DRAIN OR EACH TREE CANOPY (OUTER EDGE OF THE TREE CANOPY).
 2. NO MORE THAN 1.5" - 2.0" OF HILL TO BE PLACED UNDER ANY TREE CANOPY.
 3. NO EXPANSION JOINTS TO BE PLACED OVER ROOTS. ONLY "WEAKENED PLANES" SHALL BE ALLOWED.
- (*) WITH 1.5" - 2.0" COVER

REQ'D. AT EACH TREE LOCATION

- The sidewalk bridging detail should be used where possible in instances of tree root conflicts.
- In some instances, it may be possible to leave existing curbs in place instead of replacement.
- In some instances, we may be able to make streets narrower in order to abandon curbs in place.

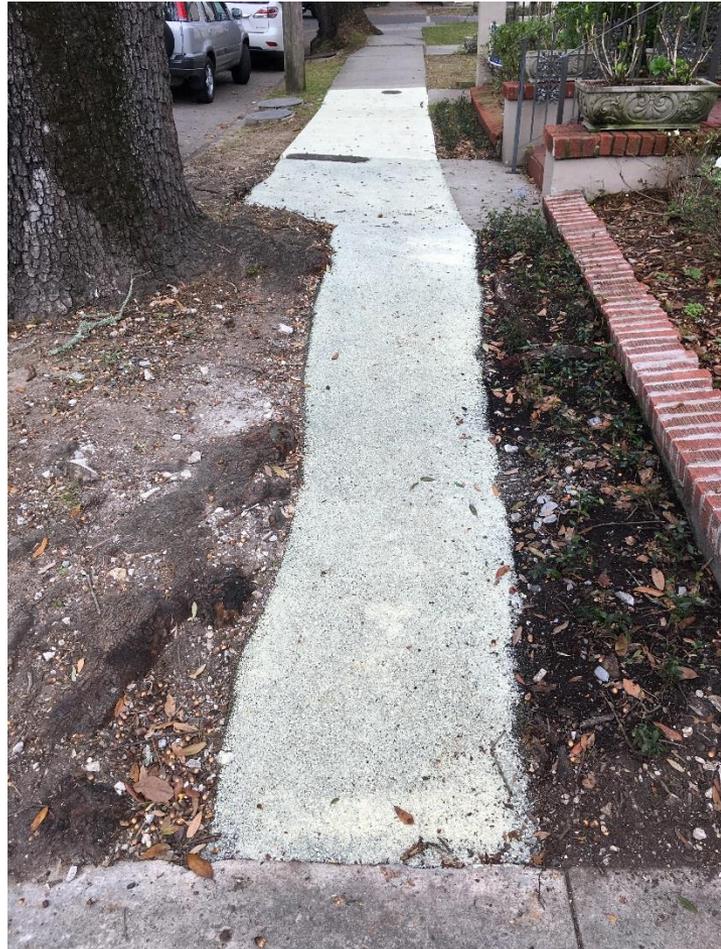
Flexipave has been installed in a few locations in an attempt to address tree root/sidewalk conflicts (pictured is 7927 St. Charles Avenue).

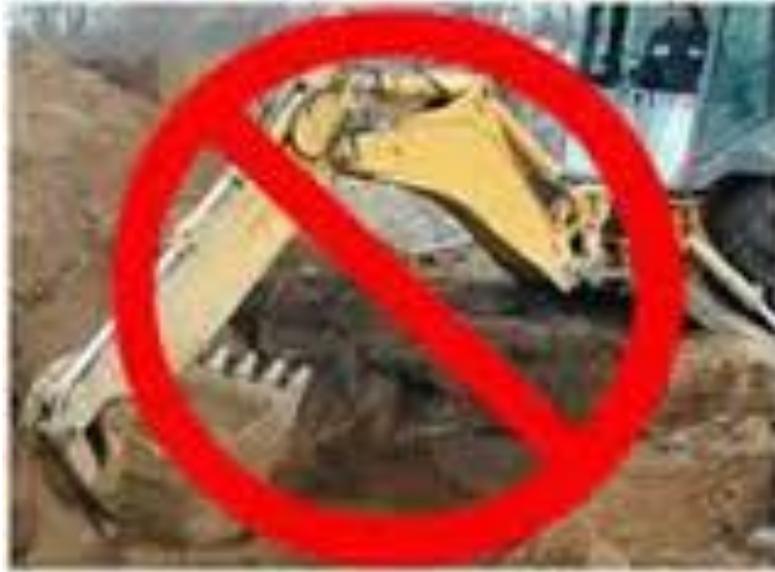
Using backhoes anywhere near a tree will cause major damage to the tree.

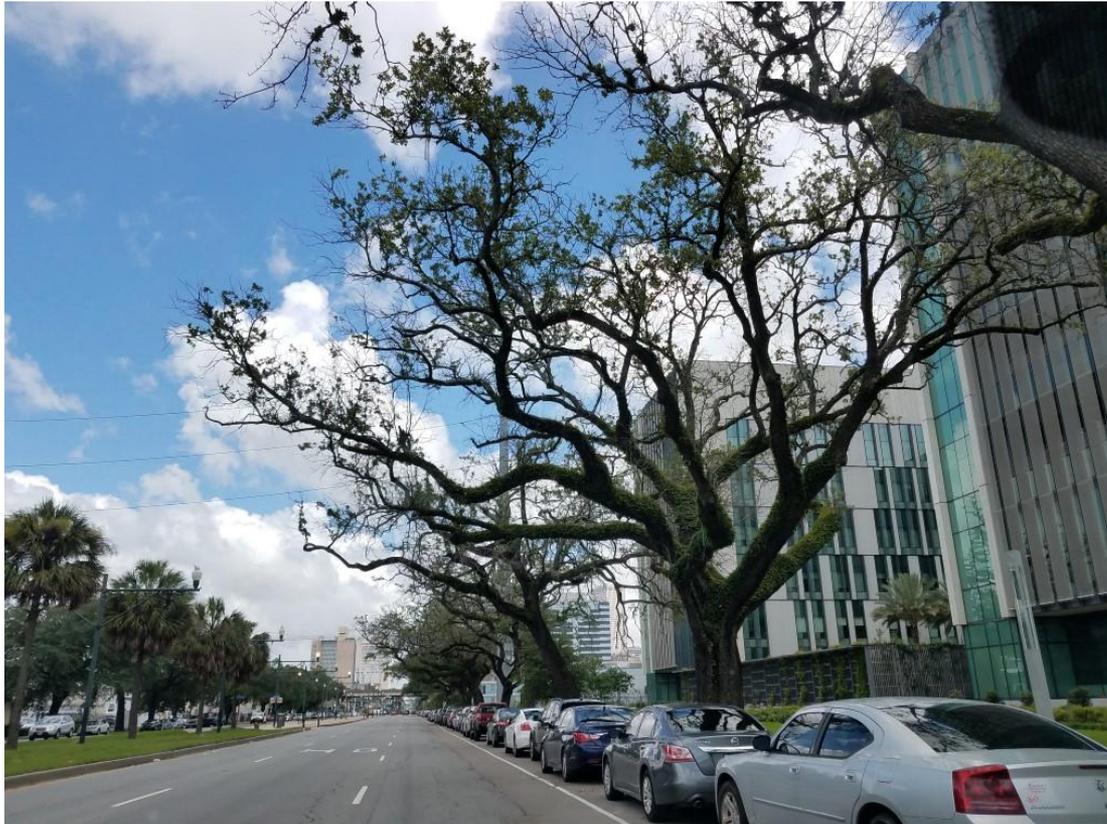
Biomedical District (Canal Street)

The trees along Canal Street were subjected to root disturbance as a result of utility, sidewalk and other construction. The trees went into rapid decline as a result of the severity of the root damage. Canal Street will continue to lose its signature live oak canopy over the coming years.

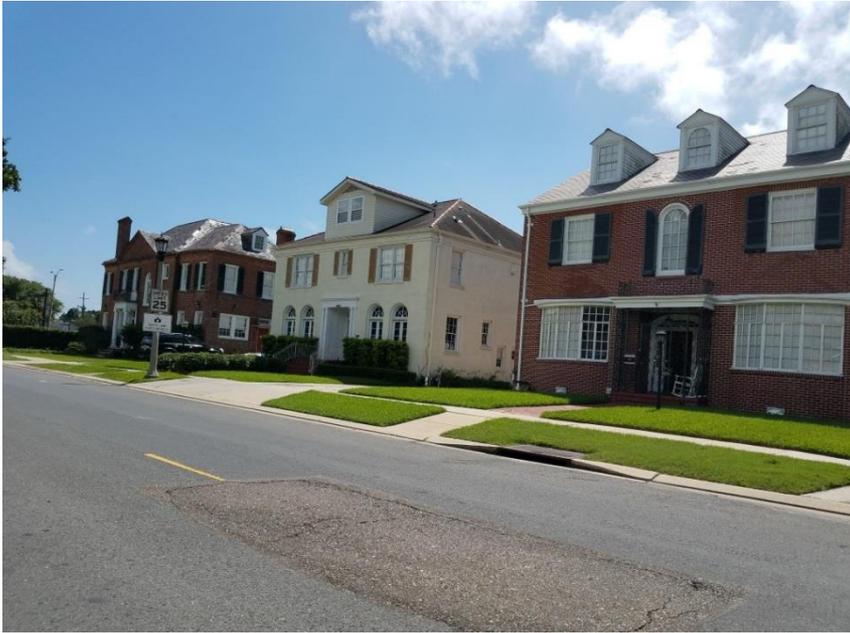
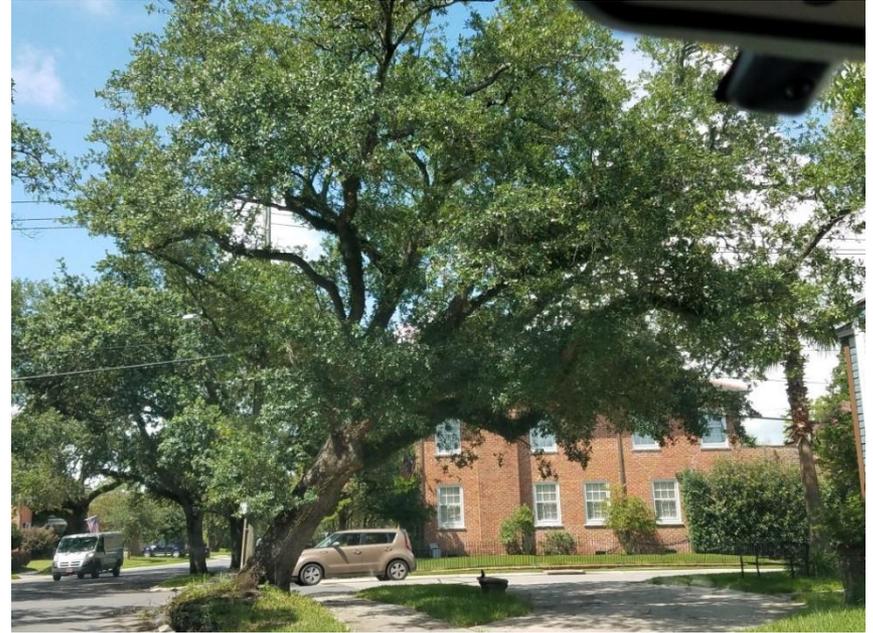
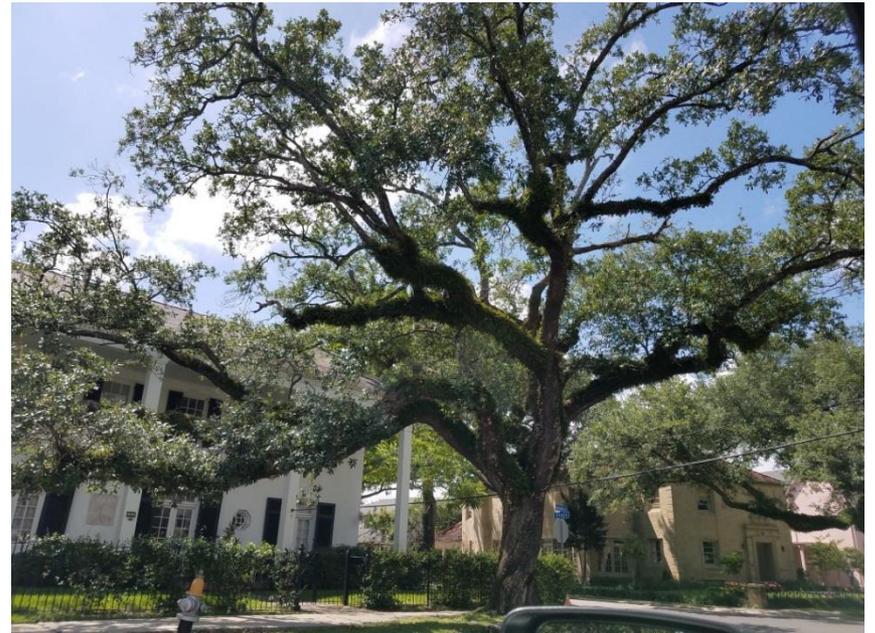
Vendome Place

This street/sidewalk project resulted in the demise of mature live oak trees, permanently changing the character of this formerly tree lined street. Some of the trees lost their structural integrity and began to lean when roots were severed. Many of the remaining trees continue to decline.

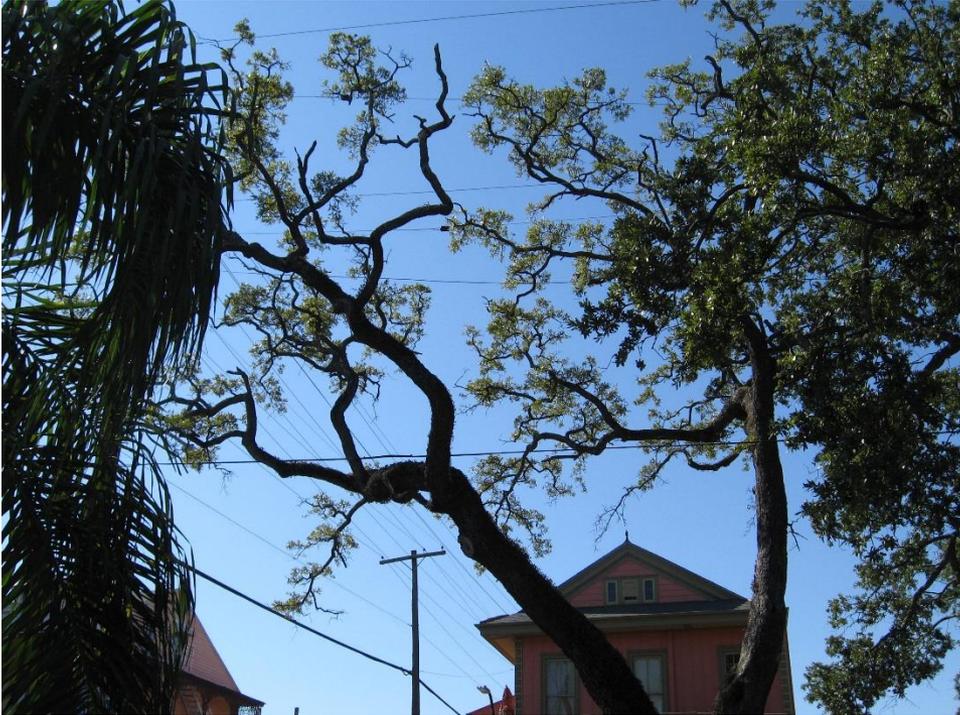
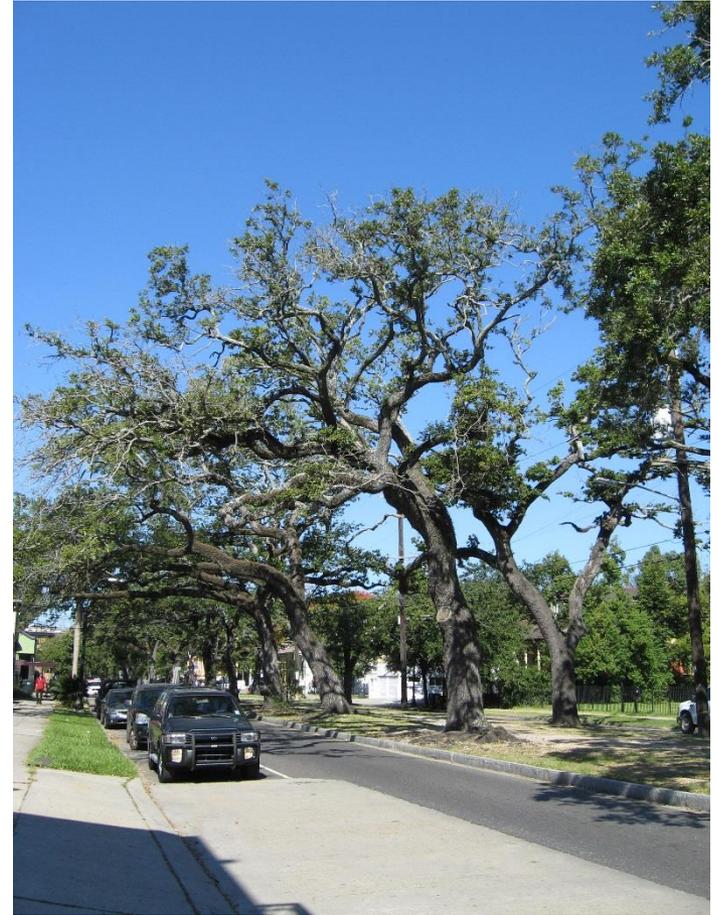
Esplanade Avenue

A curb replacement project resulted in the slow demise of mature live oak trees on the neutral ground many years after construction ended. Over 13 large live oaks were removed from the neutral ground in 2015, and many of the remaining trees continue to decline.

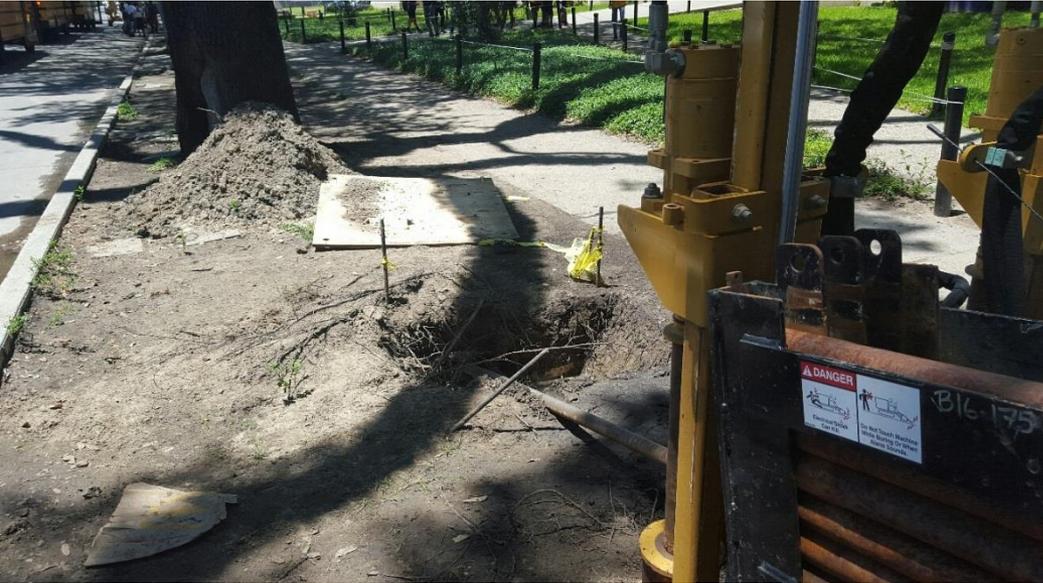
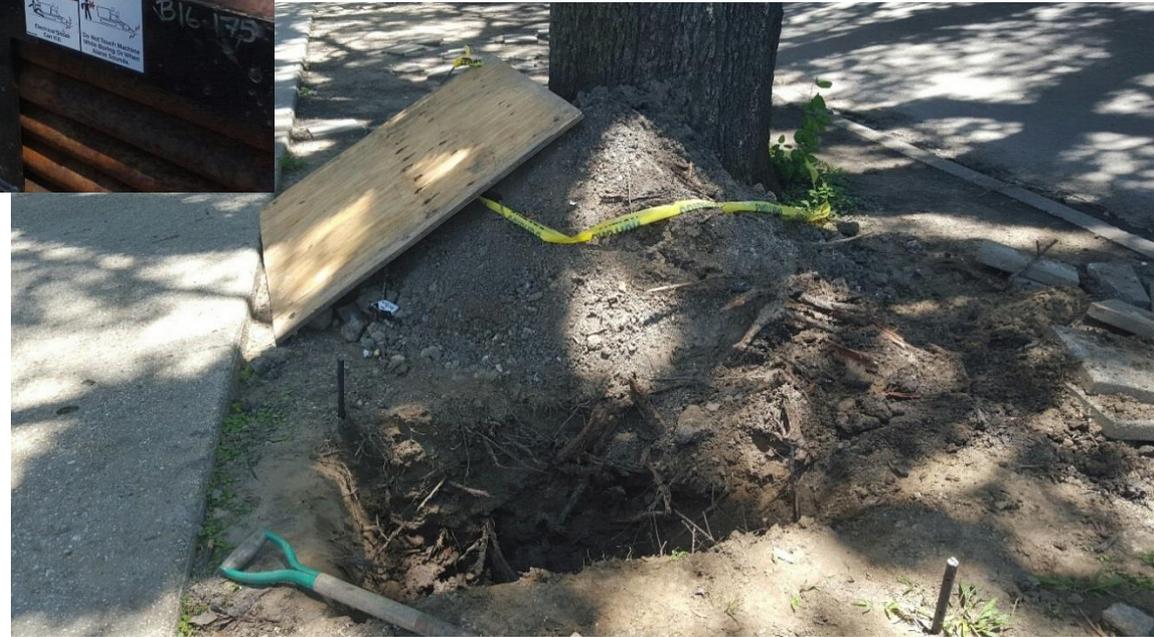
Time will reveal whether trees survive recent construction damage, such as the damage pictured resultant from recent installations.
