Vieux Carré Commission Architecture Committee Meeting

Tuesday, September 26, 2023

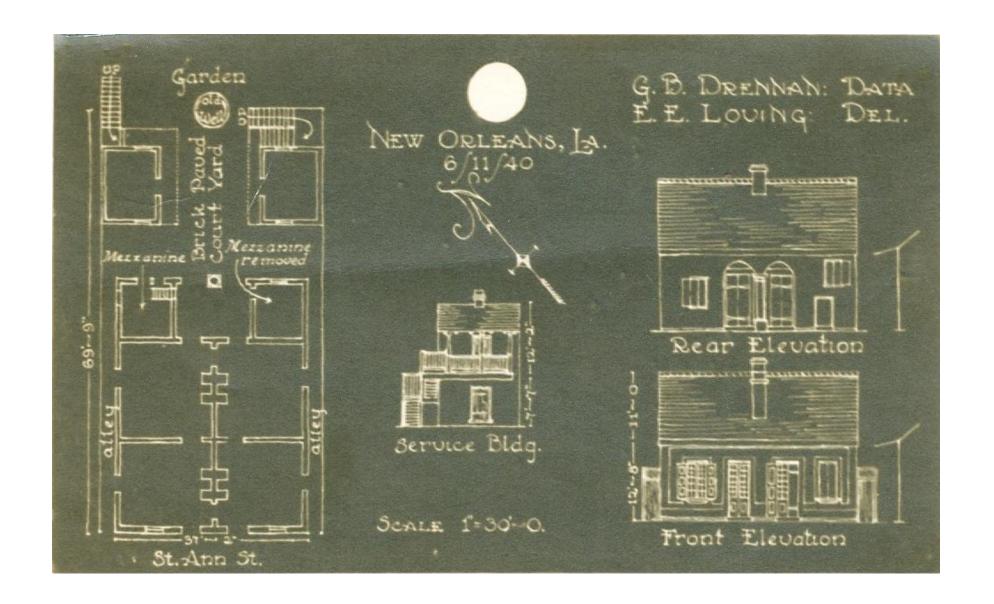
915-17 St. Ann, HABS Survey

STATE	COUNTY	TOWN OR VICINITY	
Louisiana	Orleans	New Orleans	
INDEX NUMBER		l Gaillard, Jr. Cottage Ann street	
REPRESENTED IN NEGATIVE FILE	SPECIAL SECTION ASSESSMENT ASSESS	RY: Built circa 1824 by and Gaillard, Jr. Present	
PUBLISHED PHOTOGRAPHS	owner: Harold Schilke. DESCRIPTION: One-story. Front brick. Sides		
PUBLISHED DRAWINGS	and rear stucco on brick. Loggia with mezza- nine in rear. Slate, gable roof. 2 similar 2-story brick service buildings with wood		
••• 6—8369		rt Records. Map of New Orleans 1808. AMERICAN BUILDINGS SURVEY
