DPW780

Walking Audit  
Connecting New Orleans East  
Stakeholder Update

# Walking Audit - Overview

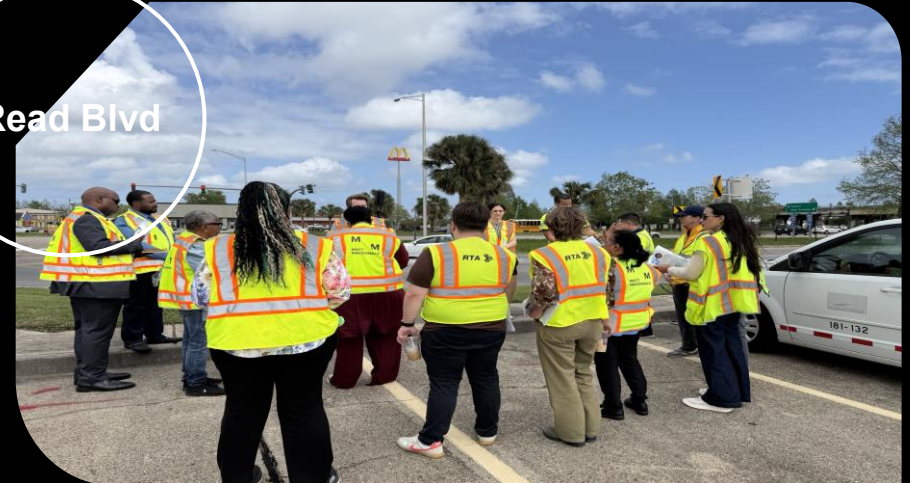
Read Blvd

- Participants recognize safety concerns related to driver behavior in the area and also acknowledge the corridor's potential for economic growth.
- Observations at the Read interchange indicate that while pedestrian infrastructure exists, it does not fully comply with ADA requirements. Specifically, sidewalks are absent in areas adjacent to ADA ramps, limiting accessible pedestrian connectivity.
- At the Crowder interchange, attendees observed a pedestrian jumping a fence to access the service road as a shortcut.
- Participants also noted that the distance required to cross the major interchanges are excessive with an opportunity to evaluate and identify opportunities to shorten crossing distances for pedestrian safety and user comfort.
