# Above the Flood: Elevating Your Floodprone House

FEMA 347/ May 2000

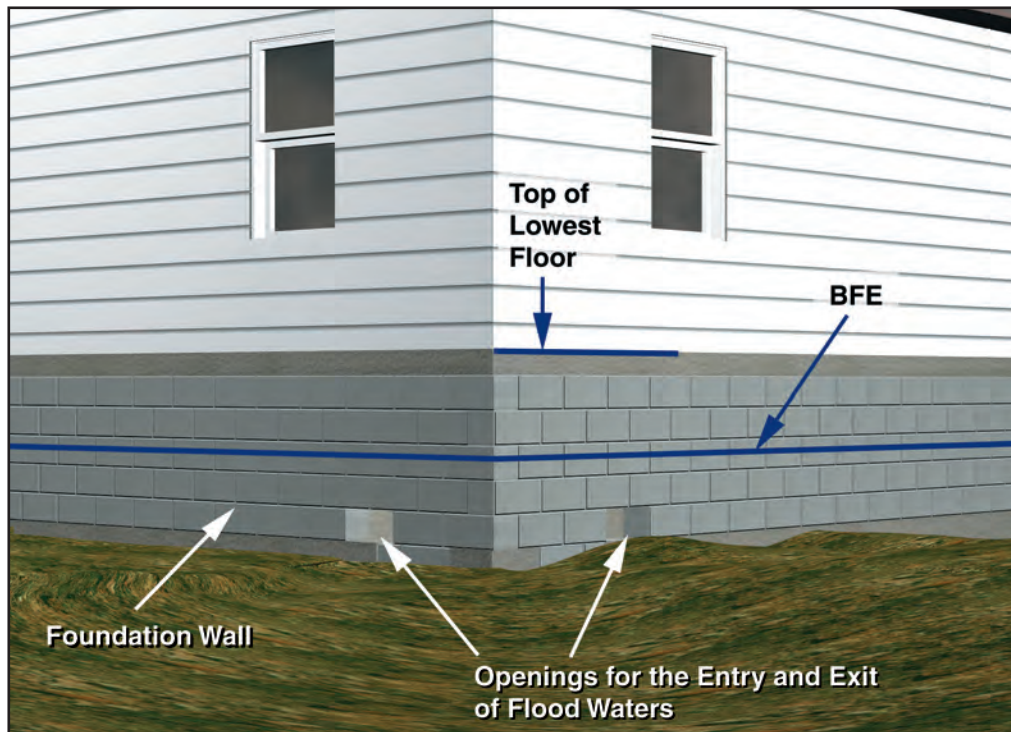
**Figure 6**

In a new, substantially improved, or substantially damaged building in an A zone, the elevation of the lowest floor must be at or above the BFE.

In A zones, where flood hazards are less severe, buildings may be elevated either on an open foundation or on continuous foundation walls below the BFE (Figure 6). Regardless of the type of foundation used, A-zone buildings must be elevated so that the **lowest floor** is at or above the BFE, as shown in Figure 6. If continuous walls are used below the BFE, they must be equipped with openings that allow flood waters to flow into and out of the area enclosed by the walls (Figure 6). Allowing the entry and exit of flood waters ensures that water pressures will be the same on both sides of the walls and reduces the likelihood that water pressure will cause the walls to fail.

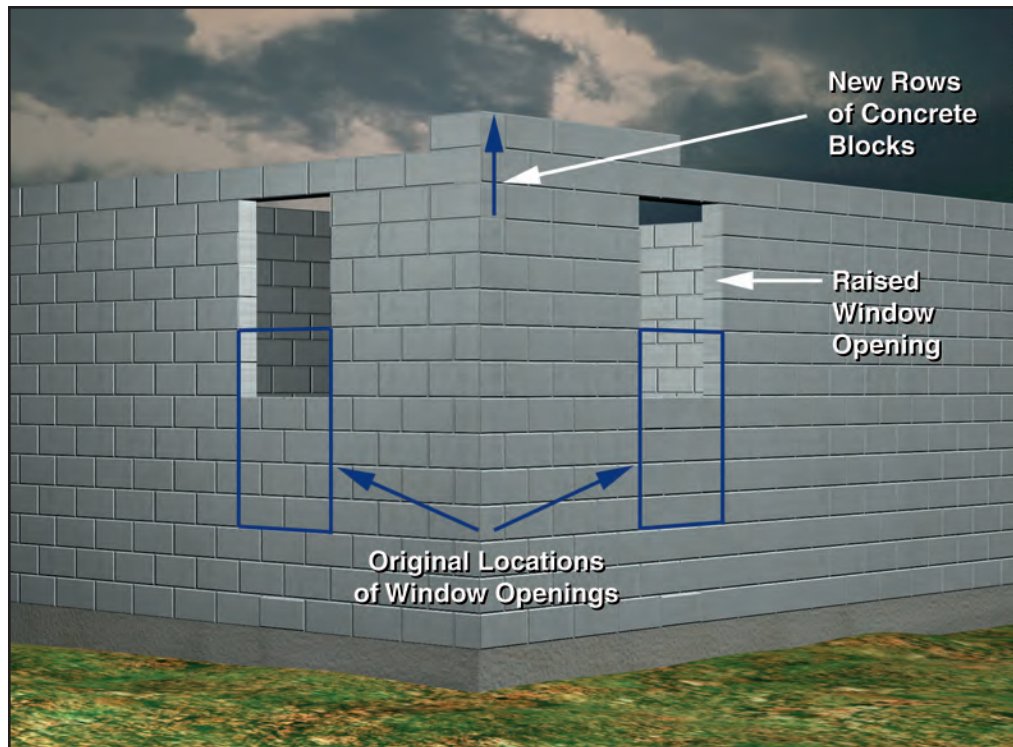
The tops of the walls and bottoms of the window openings are raised with concrete blocks.

After the roof, windows, and doors are removed, several courses of concrete block are added to the tops of the existing walls and to the bottoms of the window openings (Figure 11). A corresponding number of blocks are removed from the tops of the window openings so that the size of the windows will remain the same. In addition, although not shown in Figure 11, concrete bond beams are formed in place at the tops of the extended walls to provide structural reinforcement.

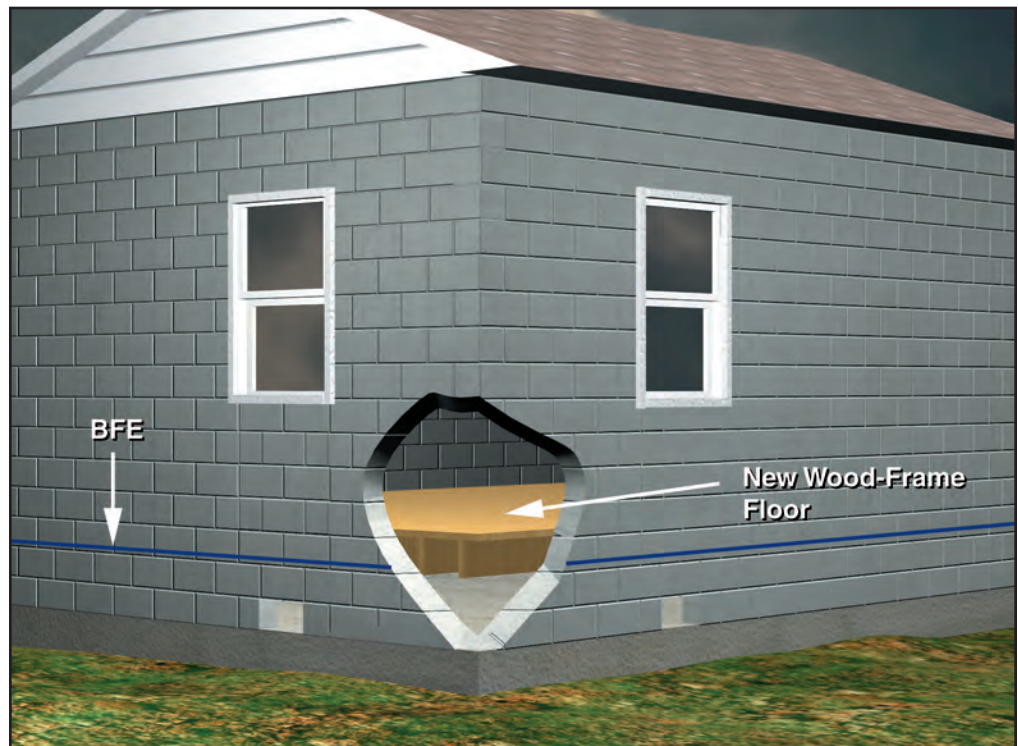
**Figure 13**  
A new wood-frame lowest floor is constructed above the flood level, and the roof, windows, and doors are reinstalled.

Blocks are removed from the walls of the house at selected locations within 1 foot of the ground (Figure 12). The resulting openings will allow flood waters to flow into and out of the lower area of the house so that the water pressures on both sides of the walls will remain the same. The roof and windows are then replaced, and a new wood-frame floor is constructed above the flood level (Figure 13).

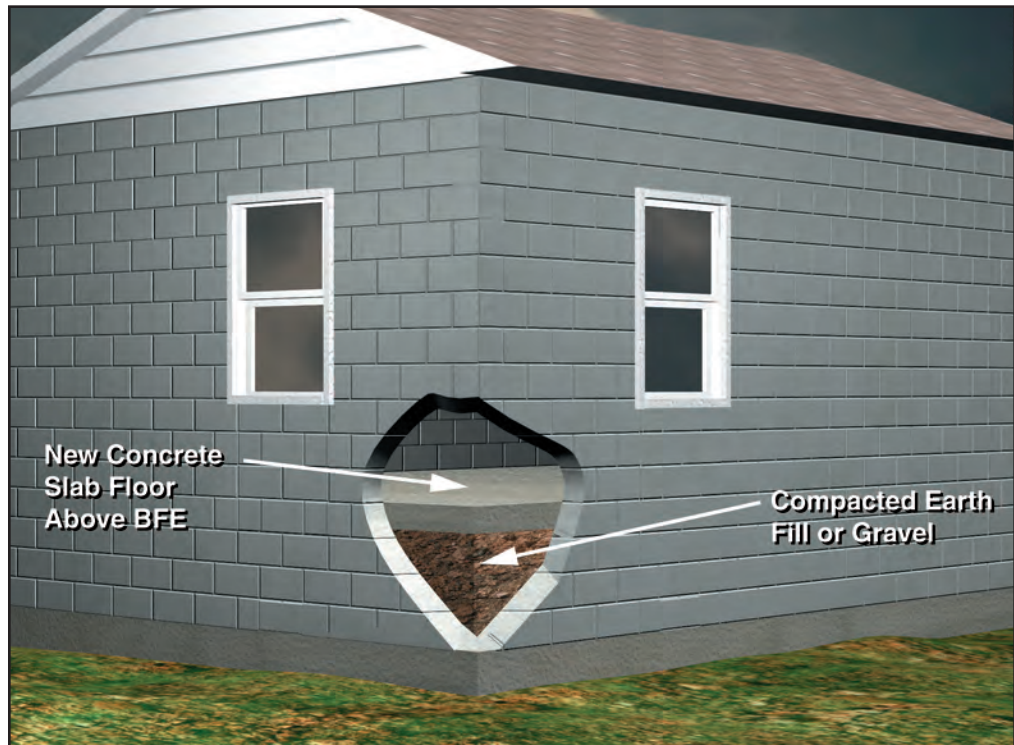
**Figure 14**  
An alternative to building an elevated wood-frame floor is installing a new, elevated concrete slab floor on fill placed over the old slab.

A homeowner who chooses Technique 1 may decide to build a new concrete slab floor instead of a wood floor (Figure 14). When this option is chosen, compacted fill dirt or gravel is placed on top of the old slab and the new slab floor is poured on top. Because the area below the new floor is filled with dirt or gravel, wall openings are not required.

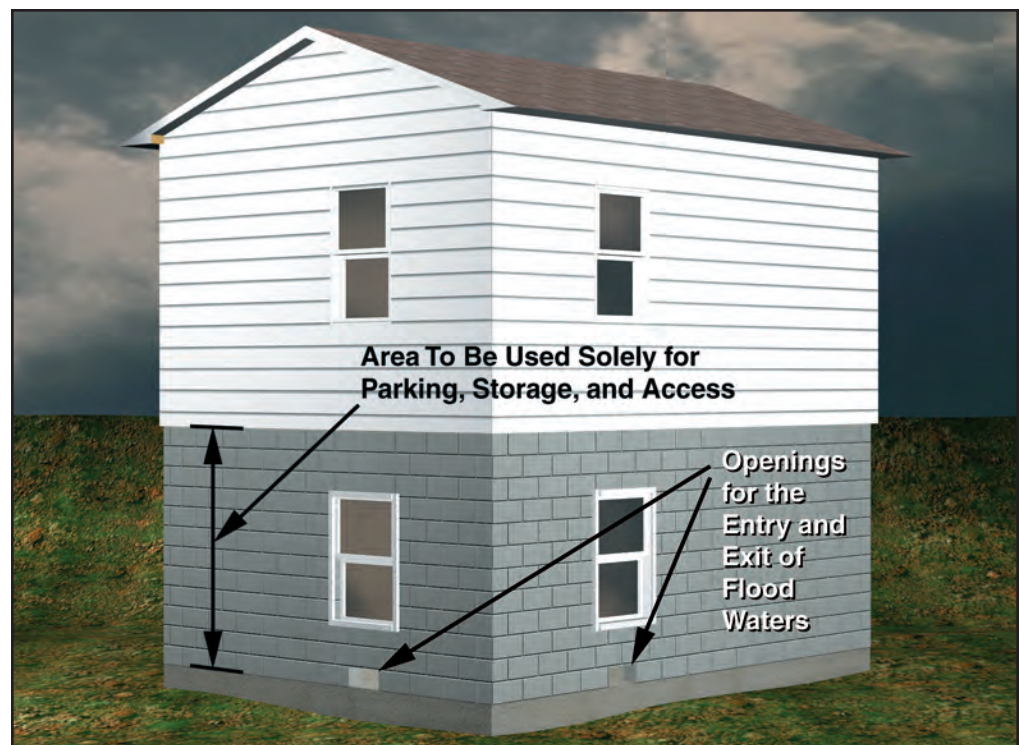
**Figure 16**  
The new second-story walls are covered with siding or stucco.

Some homeowners prefer that the second story be constructed of masonry, but wood- or metal-framing is more common, primarily because it is lighter and less expensive. The roof is replaced, and blocks are removed from the walls to allow flood waters to enter and exit. Exterior sheathing is then added to the framed walls of the second story, the new windows are installed, and siding or stucco is applied to the sheathing (Figure 16).

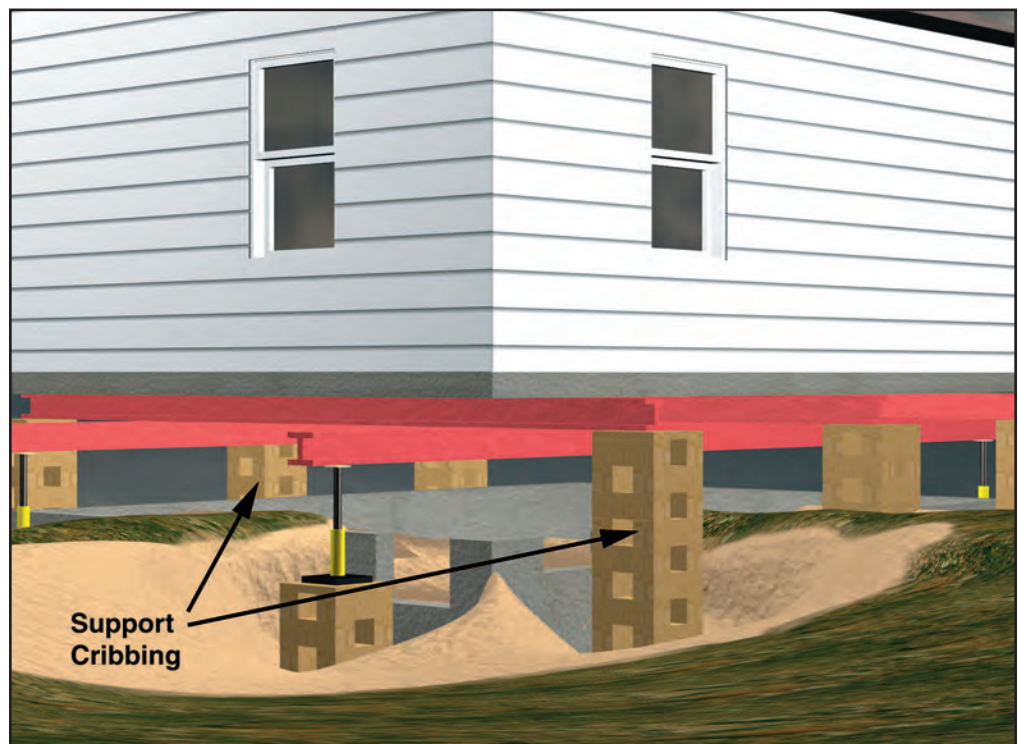
**Figure 19**  
The house is temporarily supported on cribbing.

The house is then jacked up. When the jacks have extended as far as possible, the house must be supported temporarily while the jacks are raised. Both the house and the jacks are usually supported on “cribbing”—temporary piles of crisscrossed timbers (Figure 19). The jacks are then used to raise the house higher.

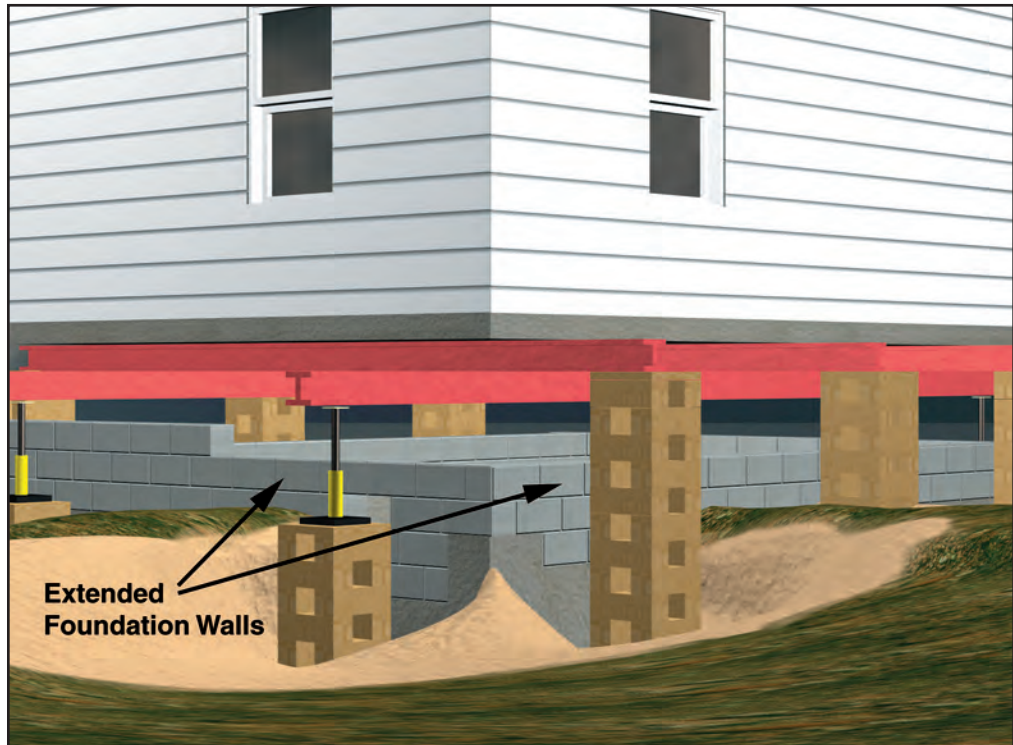
**Figure 20**  
New, extended foundation walls are constructed with concrete blocks.

This process is repeated until the house is raised to the desired height. The foundation walls are then extended upward with additional rows of concrete block (Figure 20). As in the previous techniques, openings are made in the walls within 1 foot of the ground so that flood waters will be able to flow into and out of the area below the elevated floor. The jacks and beams are removed, and the openings left around the beams are filled with blocks (Figure 21).

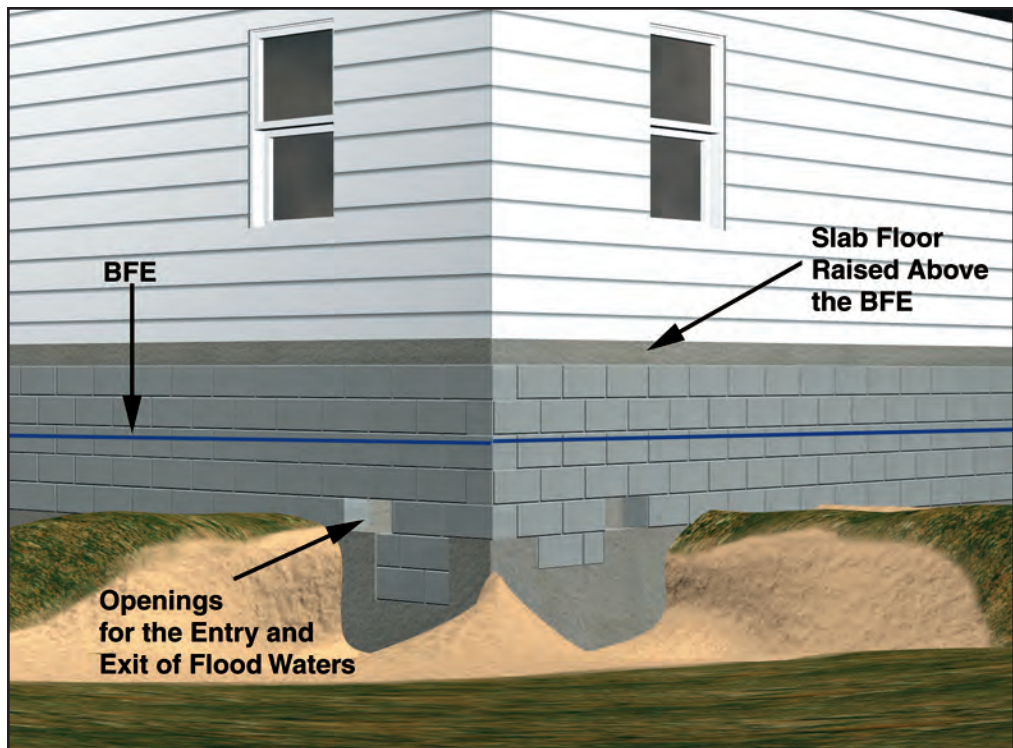
**Figure 21**  
Elevated house and slab on new, extended foundation walls.

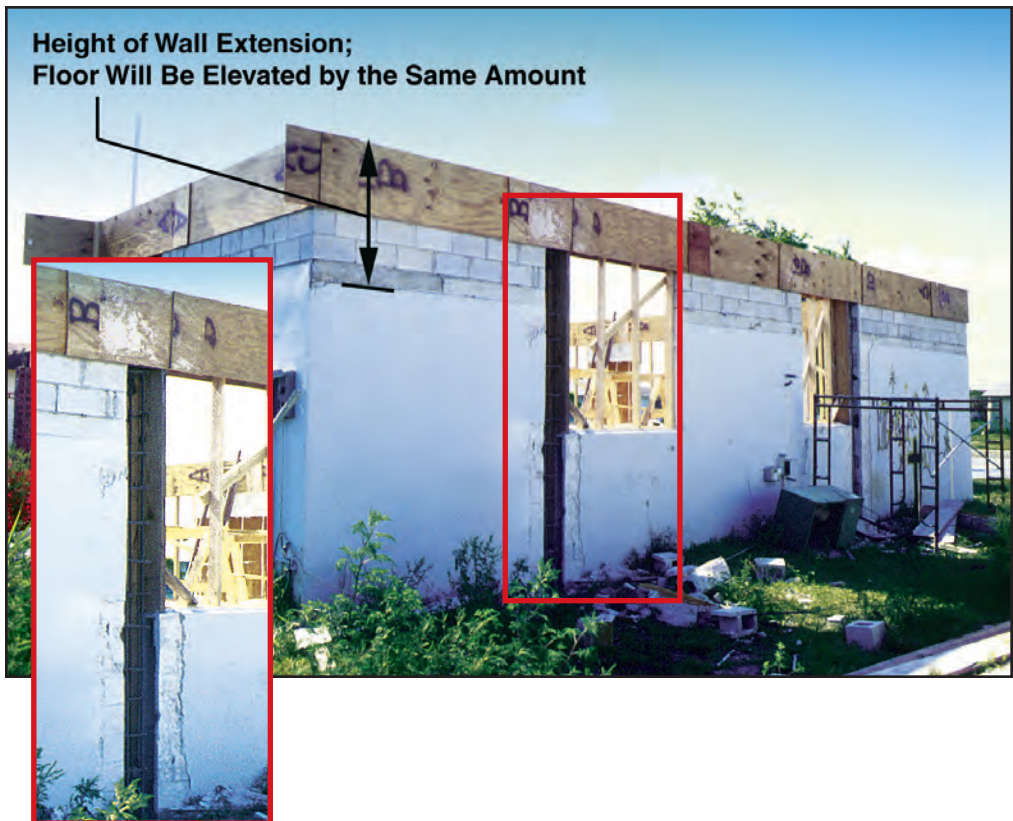
**Figure 24**  
Another view of the extended walls. The vertical cuts in the walls next to the windows are for concrete tiedown columns that will be cast in place to further strengthen the extended walls against wind loads. The owner of this house was able to meet the elevation requirement by raising the floor only a few feet, as indicated by the amount that the walls have been extended.

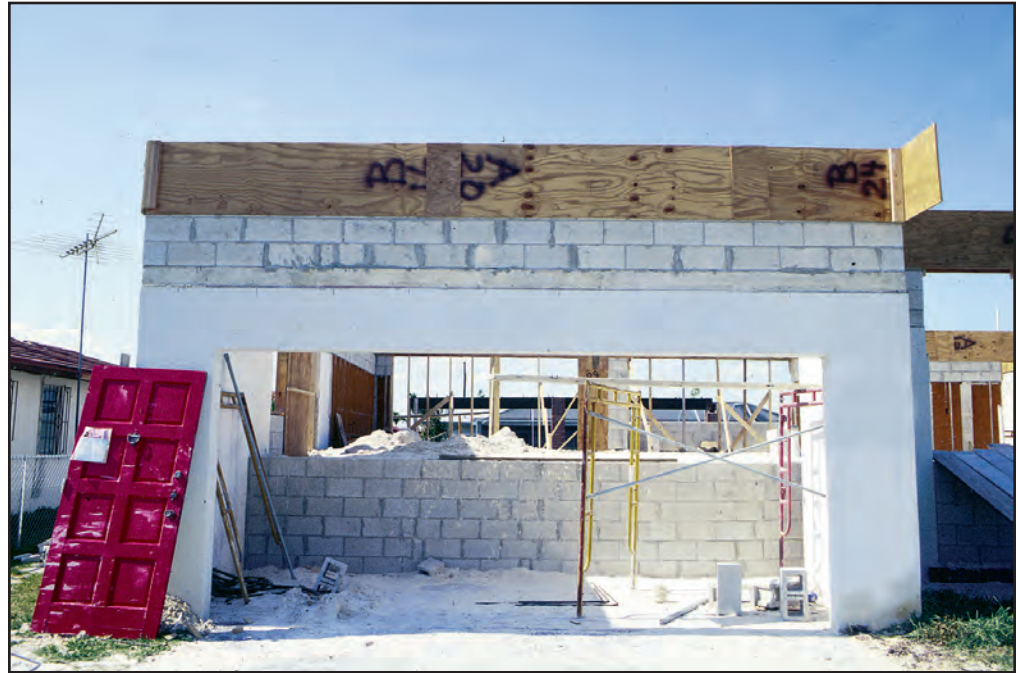
**Figure 25**

This view through the garage door reveals the different levels of the elevated slab floor, in the background, and the unelevated garage floor.

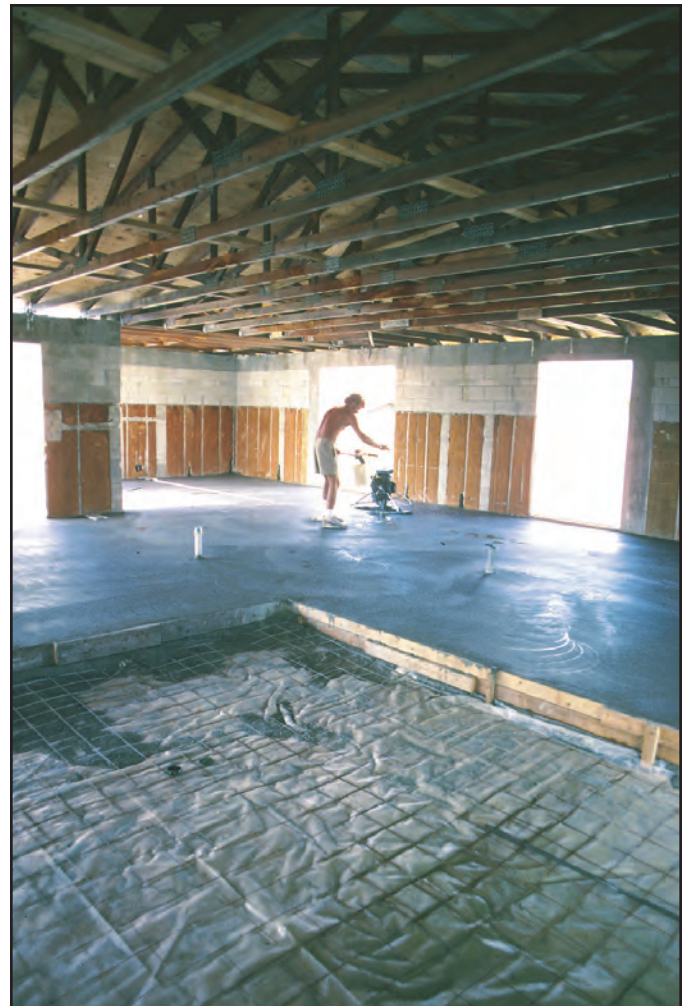
**Figure 26**

The roof has been rebuilt with the salvaged trusses, and most of the new concrete slab has been poured on top of the sand fill. The open area in the foreground, where plastic sheeting and wire reinforcement can be seen on top of the sand fill, is where the remaining part of the slab will be poured.

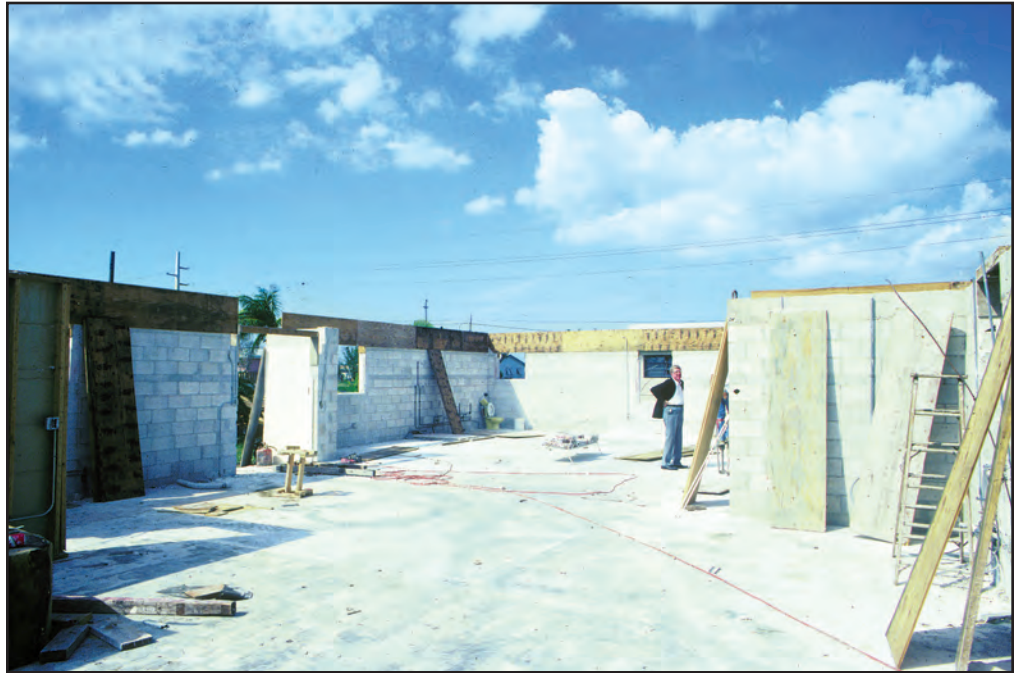
**Figure 40**

After the roof was removed and the storm-damaged interior gutted, the walls of the house were extended upward and a new bond beam added at the top.

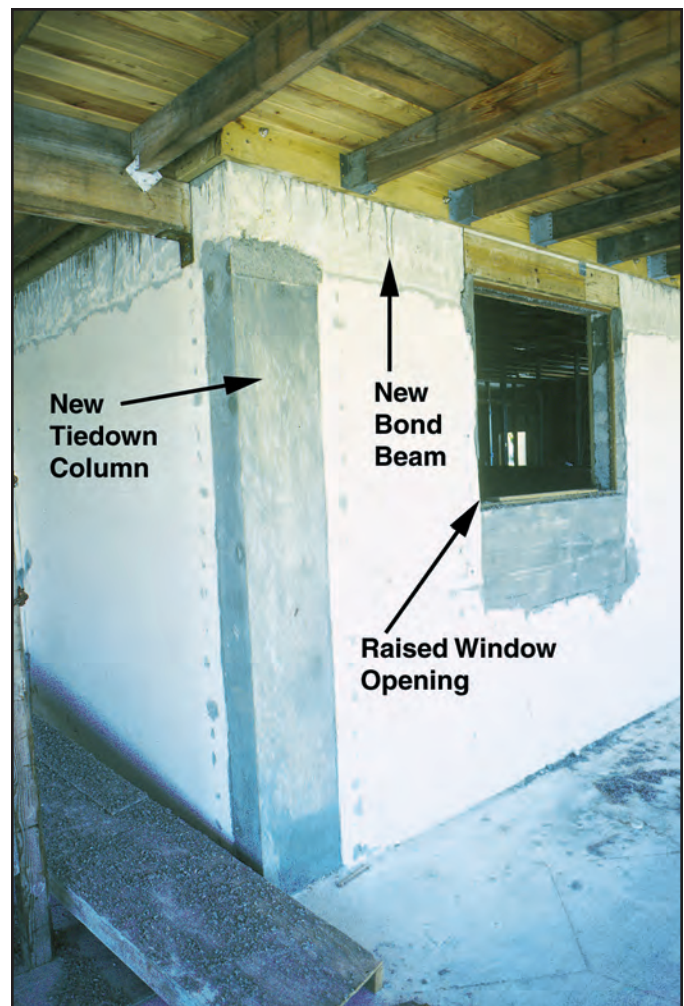
**Figure 41**

Note the new bond beam at the top of the extended wall, the new concrete tiedown column at the corner, and the raised window opening.

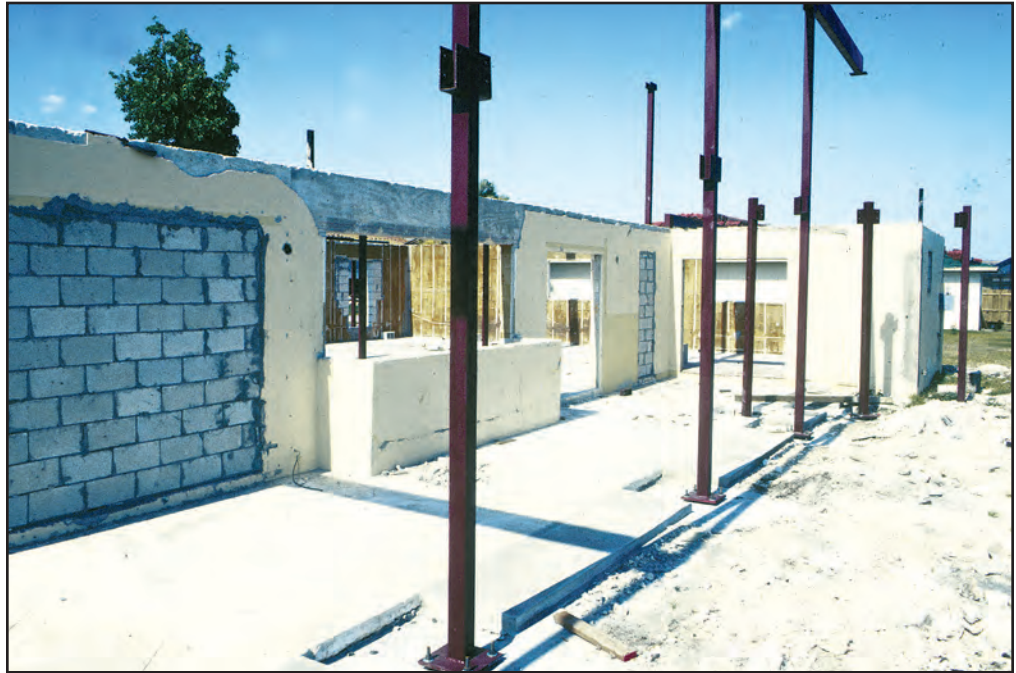
**Figure 52**

The existing first-story walls have been strengthened by the addition of concrete block. Metal columns and beams have been added to help support the new second story.

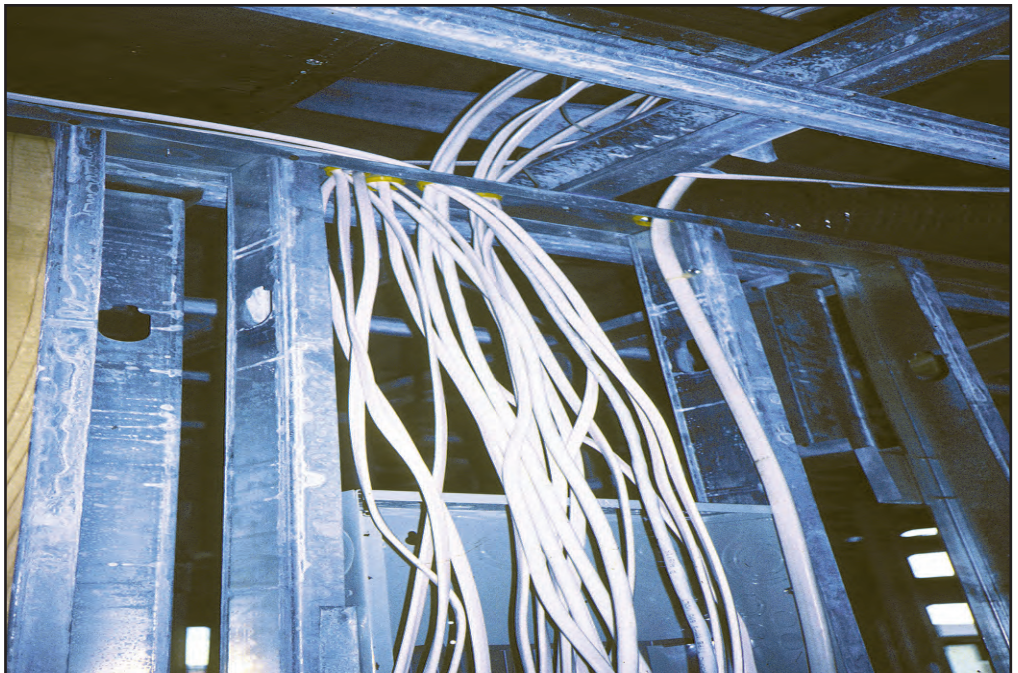
**Figure 57**

The project progresses with wiring and other utility work. As in each of the other house elevation projects, all current building code requirements must be met.

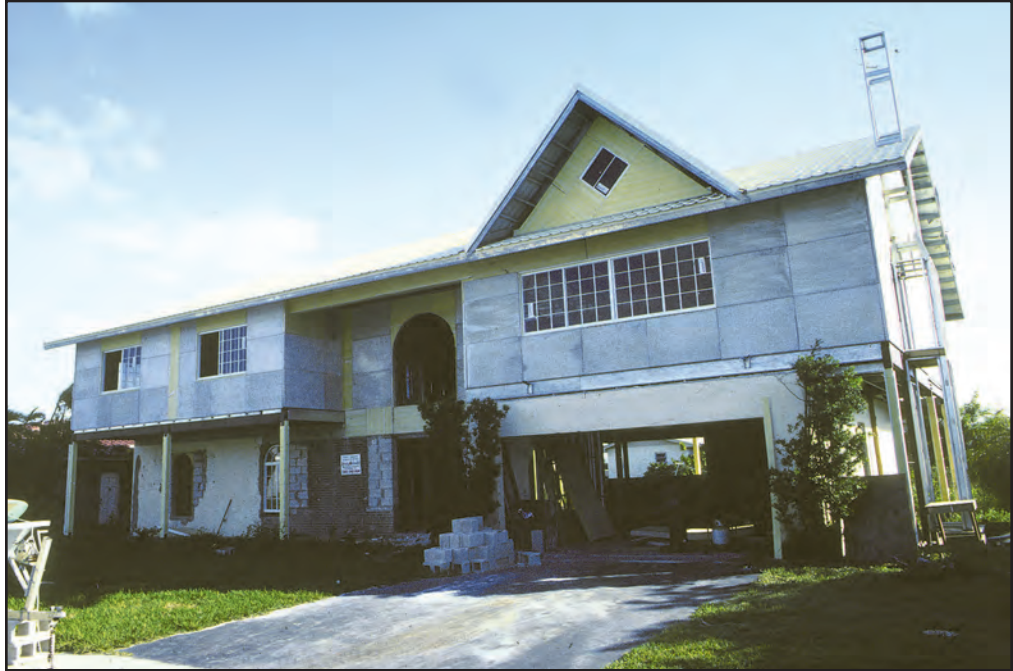
**Figure 58**

The new second story  
nears completion.  
The roof is made of  
formed metal panels.

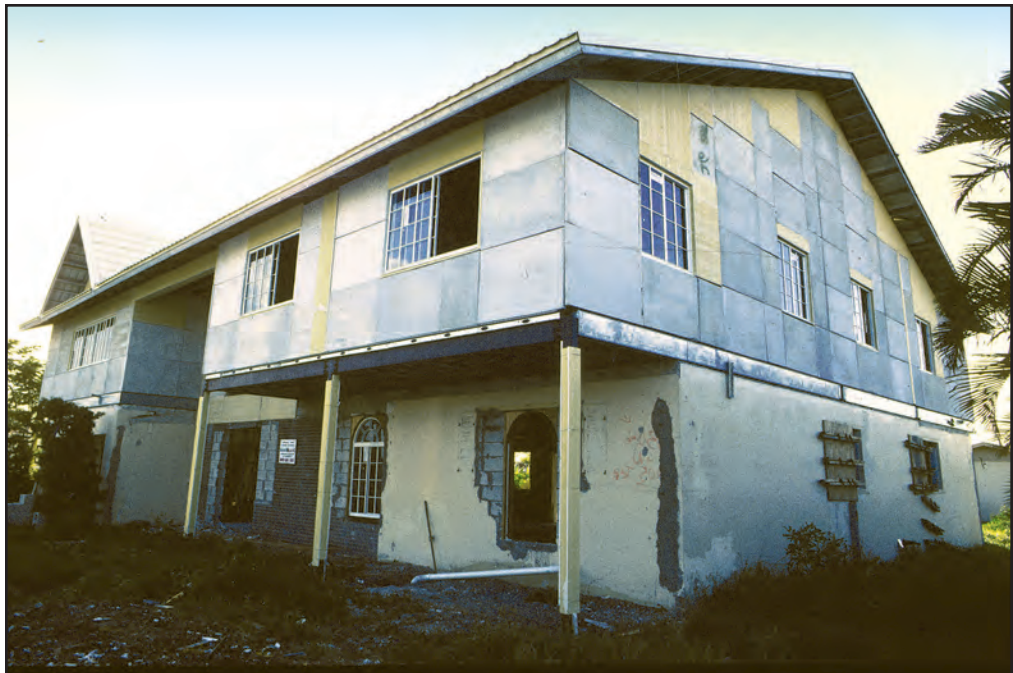
**Figure 59**

The exterior  
walls consist of  
prefabricated  
concrete panels.  
Innovative techniques  
such as those  
employed in this  
project are helping  
homeowners who  
need practical and  
economical methods  
of repairing and  
protecting their  
houses.
