LINCOLN BEACH SITE ASSESSMENT REPORT

PREPARED FOR THE CITY OF NEW ORLEANS
Department of Public Works

DIGITAL ENGINEERING & IMAGING, INC.

April 2021

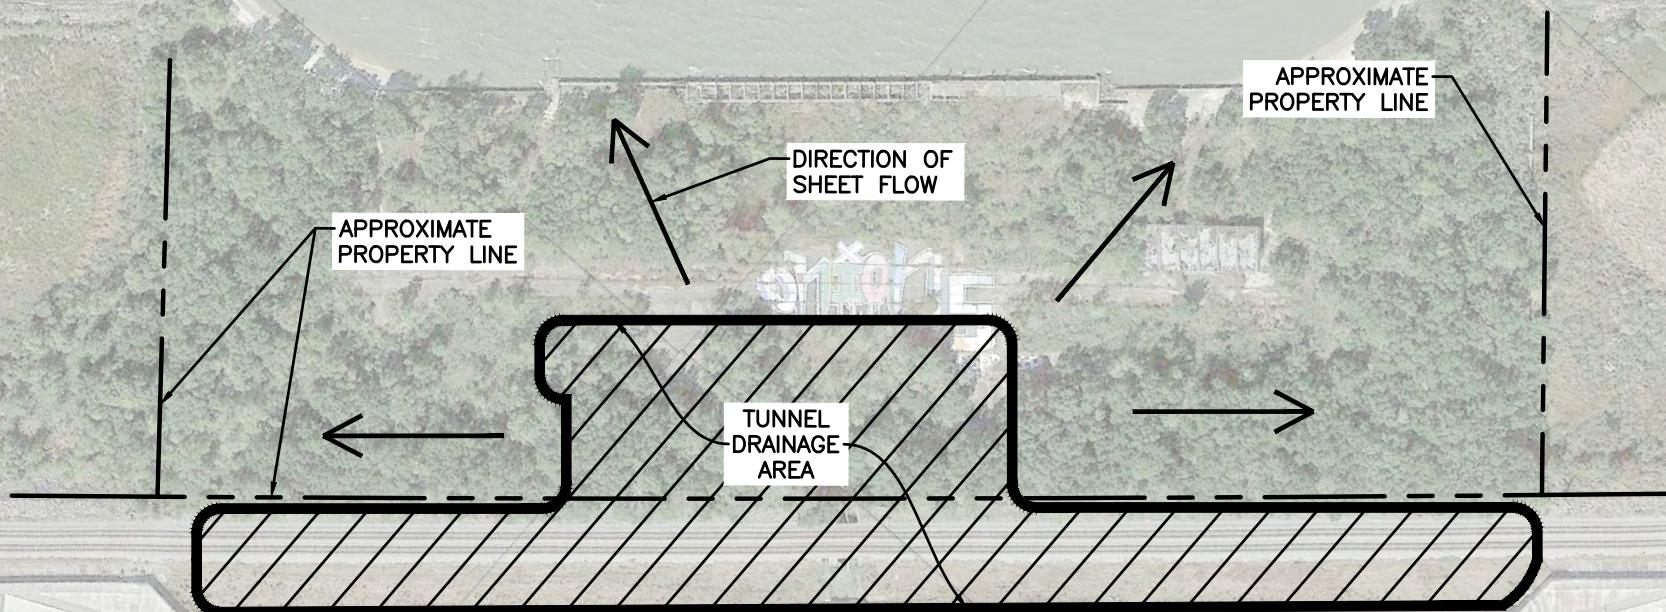
FIGURE 1
DRAINAGE MAP
LINCOLN BEACH
SCALE: 1"=200'

Storm water at Lincoln Beach flows outward from the highest elevation at the concrete pavement in the center of the property as shown in the Drainage Map in Figure 1. From the central high point, storm water flows to the southwest, northwest, and northeast into Lake Pontchartrain. Storm water flows southeast from the high point and collects at the lowest point of elevation in the tunnel beneath the railroad shown in Figure 2. The storm water that falls between the railroad tracks and floodwall also flows to the low point in the access tunnel. Based on record drawings, survey data, and field review, it is believed that the southern-most tunnel under the railroad tracks drained by gravity to the west. Record drawings indicate this tunnel has a constant slope to facilitate drainage to an inlet, which then drained by gravity to Hayne Blvd. No record drawings are available for the center and north tunnel. Based on field investigations and review of record drawings for the L-20 flood gate, it is believed these tunnels were drained by a pump system. These two tunnels each slope to low points at their midpoints where apparent trench-style inlets collect water. The L-20 flood gate record drawings indicate a previously existing sump and pump system, which it is believed was connected to the trench drains. Record drawings indicate this sump pump system discharged to the gravity system on Hayne Blvd through a penetration in the flood wall subsurface sheet pile. During construction of the floodwall the pump was removed and the sump was backfilled with sand and covered with concrete. Therefore, drainage upgrades will be necessary at the access tunnels to remove the ponding storm water.

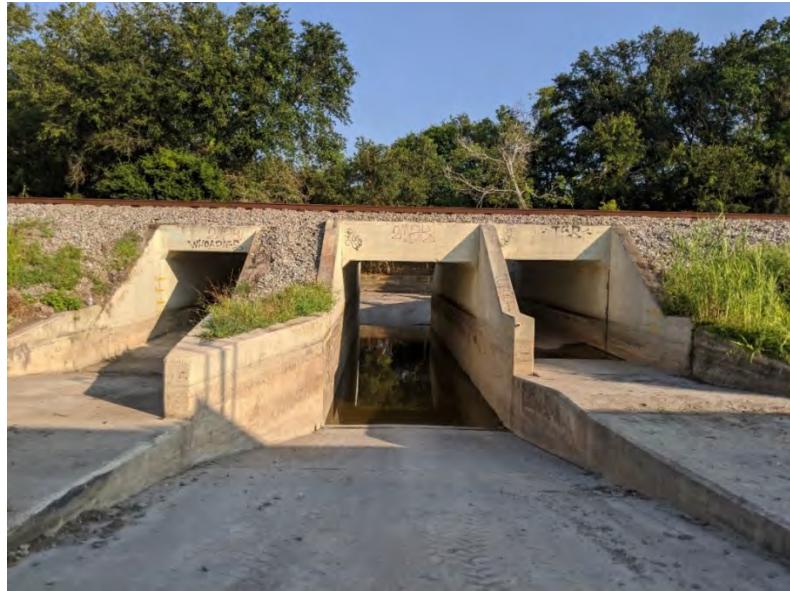
Figure 2: Access Tunnel to Lincoln Beach

The existing drainage features described above are currently not functional and the condition of the pipes is unknown. All drains are filled with sediment and debris and the tunnels remain flooded with storm water. Since the access tunnel is the lowest point in the area a pump will be required to remove the water. Record drawings indicate that there may be an existing penetration in the floodwall that connects to the existing gravity pipes on Hayne Blvd from where the tunnel previously was pumped. Due to its age, this existing penetration will need to be cleaned and video inspected to determine if it is structurally adequate to discharge the storm water from the access tunnel as shown in Drainage Alternative No. 1 in Figure 3. In this drainage concept a valve would be necessary at the floodwall to prevent backflow into the drainage system on Hayne Blvd during storm surges. If this existing sheet pile penetration cannot support future upgrades, the storm water will need to be pumped to discharge in Lake Pontchartrain as shown in Drainage Alternative No. 2 in Figure 4.

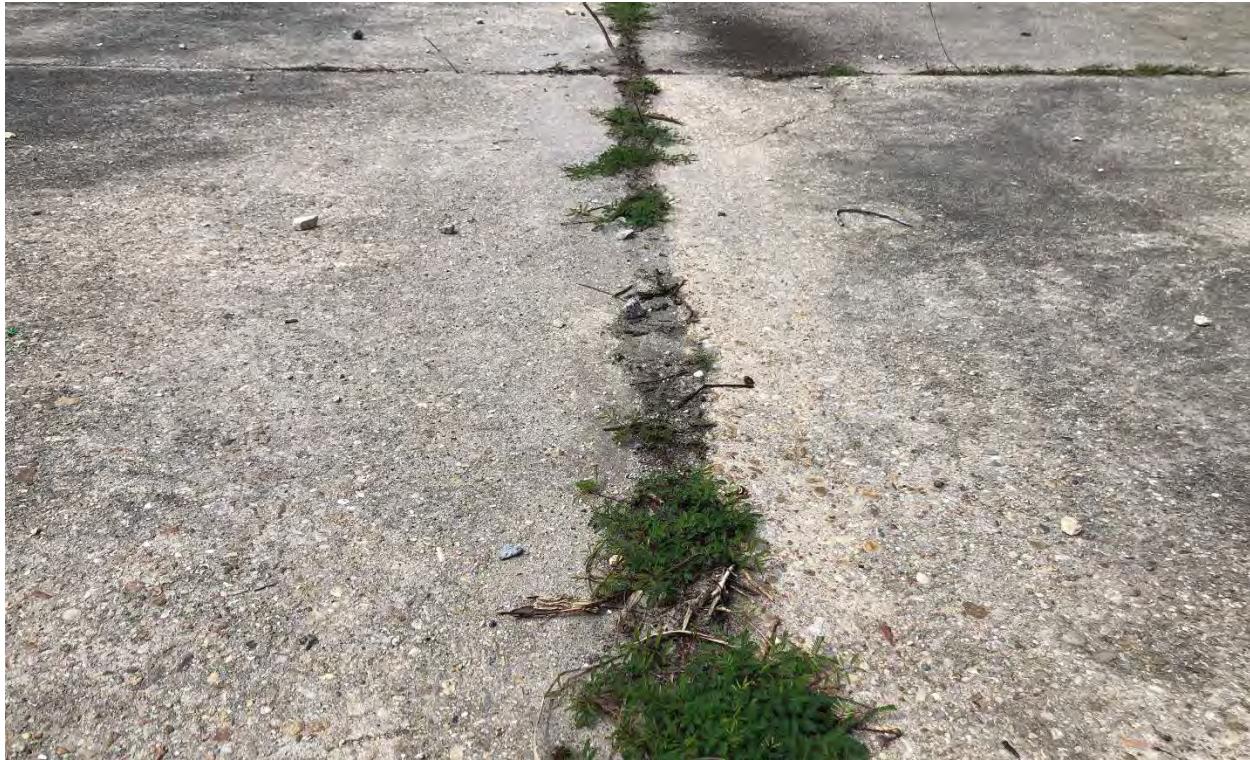
The initial assessment of the nearly 80,000 square feet (8,889 square yards) of existing concrete panels throughout the property is that a majority of the concrete appears to be in good condition, but the joints between panels will need to be cleaned and resealed. Almost all of the joints have become overgrown with grass and filled with dirt from years of abandonment (Figures 8 & 9). There are nearly 9,300 linear feet of transverse and longitudinal joints that will need to be cleaned and resealed. Typical unit cost for joint cleaning and sealing is approximately \$3 per linear foot.

Figure 8: Overgrown joints between concrete panels.

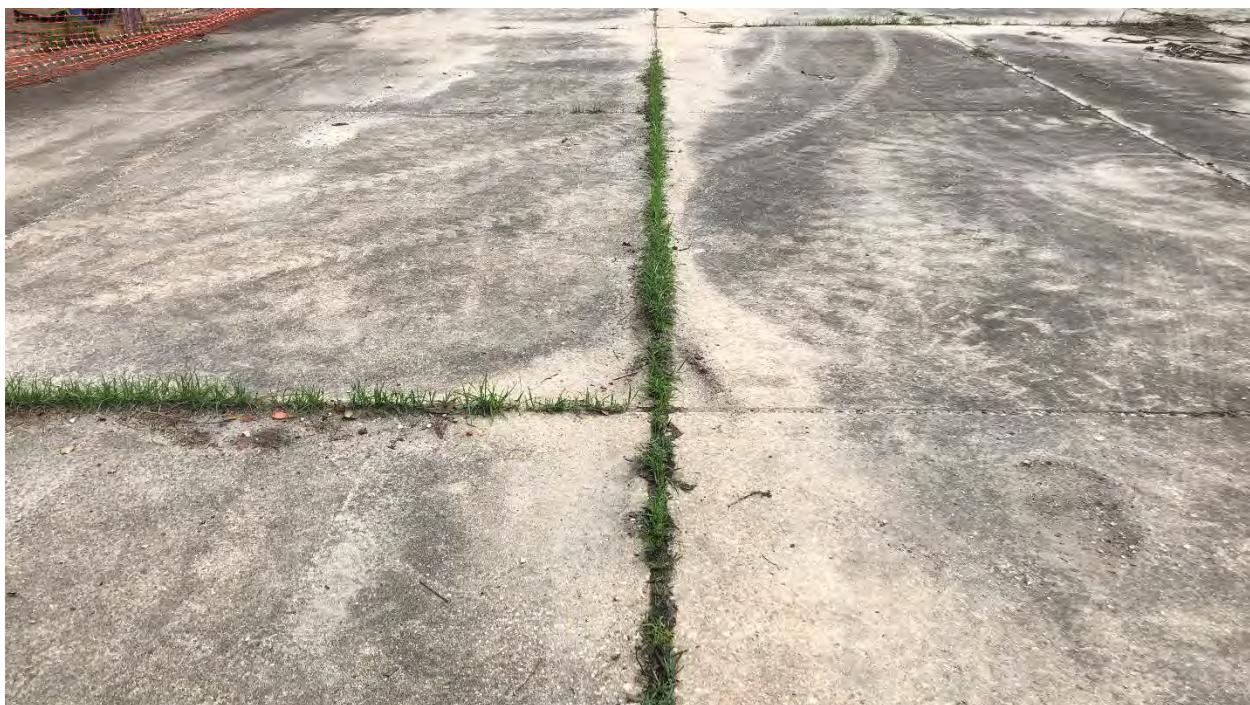
Figure 9: Overgrown joints between concrete panels

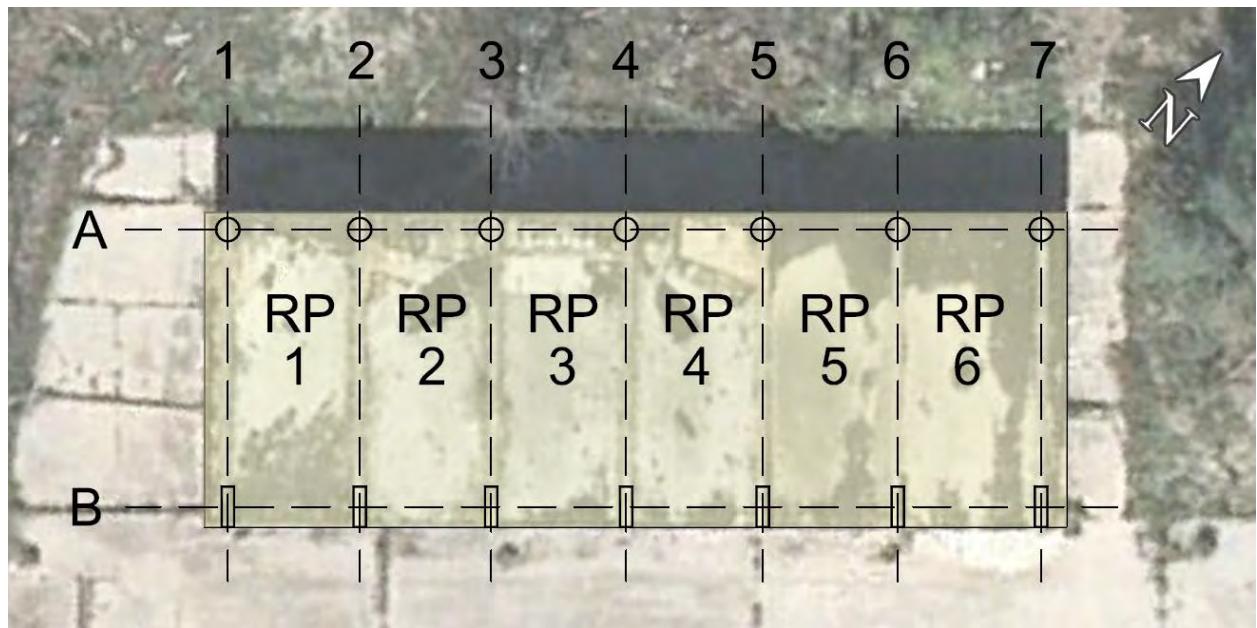
Figure 16: Layout of the west pavilion

The rectangular columns appeared to be structurally sound, though some slight cosmetic cracking was present. The circular columns displayed visual damage. There is spalling of concrete on the bottoms of columns A1, A2, A6, and A7 revealing the reinforcement. Column A5 had significant spalling revealing the bottom 4' of reinforcement and had been repaired prior to the second site visit. On the north side at the top of all columns, except the repaired A5, there is cracking caused by the columns flexing inward due to the weight of the roof. There is some minor cracking on each of the roof panels, and some exposed rebar on the ceiling due to the rebar not being placed properly when the structure was built. The original tar and gravel coating on the roof is in poor condition and needs to be replaced.

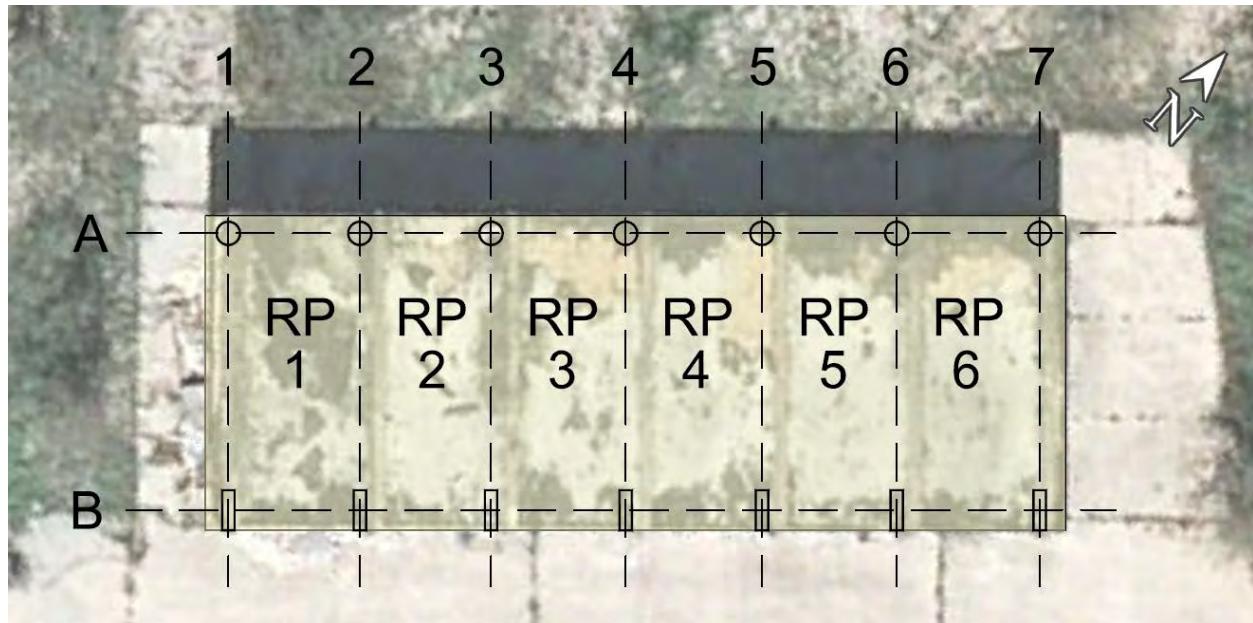
Figure 21: Layout of the east pavilion

The rectangular columns appeared to have the same small cosmetic cracking as the west pavilion and appear structurally sound. Similar to the west pavilion, all of the circular columns have stress cracking on the north side of the columns caused by the roof load. Columns A2, A5, and A7 have spalling near the bottom of the columns revealing reinforcement, while columns

A1 and A3 are spalling at the mid height of the columns. Roof panel 1 is in poor condition due to repeated fires created under that portion of the ceiling by encampments. Heat from the fires has caused excessive spalling and deformation of reinforcement within the concrete. Roof panel 5 has significant cracking that originates from column A6, showing that the roof panel has failed.

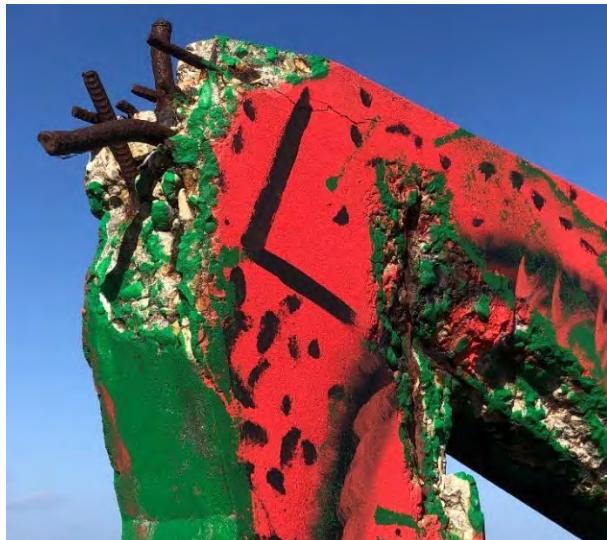
Figure 30: Exposed rebar on where pool canopy connected to support.

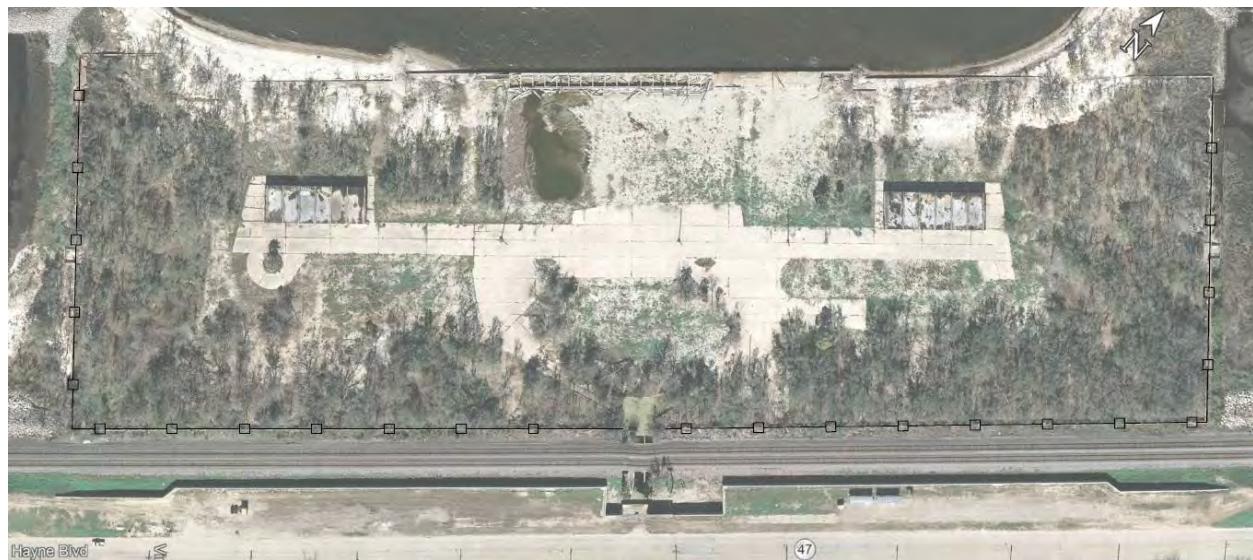
Figure 36: Location of brick perimeter fence for the Lincoln Beach Property

There is approximately 2,250 linear feet of brick fencing surrounding three sides of the Lincoln Beach property. Some portions of the fence have been knocked over on the west side of the property, as well as a portion on the southwest side that potentially provides access to the property for people who go around the floodwall. The brick wall has brick pilasters spaced every 20' to provide support, but most of these pilasters have become detached from the wall. The brick fence is salvageable. The damaged or knocked down portions of the wall will need to be replaced to match the original design. The detached pilasters will need to be repaired or replaced to attach them to the wall to provide support against wind shear at a cost of \$1,500/pilaster. Additional pilasters may need to be placed between the existing pilaster locations to bring the wall up to IEBC 2018 and ACI 530/530.1-13: Building Code Requirements and Specification for Masonry Structures and Companion Commentaries.

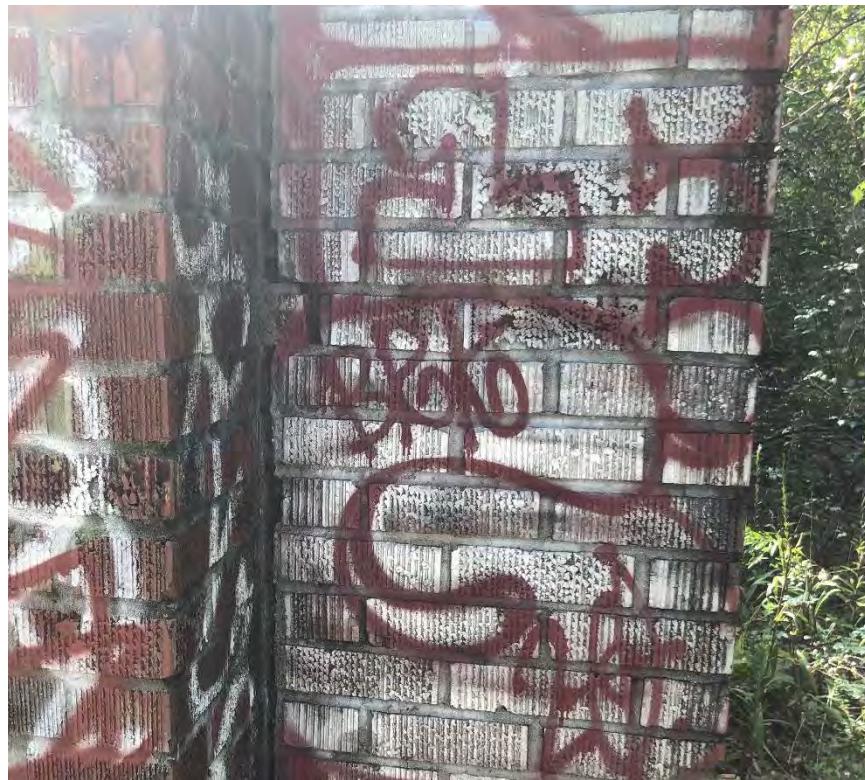
Figure 37: Separation of pilaster from the brick fence

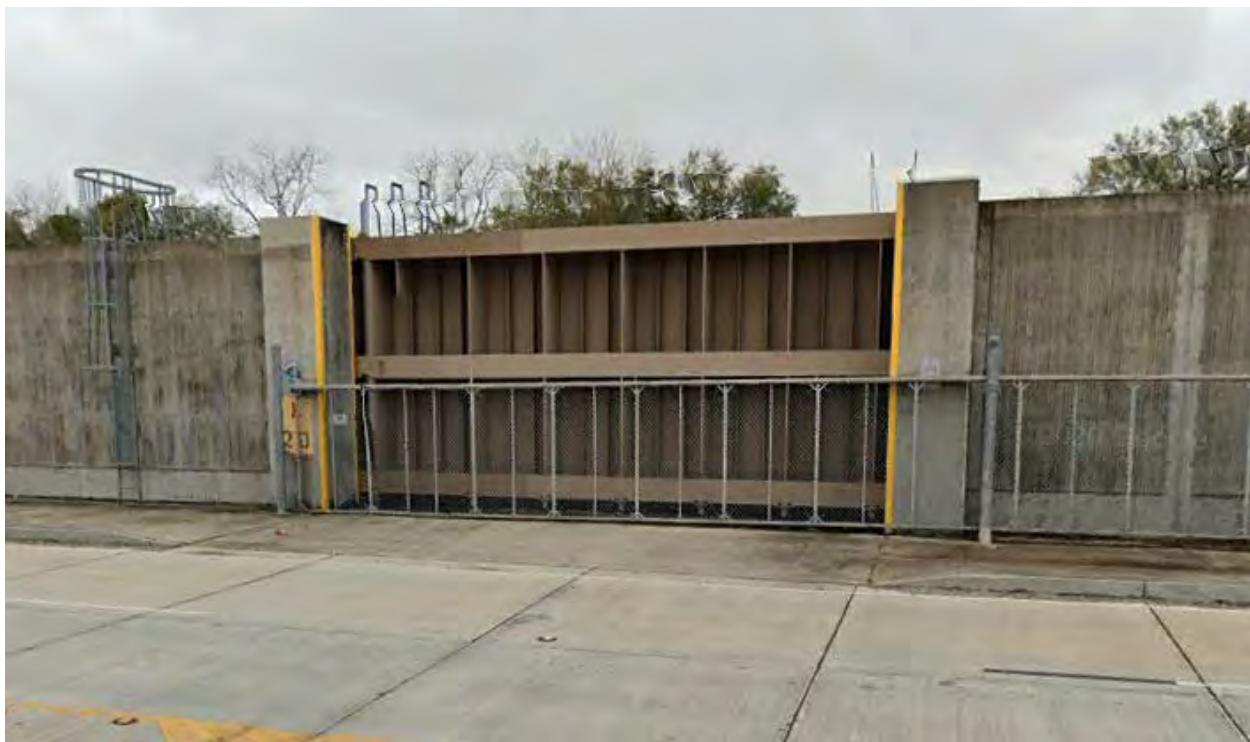
Figure 45: Closed Flood Gate

Access to the site is bottlenecked through a 30' wide sliding floodgate with no other access points. If the City of New Orleans chooses to prohibit vehicular traffic, removable bollards are recommended behind the flood gate to deter drivers from turning into the area. A concrete barrier could be placed in front of the driving tunnel that is in between the two (2) pedestrian/bicyclist tunnels.

If the City of New Orleans wishes to keep vehicular traffic open, protection for the pedestrians/bicyclist will be needed. To ensure the safety of pedestrians/bicyclists, it is proposed that striping, delineators, bollards, or concrete barriers should be placed adjacent to the edge line striping to create a minimum 8' wide path to protect the pedestrians/bicyclist while passing through the flood gate. Any improvements shall be coordinated with SLFPA-E to ensure proper operation of the flood gate.

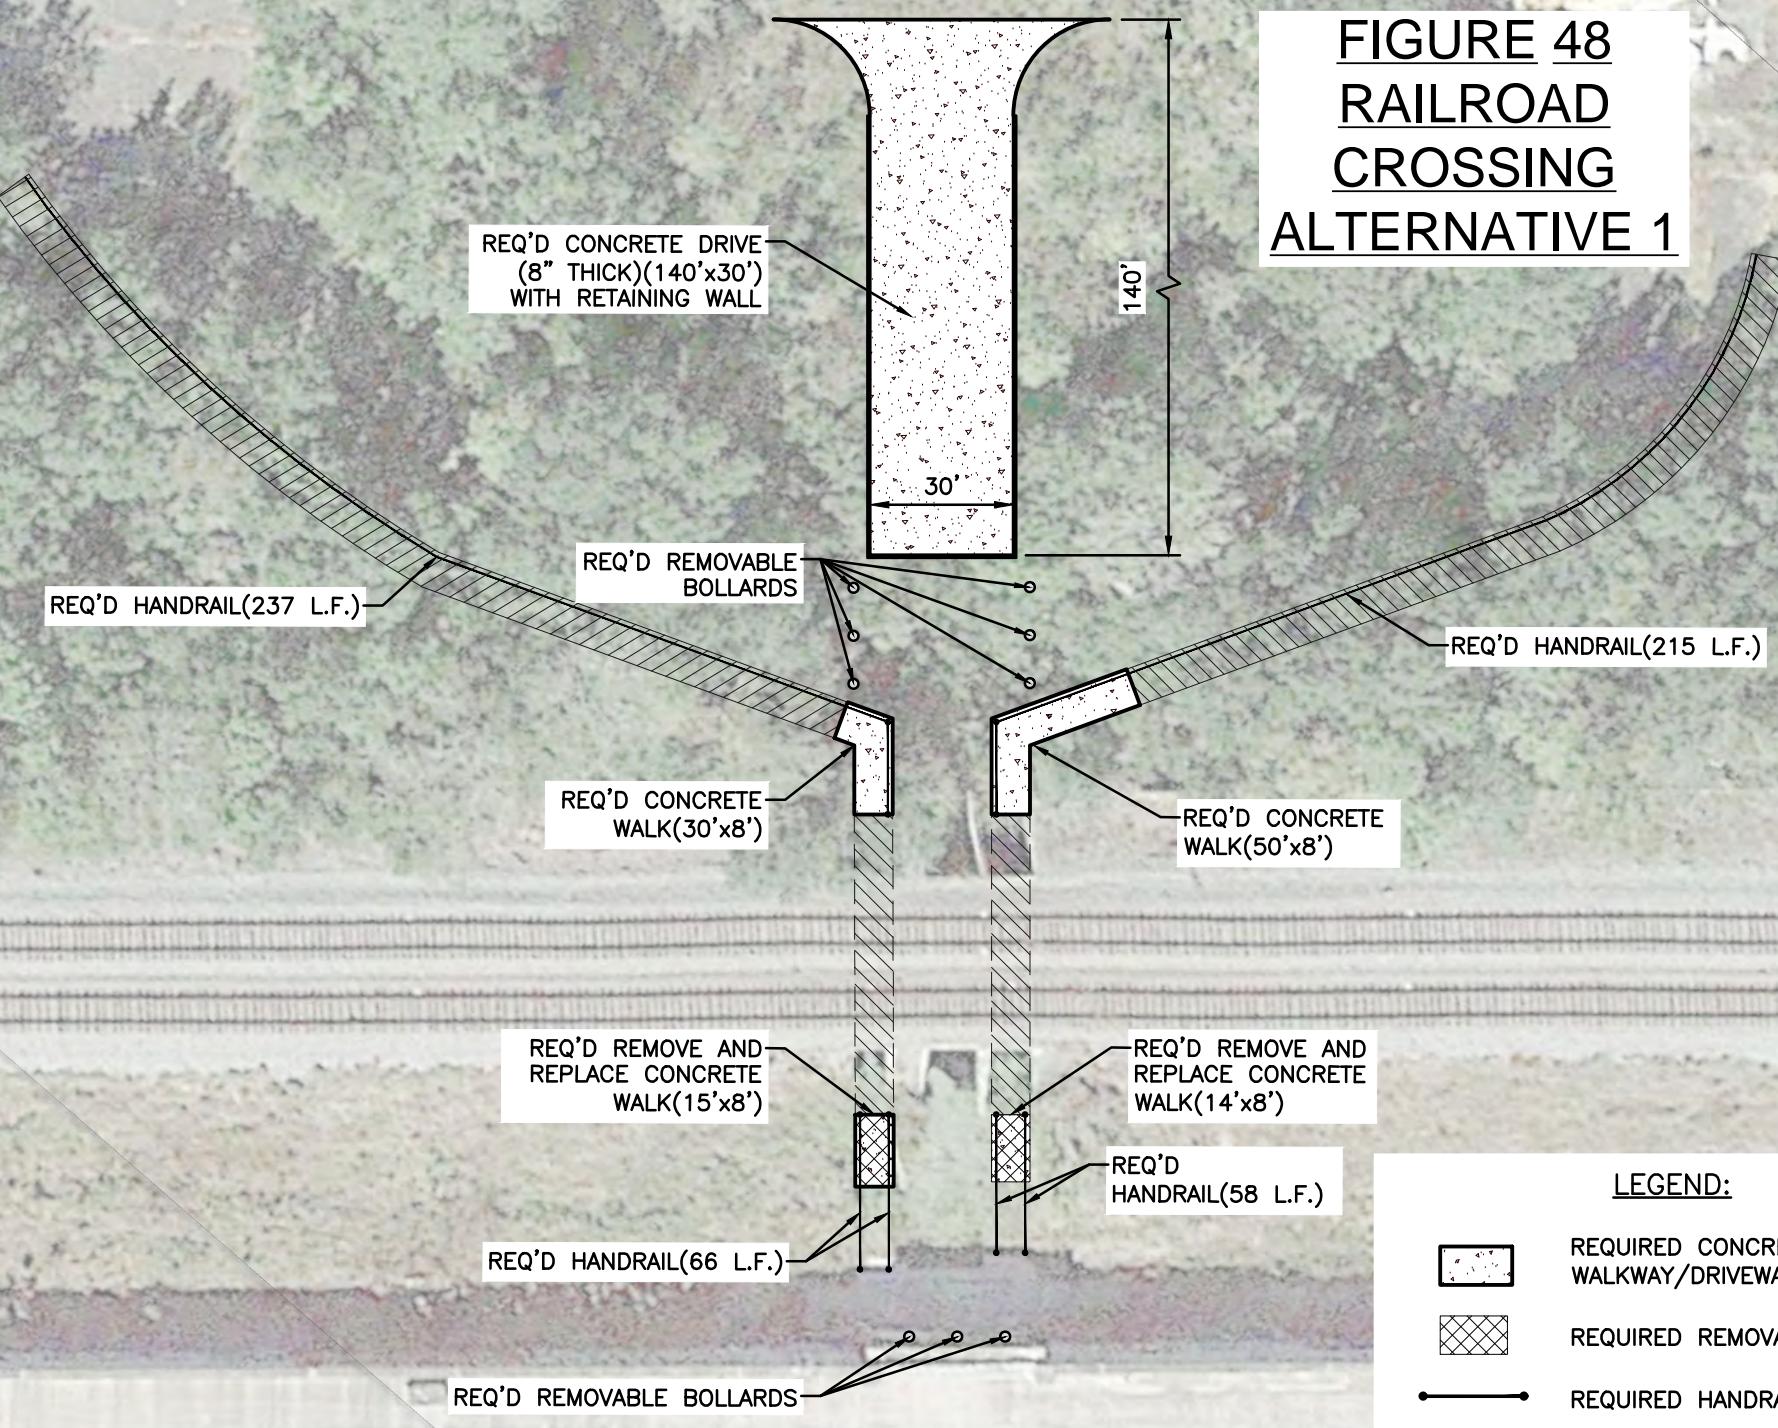
FIGURE 48 RAILROAD CROSSING ALTERNATIVE 1

On the beach side of the pedestrian tunnels, the 30'x8' and 50'x8' sections of concrete walk adjacent to the East tunnel and West tunnels, will need to be replaced and embankment will be required to restore the area to the existing grade. Handrails will need to be placed on at the entrances and exits of both tunnels where drop-offs exist (See Figure 48). Also, these tunnels hold rainwater during and after every rain event and will need to be addressed as discussed in Technical Memo 2 - Utility Assessment.. A pump or drainage solution will be needed to alleviate the drainage issues inside the tunnels.

The existing vehicular tunnel is 11'-11" tall by 11'-10" wide and can accommodate one vehicle at a time. If the City would like to utilize this tunnel for small vendors and emergency vehicles, it should be limited to mid-size trucks for vendors and normal ambulance sized van with a vertical clearance of 9.5' or under. Firetrucks may not be able to fit due to restricted height and slopes of the approach slab, depending on the vehicle. To improve vehicle access for mid-size trucks and trailers, it is recommended that the approach slab on the lake side of the tunnel be extended straight towards the paved area. This improvement would require minimum coordination and approval from the railroad company. See Figure 48 for proposed improvement detail.

The first alternative for crossing the railroad tracks is to utilize the existing tunnels by making the minimal improvements necessary for safe, universal access. The existing height of the tunnels is 7.5' and the minimum desired vertical clearance requirement for bicycles is 8 ft. Low clearance signs should be added to all entrances to the tunnels to warn bikers of the hazard.

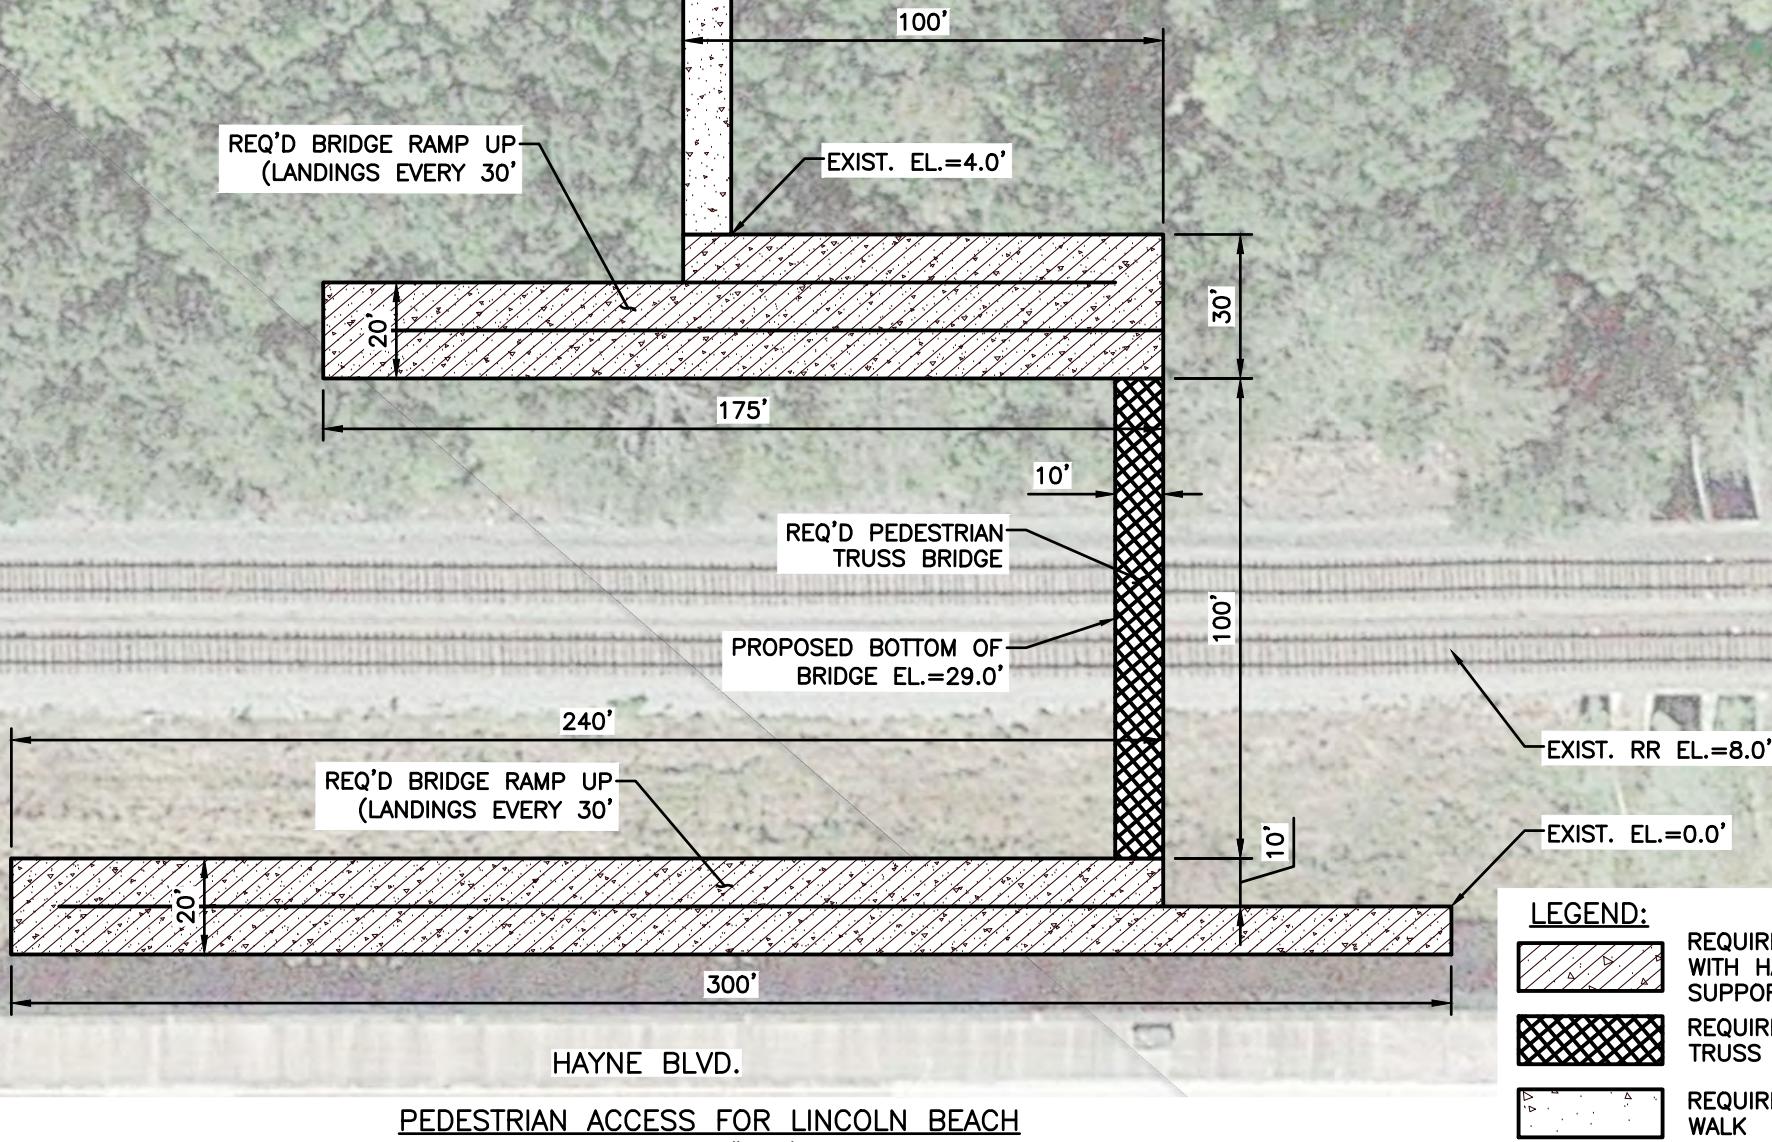
FIGURE 51 RAILROAD CROSSING ALTERNATIVE 2

Replacing the existing 3 tunnels with a new vehicle/pedestrian tunnel has also been explored. A box culvert tunnel could accommodate vehicular access and an 8' wide pedestrian/bicyclist path. The removal and replacement of the existing tunnel will require extensive temporary bracing and the possibility that the railroad tracks be closed for 1-2 months. The Railroad owner has made it clear that their tracks must always remain open. After speaking with Norfolk Southern, this new tunnel or tunnel replacement will take approximately 3 years to approve and suggestions were made to "look at other alternatives".

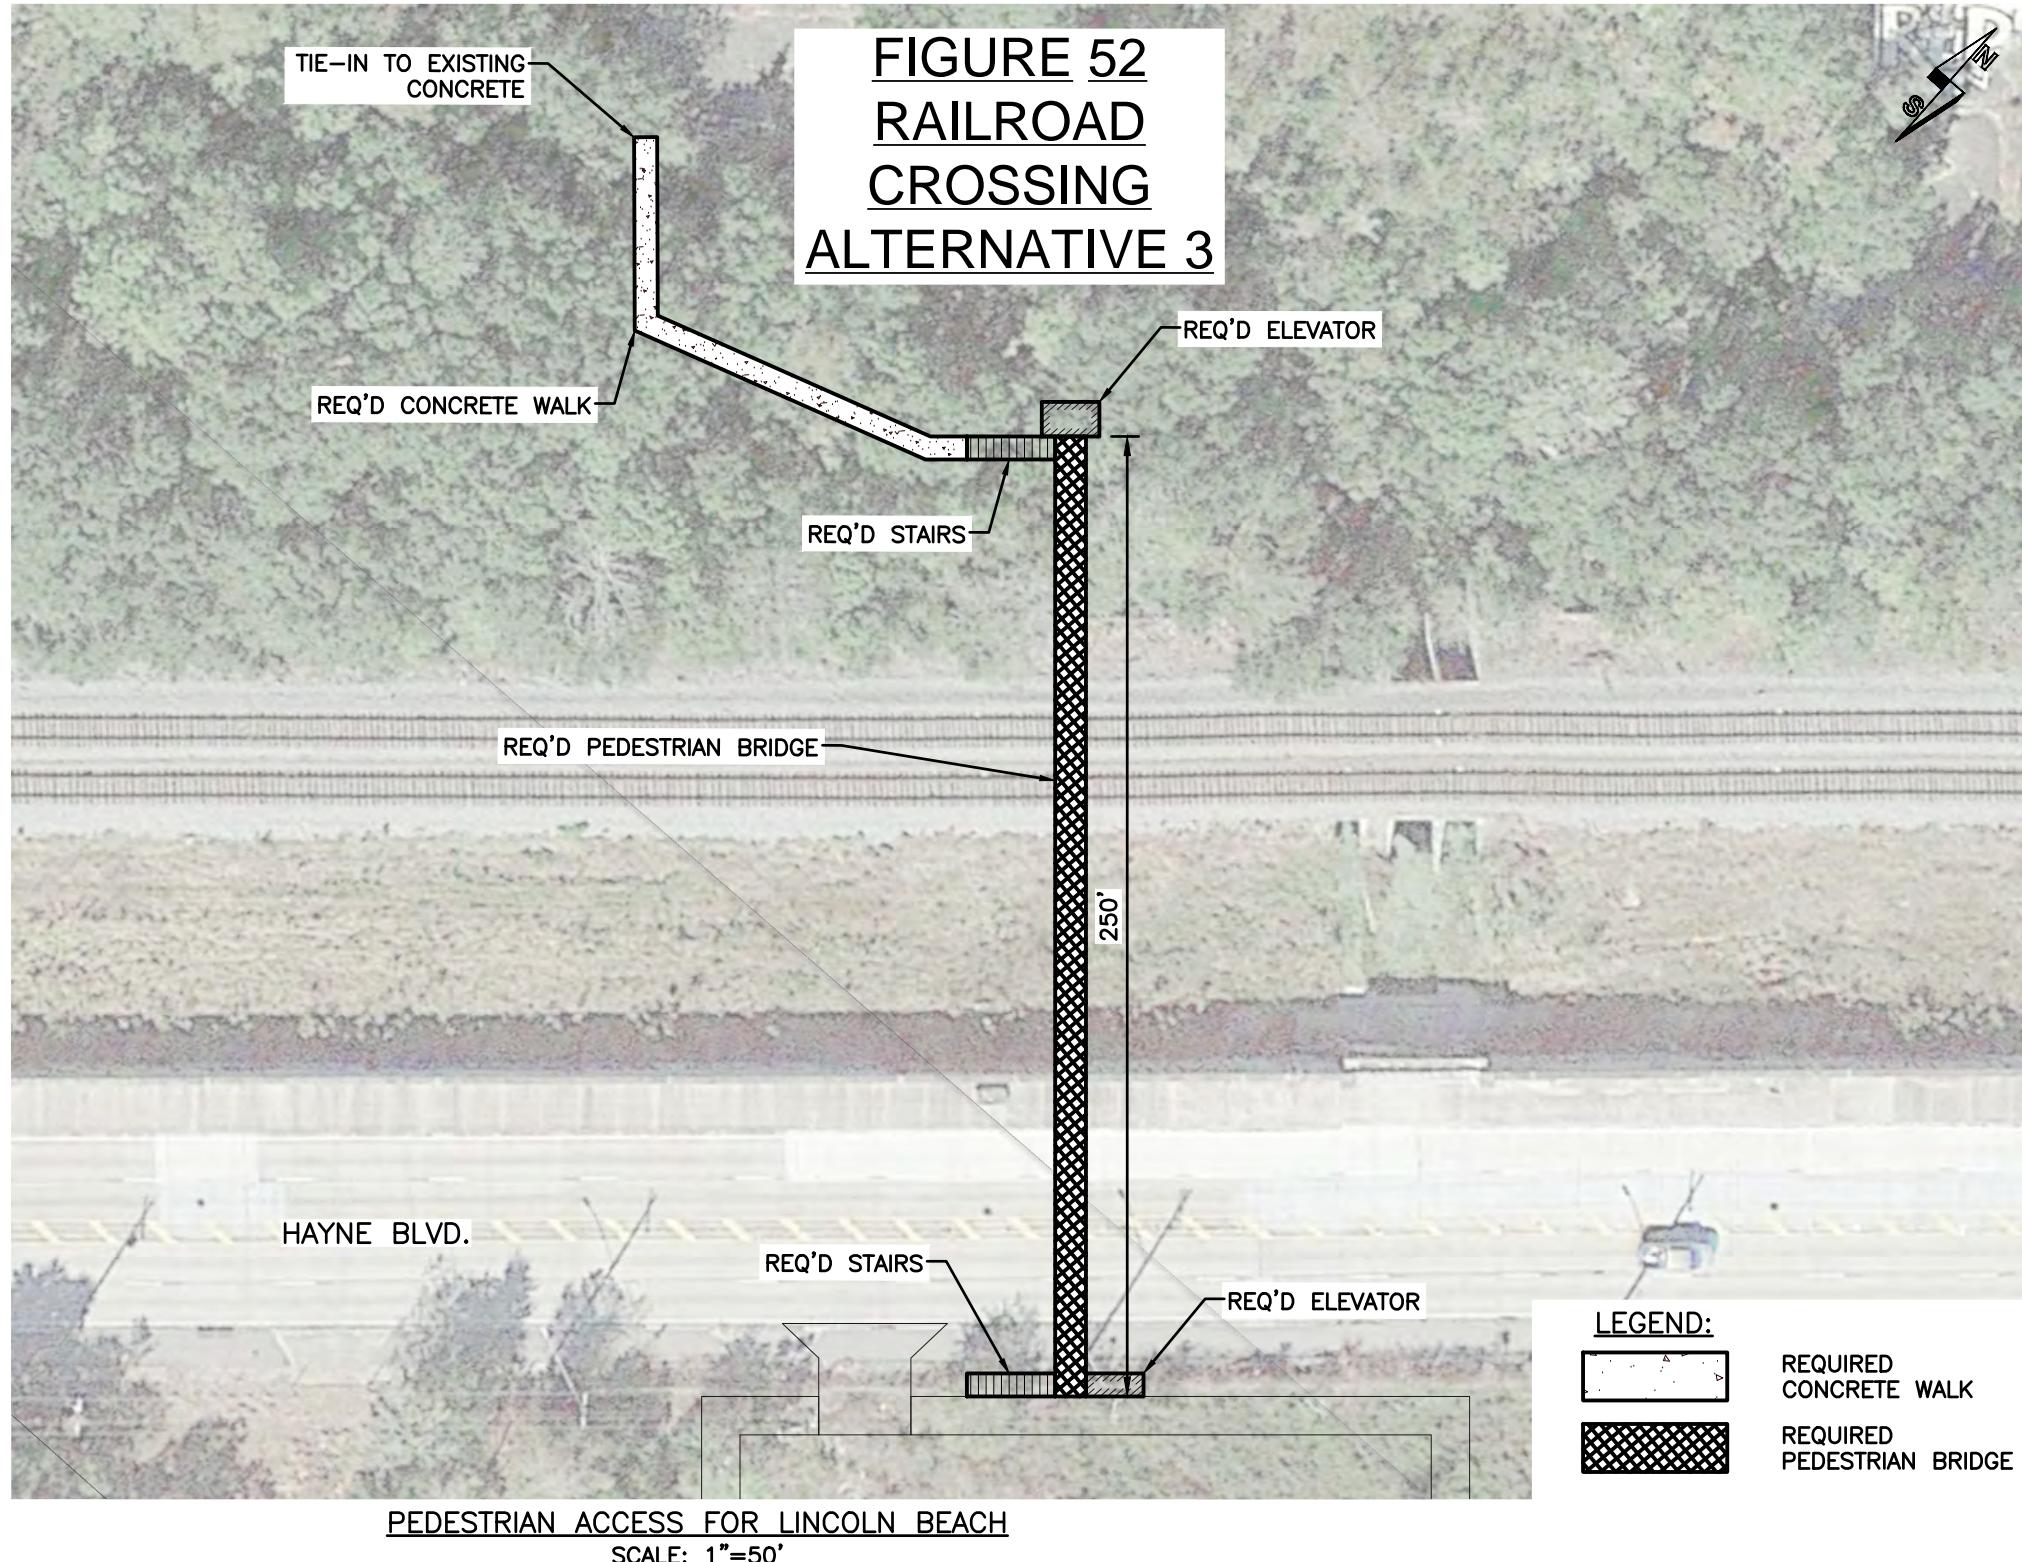
FIGURE 52
RAILROAD
CROSSING
ALTERNATIVE 3

The installation of a pedestrian/bicyclist bridge over the railroad tracks is also an alternative to consider. The elevation of existing ground for the land between the flood wall and the railroad is approximately 0.0 feet NAVD 88, while the elevation of the railroad tracks is approximately 8.0 feet NAVD 88. Significant ramping is needed to reach the grade of 21-24 feet above the railroad tracks to achieve this improvement. An example of the ramp up is shown in Figure 49. These are the minimum vertical clearance requirements that differ per railroad company. The decking for the bridge can be concrete or a lighter composite material with a longer life span. The installation of the bridge would require minimal closing of the rail line of a few hours. Elevators and stairs can be installed in place of the ramps. With the installation of elevators comes a yearly maintenance cost of approximately \$5,000/year. The average wait time for an elevator will be approximately 1 minute. The pro of installing an elevator and stairs is the quick nature that pedestrians can enter and exit the pedestrian bridge area. One downfall is the limited space for multiple bicycles to fit into the elevator. Railroad permitting will be required and conversations with Norfolk Southern indicate it will take approximately 1 year for the approval process. See Figure 51 for proposed improvement detail. The costs shown below are base costs for the pedestrian bridge and should not be taken as final costs.

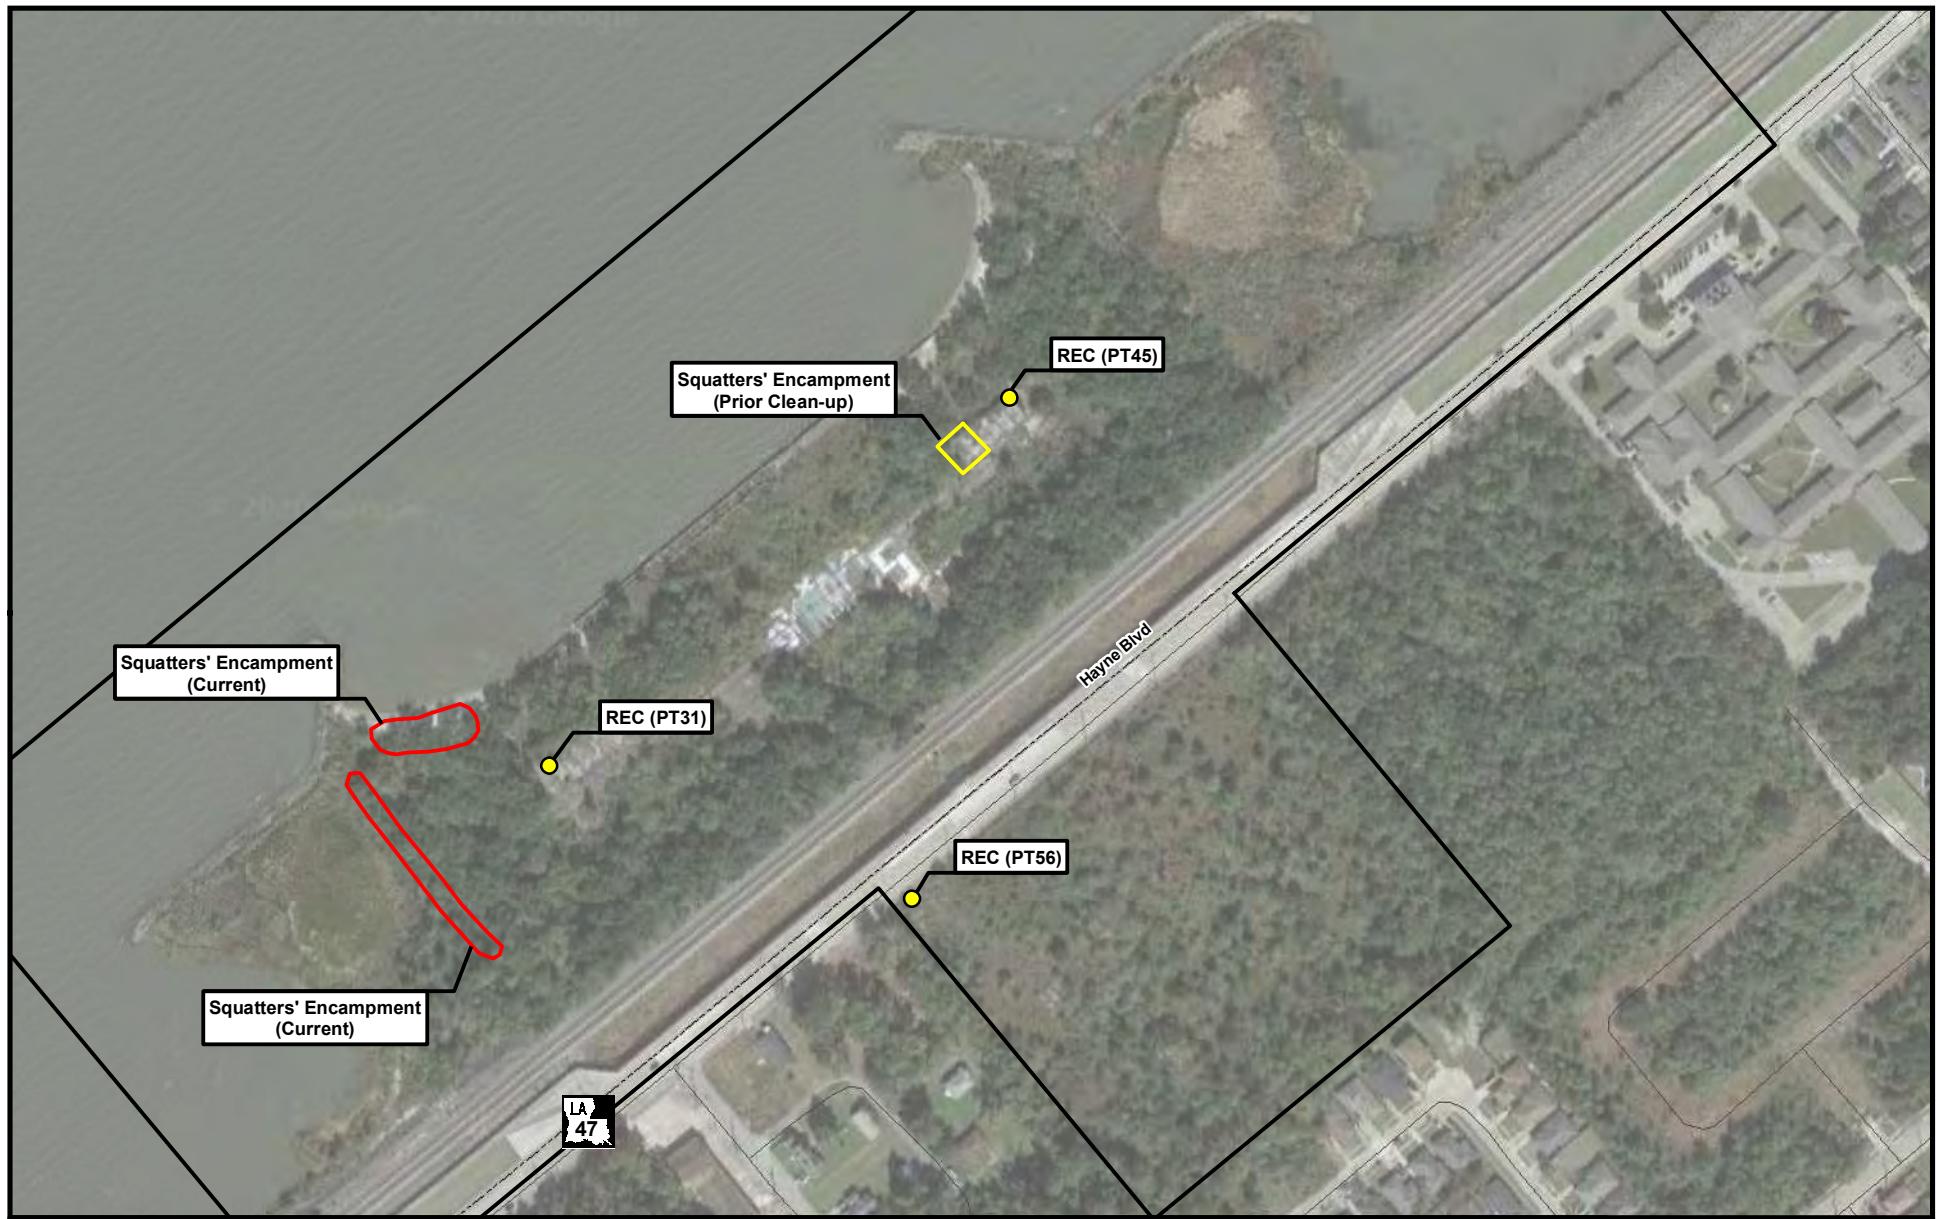
Figure 5: Observed Potential RECs

The ASTM E1527-13 Standard requires an opinion regarding evidence of RECs identified during the ESA process. ELOS is of the opinion that this assessment has revealed evidence of potential RECs in connection with the Subject Property. The location of potential RECs observed on the Subject Property are shown in **Figure 5** and marked with the corresponding photograph point (PT) number from the Photograph Log in **Appendix F**. Potential RECs include the two piles of contractor-style garbage bags near the west and east pavilions; the current and any former locations of the squatters’ encampment and associated debris piles; and the debris pile along the north chain-link fence of the parking lot area which contained automotive fuel tanks. Due to the unknown nature of the contents of the garbage bags and squatters’ encampment and debris pile, ELOS suggests personal safety measures consistent with biohazard protection guidelines be used when disposing the bagged garbage and further investigation, decontamination, or remediation of the squatters’ encampment and debris pile.

This Phase I ESA revealed evidence of potential RECs from substances in, on, or at the Subject Property. The locations of these RECs are shown on **Figure 5**. Potential RECs include the piles of garbage bags under the west and east pavilions; the automotive fuel tanks along the northern fence line of the parking lot area; and the current squatters encampment and any former location of the encampment and their associated debris piles on the Subject Property.

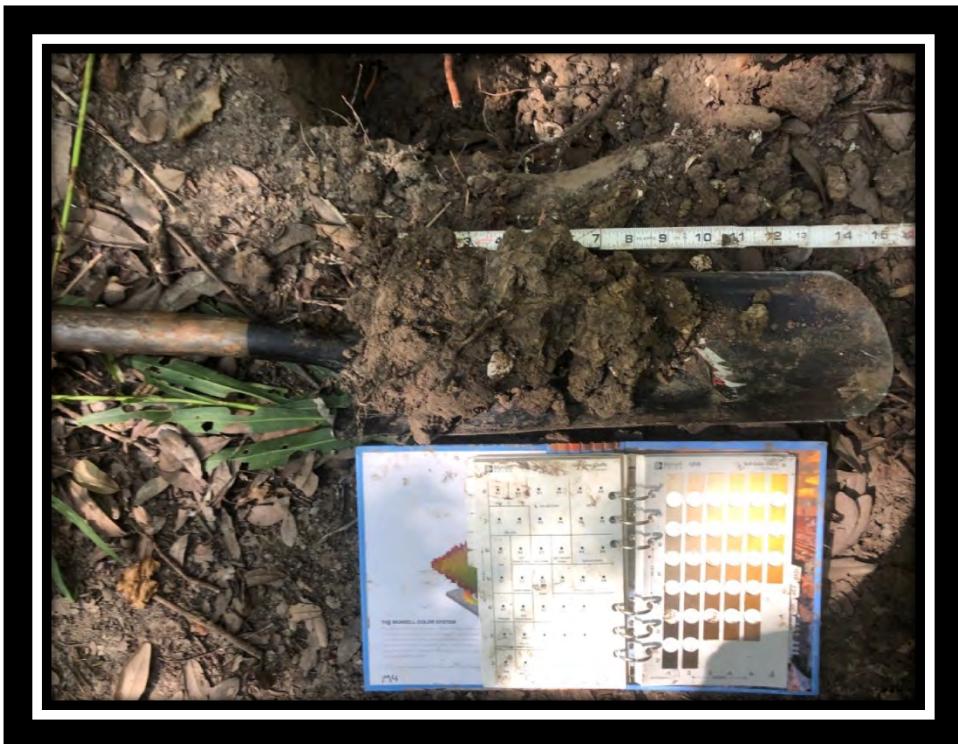
Shovel met resistance due to fill material at 9 inches

Photo 9: Soils Sample Plot 3, Soil Sample.
