# Vieux Carré Commission Architecture Committee Meeting

Tuesday, May 11, 2021

## 715-721 Chartres

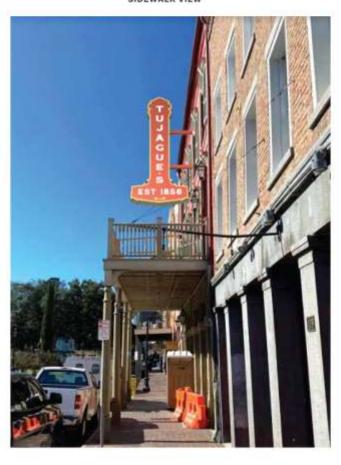
#### SIDEWALK VIEW

Painted aluminum sign cubinet with illumanted push through acrylic letters.

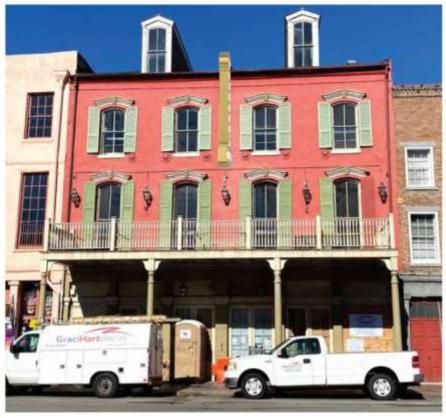
#### STREET VIEW

Painted aluminum sign cabinet with illumanted push through acrylic letters.

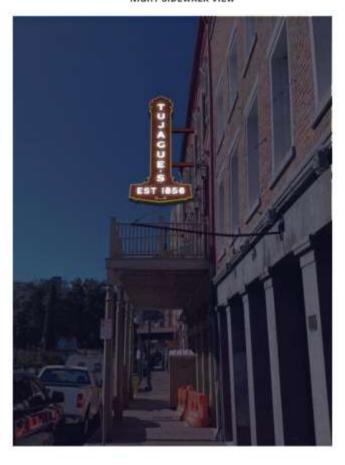
#### NIGHT SIDEWALK VIEW

Painted aluminum sign cabinet with illumanted push through acrylic letters.

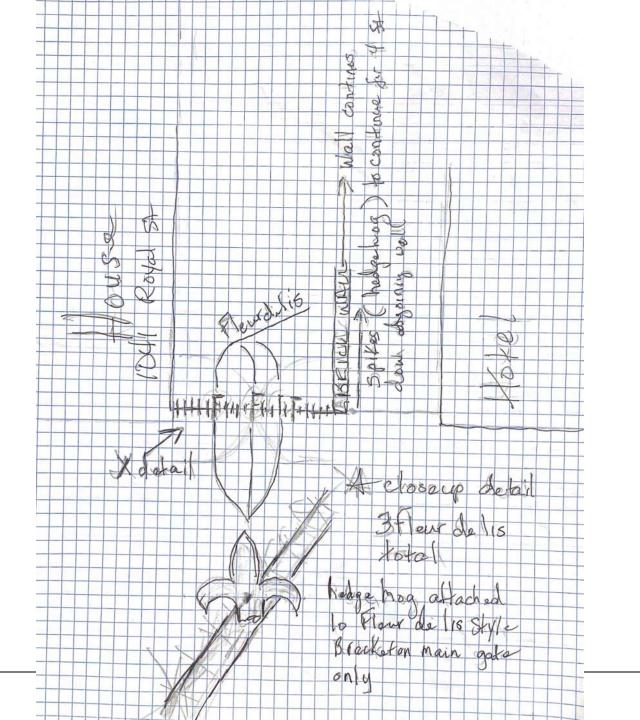
Hedge higes Proposal at 1041 Royal to be modeled after artisting hedgehoss at the corner of chartes & Ursilines

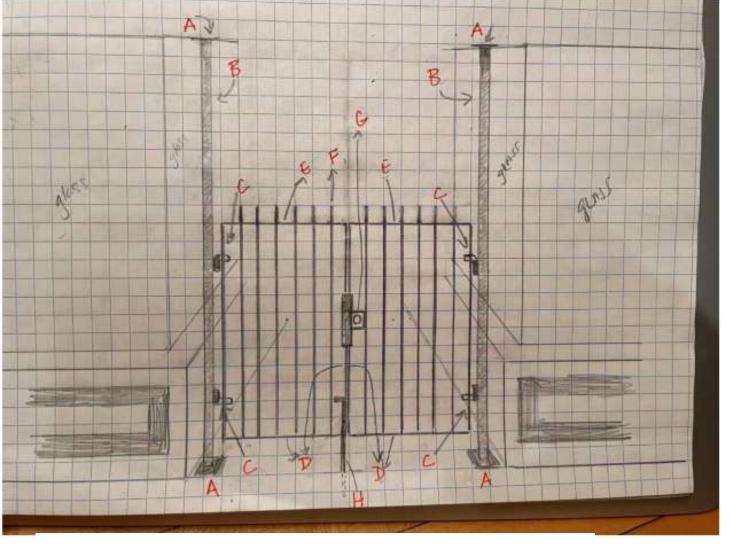
## 615-17 Ursulines – Current Proposal

The posts span from floor to ground and are approximately 8' tall.

The outer opening of the vestibule, where the gates fall, is approximately 70" wide.

Given the 2" posts, space for hinges, and 1/2" gap between gates, each gate will be approximately 30" wide.

If necessary, we would also like the option to drill a small (1/2" at most) hole into the ground where inside edge of gate will be when open. We will epoxy in a hook or loop, with the corresponding piece welded to the bottom corner of the gate to keep it in a fully open position during business hours.

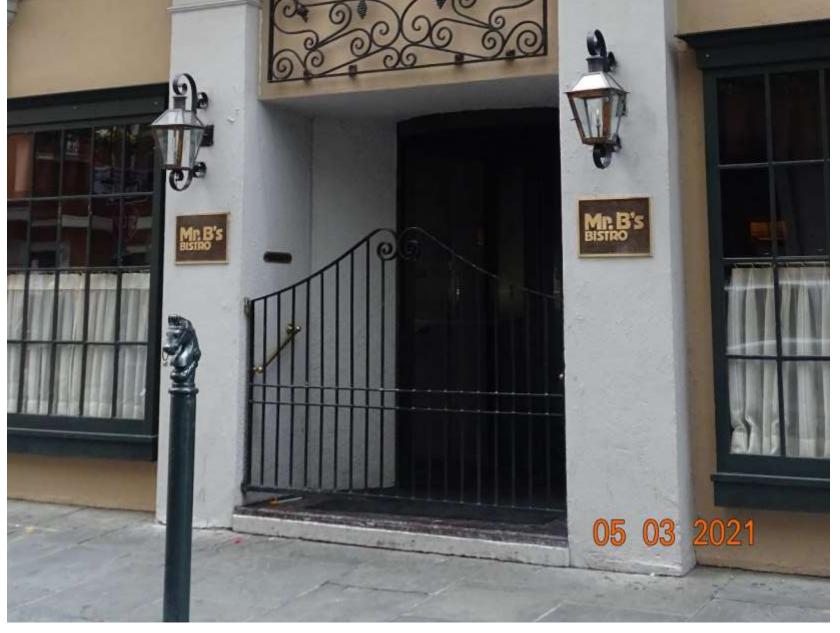
615-17 Ursulines – Approved Alcove "Gate" at 201 Royal St.

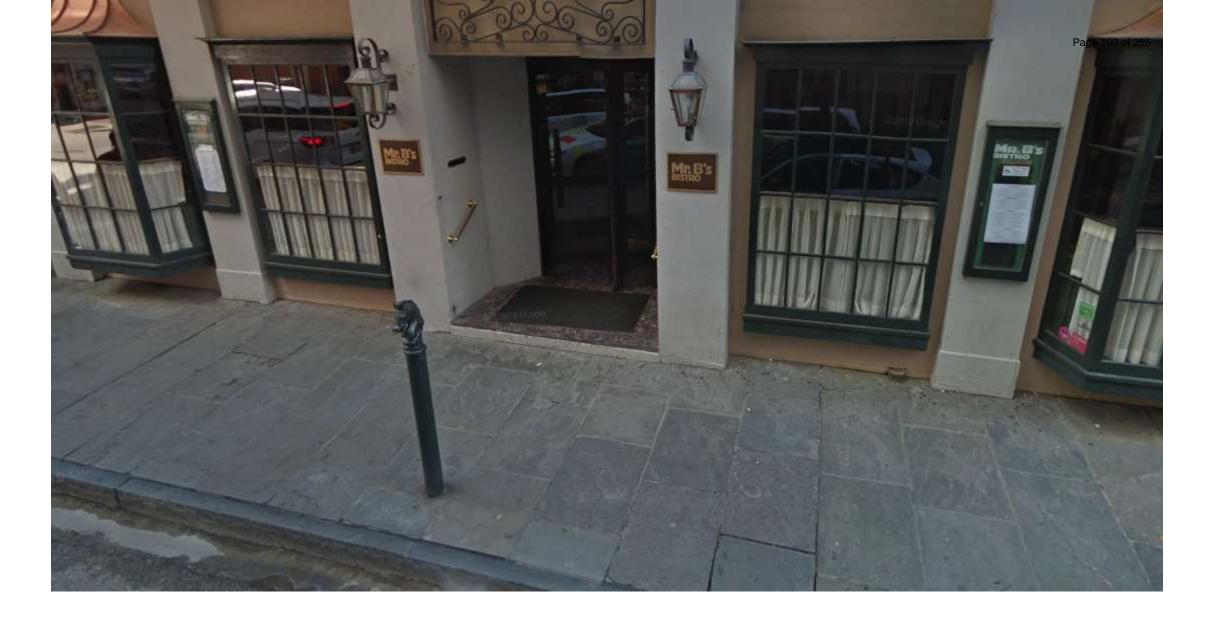
615-17 Ursulines – Approved Alcove "Gate" at 201 Royal St. when not in use

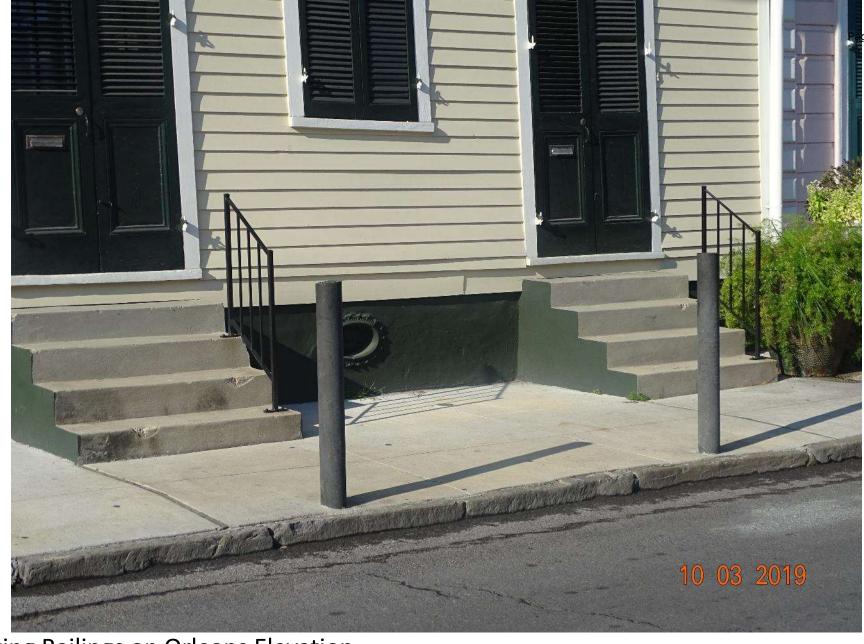
1000 Orleans – Existing Railings on Orleans Elevation

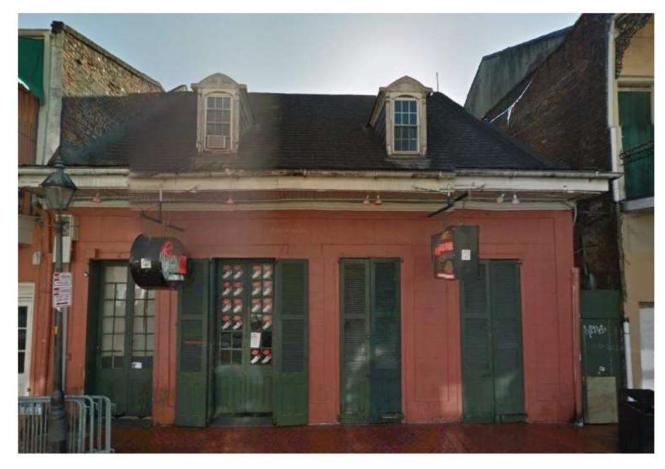
#### Primary Bourbon Street facade.

- 1. Door at left and right to be removed for new single swing glazed door to match historic profiles.
- 2. Existing shutters to be repaired.
- 3. Stucco to be repaired.
- 4. Existing cornice to remain.
- 5. Gutters / Downspouts to be replaced.
- 6. Existing composite slate roof to be repaired.
- 7. Existing dormers to be repaired. New exterior painted wood trim at dormer window surrounds and fascia.
- 8. Non-historic lights, security cameras, signage, conduit to be removed and replaced with approved fixtures.
- 9. Soffit structure to be repaired.
- 10. Window unit to be removed.

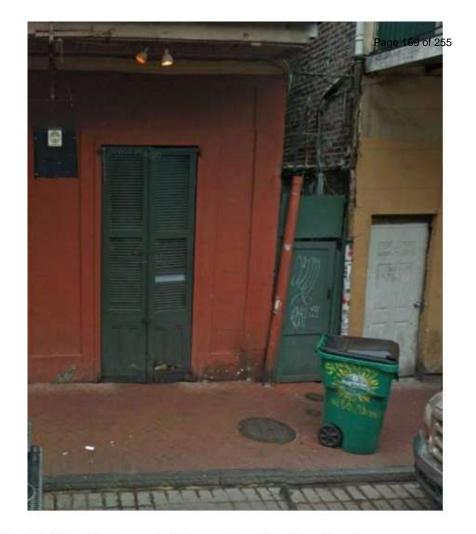
### 2 Existing Shutters and alleyway gate at Bourbon Street.

- 1. Privacy gate / barrier to be replaced with new to match historic profile.
- 2. Existing shutters to be repaired.
- 3. Stucco to be repaired.
- Door in photo behind shutters to be removed for new single swing door to match historic profiles.

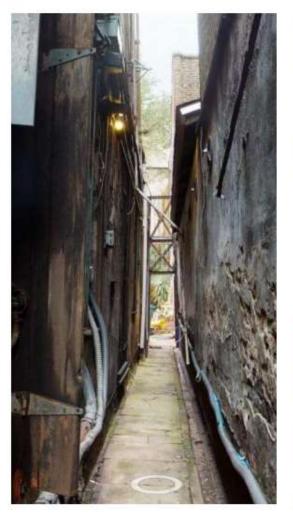
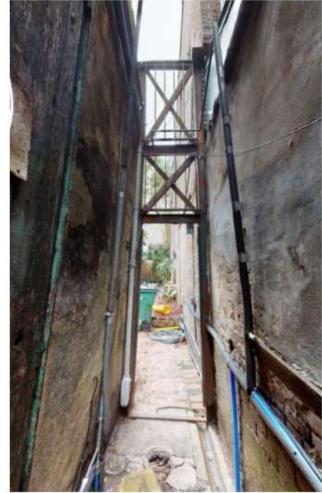
### View into Alleyway from Bourbon Street.

- 1. Services and conduit to be removed. New services + condout to be routed to reduce visual presence.
- 2. Former window openings to have infill structure repaired or replaced.
- 3. Shutters to be repaired; missing shutters to be replaced to match historic.
- Existing non historical structural bracing at end of alley to be evaluated by Structural engineer for removal or reconfiguration.
- 5. Spalling stucco to be removed.

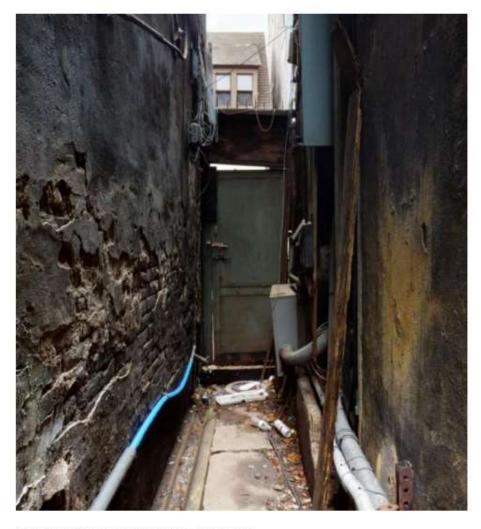
### Reverse view of alley towards Bourbon.

- 1. Electrical meters, utility services and conduit to be removed. New services + conduit to be routed to reduce visual presence.
- Former window openings (not present) to have infill structure repaired or replaced.
   Shutters to be repaired; missing shutters to be replaced to match historic.
- 4. Spalling stucco to be removed.
- 5. Privacy gate / barrier to be replaced with new to match historic profile.

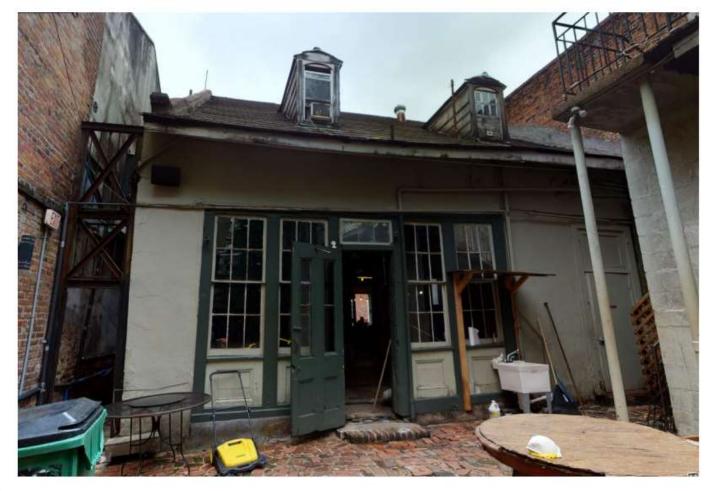
#### 6 Main Building Rear Facade.

- 1. Window / Glazed Door assembly to be replaced with new to match historic profiles.
- 2. Concrete curb below windows to be modified to be flush and finished with new stucco.
- 3. Non-compliant single riser to be removed.
- 4. Utility sink + temporary awning to be removed.
- 5. Conduit + Utility piping to be removed.
- 6. Speakers to be removed.
- 7. Window unit at dormer to be removed. Dormer windows to be replaced with new wood windows to match front historic windows. Window surround trim + fascia at dormers to be reconstructed.
- 8. Slate composite roof to be repaired.
- 9. Existing HM door to right of picture and transom infill wood panel to be removed. New transom glazing + new historic wood door to be fitted within existing trim.

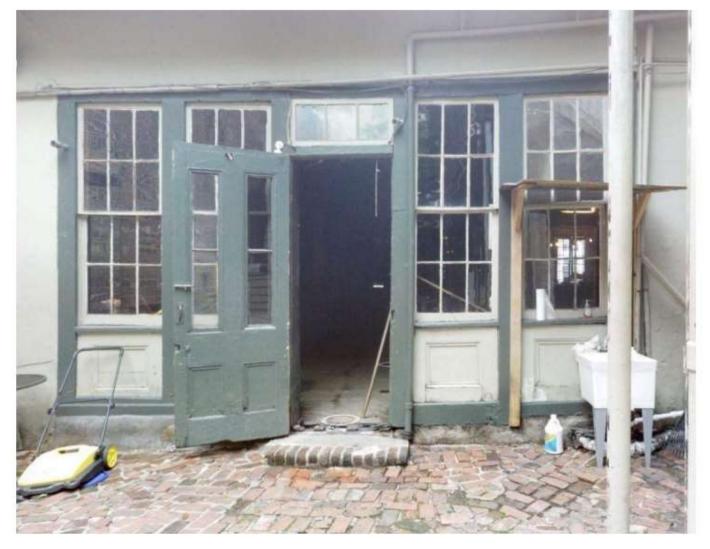
### 7 Main Building Rear Facade

- 1. Window / Glazed Door assembly to be replaced with new to match historic profiles.
- 2. Concrete curb below windows to be modified to be flush and finished with new stucco.
- 3. Non-compliant single riser to be removed.
- 4. Utility sink + temporary awning to be removed.
- 5. Conduit + Utility piping to be removed.

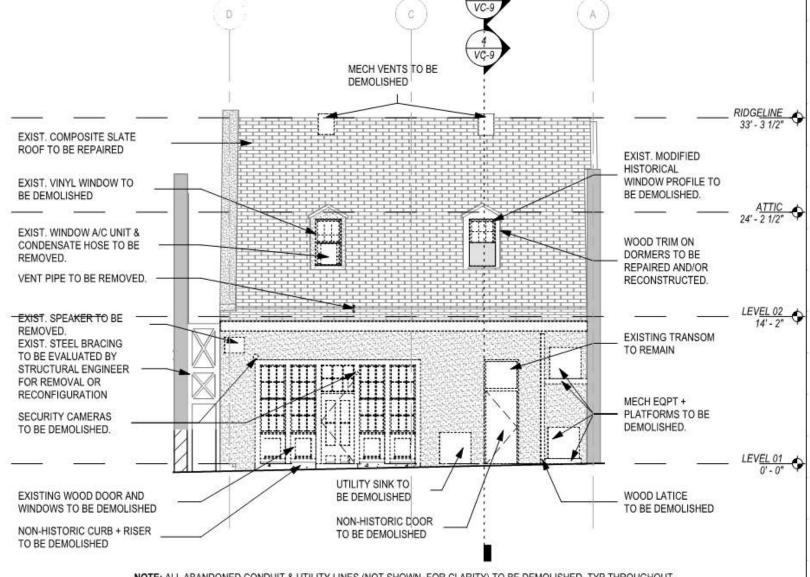
B EXIST. E ELEV - MAIN BLDG

NOTE: ALL ABANDONED CONDUIT & UTILITY LINES (NOT SHOWN, FOR CLARITY) TO BE DEMOLISHED, TYP THROUGHOUT.

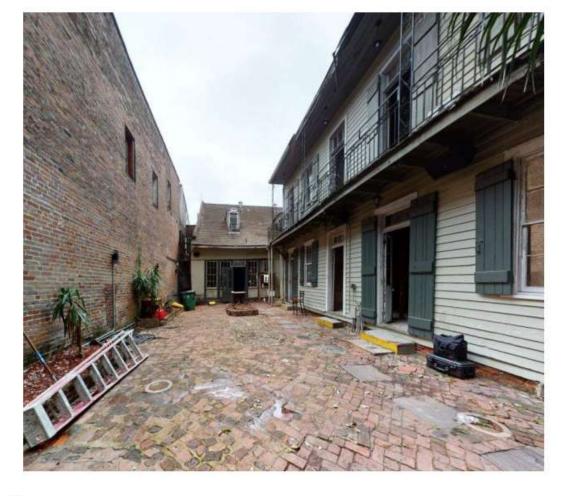
- Existing courtyard overview from rear (looking towards Bourbon)

1. Existing paving to be removed, site regraded for ADA, and new paving installed. Existing drainage channel to left side of photo to be retained.
- 2. Existing brick planting beds, plantings, and tree stump to be removed.
- 3. Select areas of masonry to be repaired, repointed as required. Vegetation to be removed from masonry, and brick / mortar to be cleaned.
- 4. Existing wall sconces and conduit to be removed.
- 5. Non-compliant single riser to rear dependency to be removed.
- 6. Non-historic pendant lights at rear dependency to be replaced. Conduit to new fixtures to be minimized.
- 7. Windows + glazed door at main building rear facade to be removed and replaced.
- 8. Vinyl window at dormer to be replaced with new wood window to match historic profiles. Dormer to be repaired and receive new window surround trim / fascia.

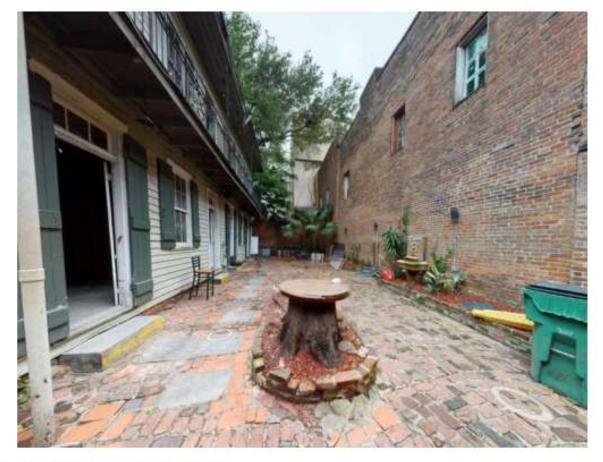
### Existing courtyard overview.

- Existing paving to be removed, site regraded for ADA, and new paving installed. Existing drainage channel to right side of photo to be retained.
- 2. Existing brick planting beds, plantings, and tree stump to be removed.
- 3. Select areas of masonry to be repaired, repointed as required. Vegetation to be removed from masonry, and brick / mortar to be cleaned.
- 4. Existing wall sconces and conduit to be removed.
- 5. Fountain to be removed.
- 6. Non-compliant single riser to rear dependency to be removed.
- Non-historic pendant lights at rear dependency to be replaced. Conduit to new fixtures to be minimized.

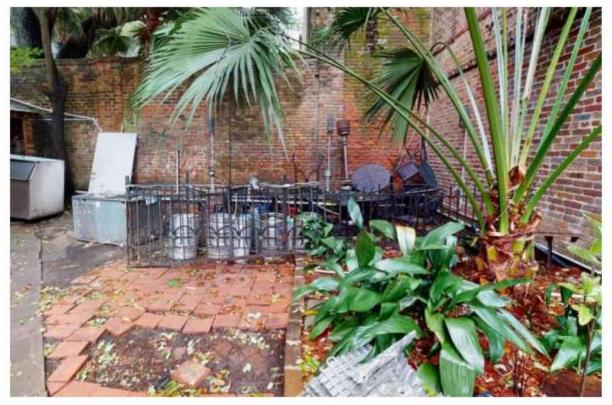
### 10 Existing courtyard rear.

- 1. Existing paving to be removed, site regraded for ADA, and new paving installed.
- 2. Existing brick planting beds, plantings, and tree stump to be removed
- 3. Select areas of masonry to be repaired, repointed as required. Vegetation to be removed from masonry, and brick / mortar to be cleaned.
- 4. Metal site fence to be removed
- 5. Ice cooler, ice machine, mech. units, patio heaters to be removed.

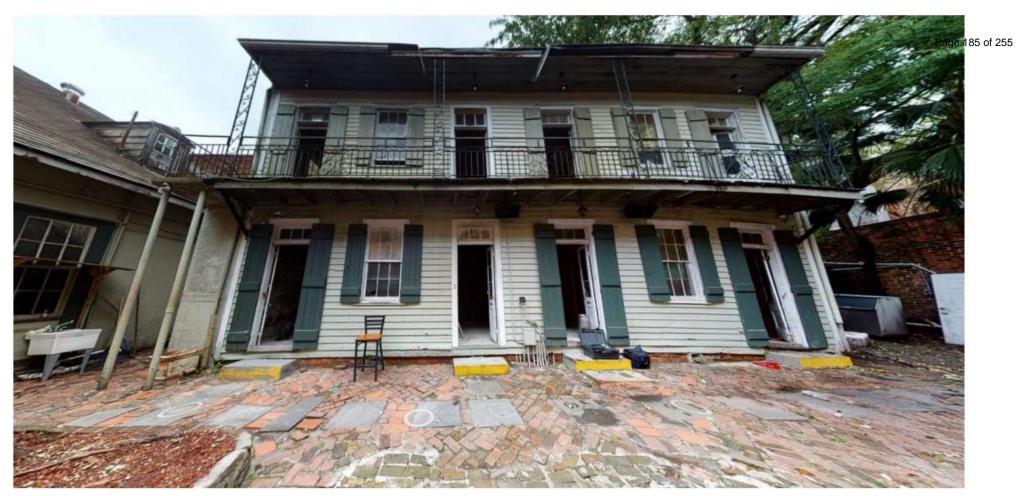
### Rear Dependency Main Facade

- 1. Non-compliant single concrete risers to be removed.
- 2. Non-historic interior concrete floor to be removed to original floor level.
- 3. Ground floors doors and shutters to be replaced with new elongated to match historic profiles in same locations. New doors will be single swing to meet current Code.
- 4. Speakers, non-historic lights, to be replaced.
- 5. Existing steel columns at stair landing to remain.
- CMU at existing concrete stair to be parge coated.
- 7. Non-historic iron guardrail at balcony / stairs and iron roof posts at balcony to be replaced with new wood guardrail, handrail, and posts.
- 8. Missing door and window shutters to be replaced with new to match existing.9. Existing windows, doors, shutters to be repaired or replaced in kind to match existing.
- 10. Gutters and downspouts to be replaced. Fascia + Soffit to be repaired as necessary.

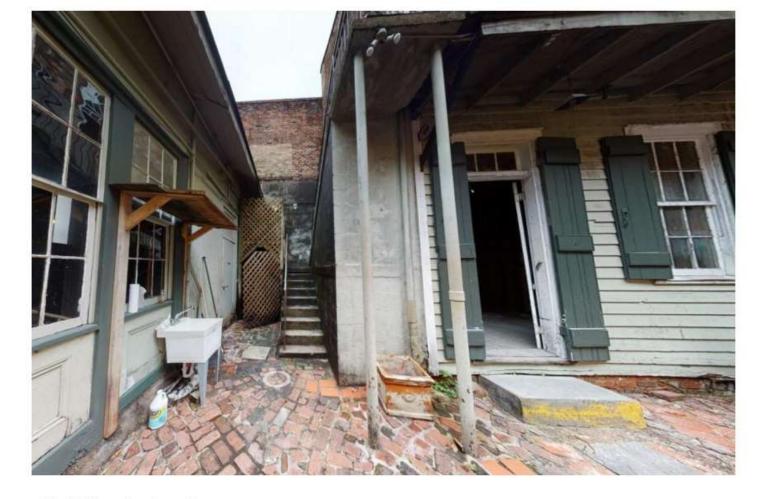
### Main Building + Rear Dependency

- 1. Non-compliant single concrete risers to be removed.
- 2. Non-historic interior concrete floor to be removed to original floor level.
- 3. Ground floors doors and shutters to be replaced with new elongated to match historic profiles in same locations. New doors will be single swing to meet current Code.
- 4. Speakers, non-historic lights, to be replaced.
- 5. Existing steel columns at stair landing to remain.
- CMU at existing concrete stair to be parge coated.
- 7. Non-historic iron guardrail at balcony / stairs and iron roof posts at balcony to be replaced with new wood guardrail, handrail, and posts.
- 8. Lattice screen and mechanical equipment to be demolished.
- 9. Non-historic door and transom infill to be removed (trim to be retained.) New glazed transom and new wood door to match existing profiles.
- 10. Existing mortar and masonry to be repaired, cleaned.

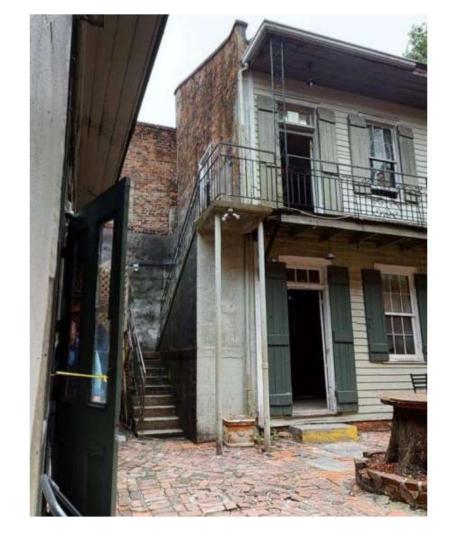
# 13

- View of existing stair and rear dependency west elevation.

1. Repair or replace existing window to match historic profiles at existing 2nd floor dependency.
- Remove spalling stucco from existing historic masonry at rear depedency. Upper level side elevation of rear dependency to receive new stucco.
   Non-compliant metal handrail and gate at stair to be demolished; replace with
- compliant hand- and guardrail.

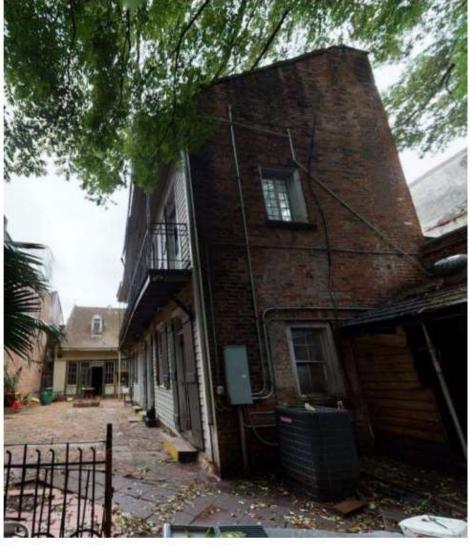
14

- East Facade of Rear Dependency Building

1. Existing electrical panel, mechanical, conduit, utility piping to be removed.
- 2. Existing masonry and windows to be repaired.
- 3. Gutters and downspouts to be replaced.
- Non-historic iron guardrail and iron posts at second floor balcony to be removed.
   Non-compliant single riser concrete stair at ground floor to be removed.

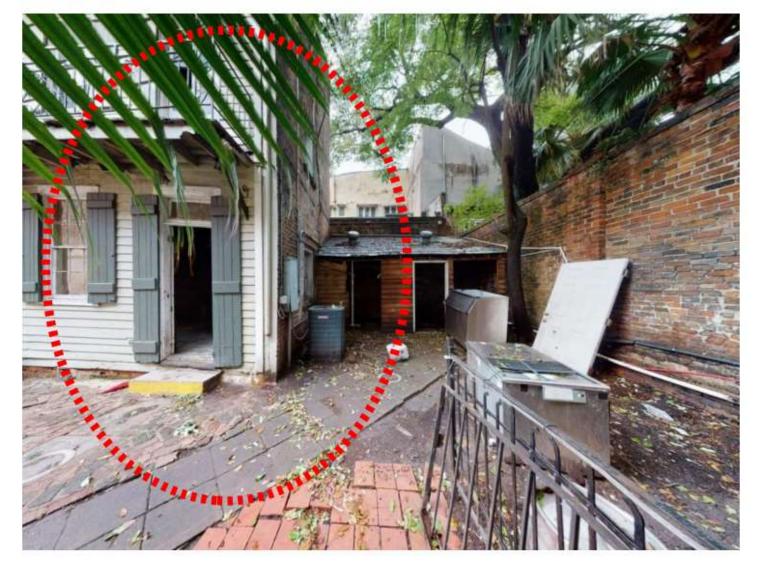
- East Facade of Rear Dependency Building

1. Structural settling of SE corner of rear dependency visible.

2. Door opening to be reframed plumb for new elongated door and shutters.
- 3. Siding to remain as is.

I, a representative of Batture LLC, visited the site on April 29, 2021 to assess the brick masonry condition at a settled corner in a historic structure at the address located above. The structure is a 2-story masonry structure with wood infill framing. A downspout is located at the settlement location. Based on the condition of the interior side of the masonry, the area has been tuckpointed. No large settlement cracks are present, which indicates no new settlement has occurred. We would recommend the masonry at the corner to remain as is in lieu of repair. The stormwater at the downspout exit should be redirected away from the foundation. The interior of the masonry wall should be further tuckpointed to fill all exposed mortar joints.

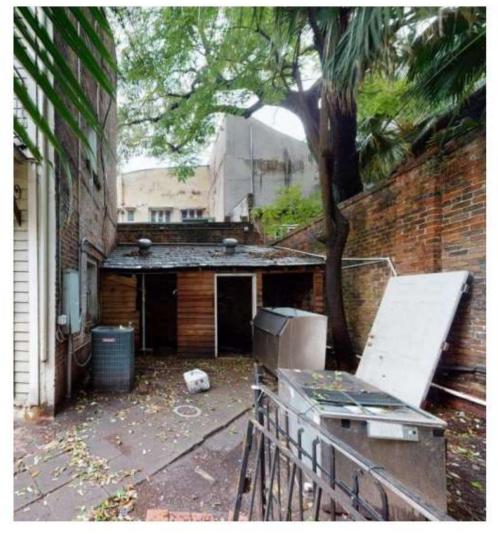
### 16 Existing Rear Shed

- 1. Existing rear shed to be removed in it's entirety. New shed structure to be built within same footprint (to be reviewed by VCC.)
- 2. Existing electrical panel on Rear Dependency to be removed.
- 3. Mechanical, conduit, utility piping to be removed.

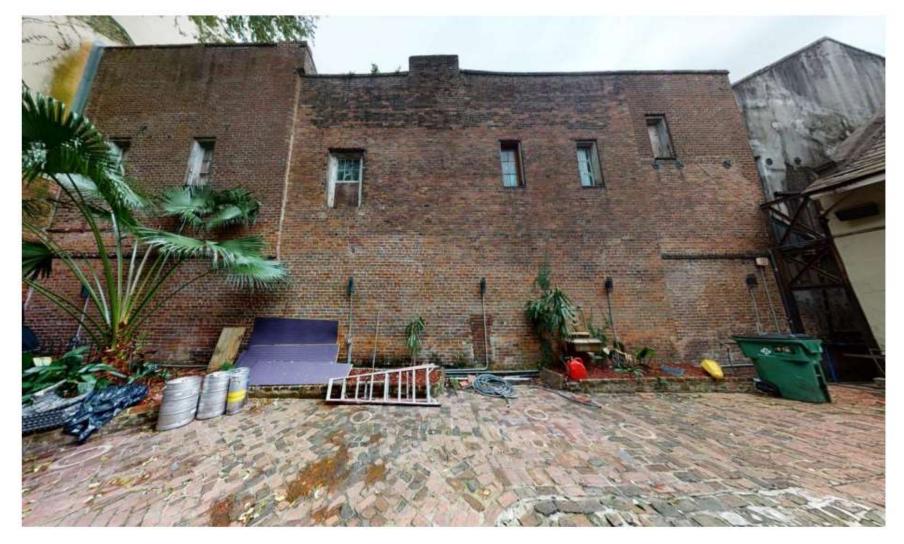
### 17 Existing Party Wall at Courtyard (view from rear shed)

- 1. Existing paving to be removed, site regraded for ADA, and new paving installed. Existing drainage channel to be retained.
- 2. Existing brick planting beds, plantings, to be removed.
- 3. Select areas of masonry to be repaired, repointed as required. Vegetation to be removed from masonry, and brick / mortar to be cleaned.
- 4. Existing wall sconces, exit light, and conduit to be removed.
- 5. Fountain to be removed.
- 6. Structural bracing to alleyway to be evaluated by structural engineer for removal or reconfiguration.

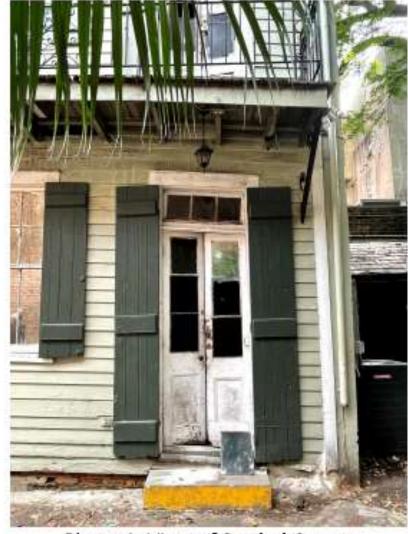
Photo 1: View of Settled Corner

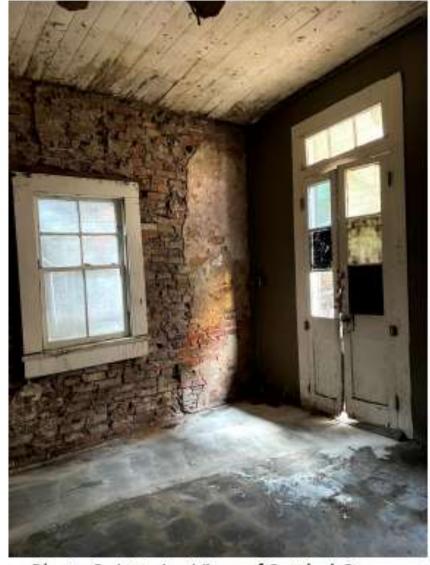
Photo 2: Interior View of Settled Corner

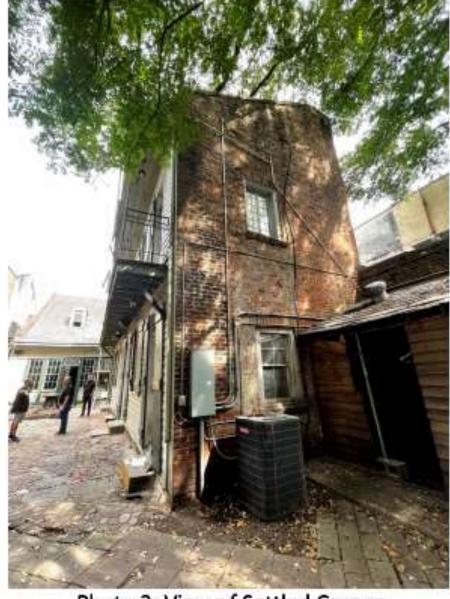
Photo 3: View of Settled Corner

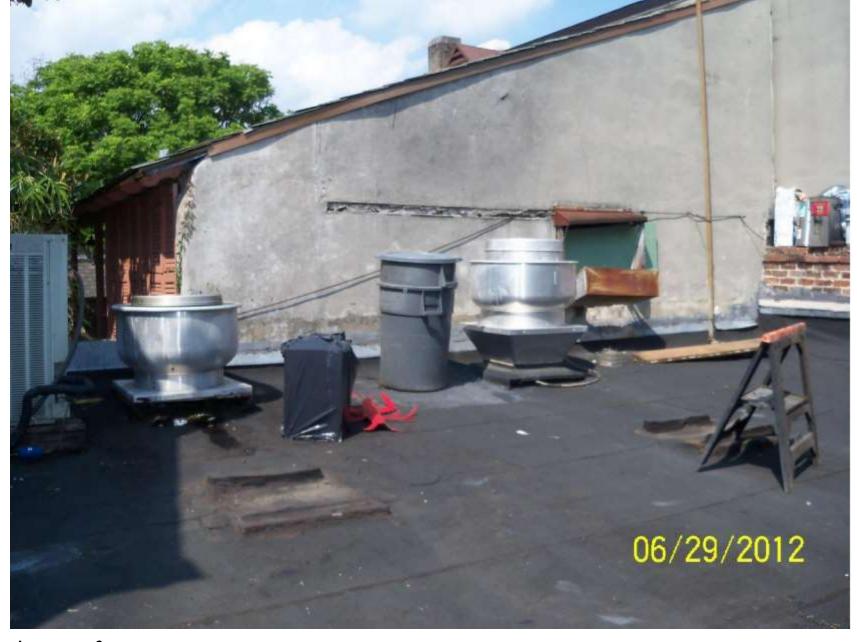
627 Bourbon – Flat Roof

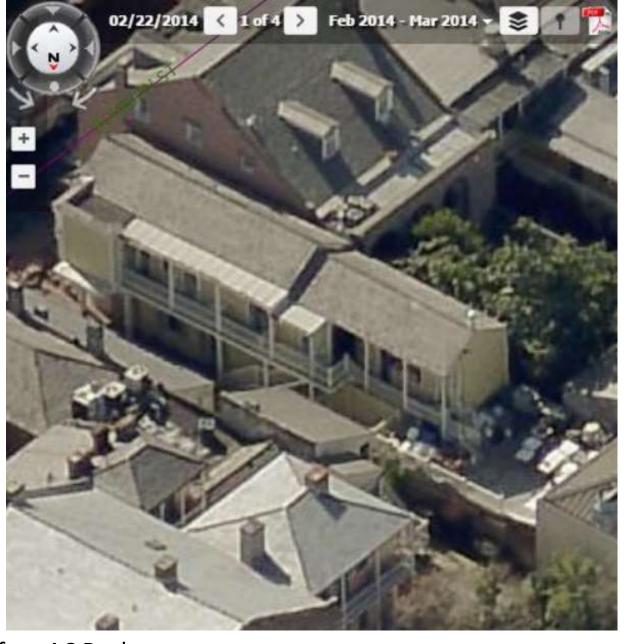
627 Bourbon – 2014 – Before AC Rack
