# Vieux Carré Commission Architecture Committee Meeting

Tuesday, March 12, 2024

**327 Bourbon**

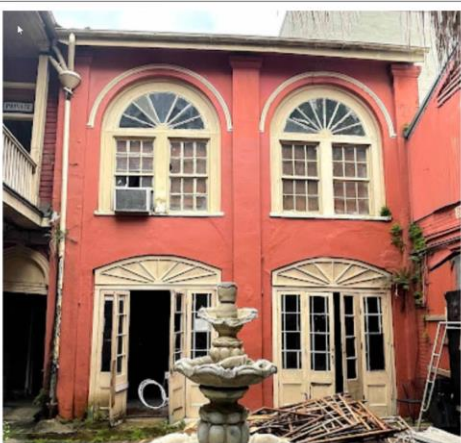
PRE-DEMO

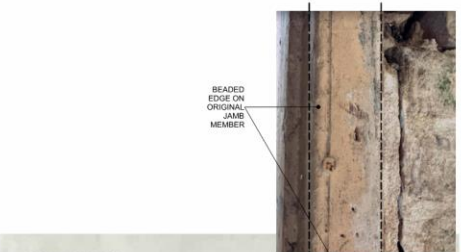
BEADED EDGE ON ORIGINAL JAMB MEMBER

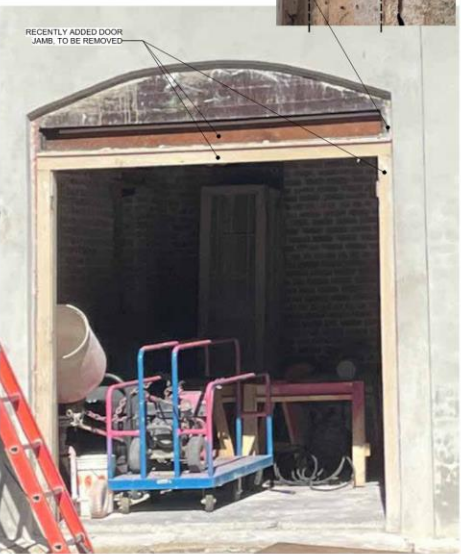
POST-DEMO

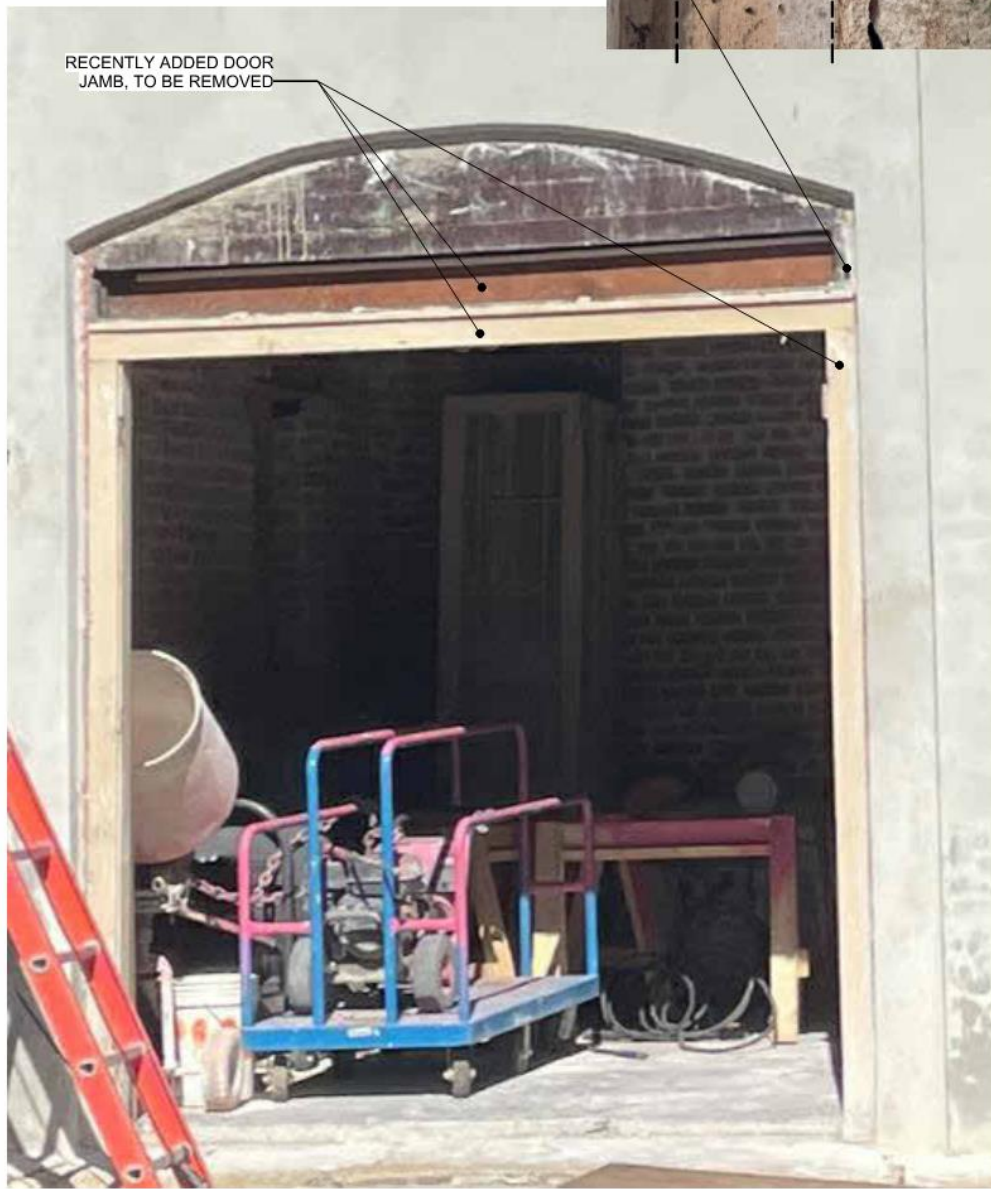
RECENTLY ADDED DOOR JAMB, TO BE REMOVED

POST-DEMO

DOOR ELEVATIONS D17 - EXISTING CONDITIONS  
3/4" = 1'-0"

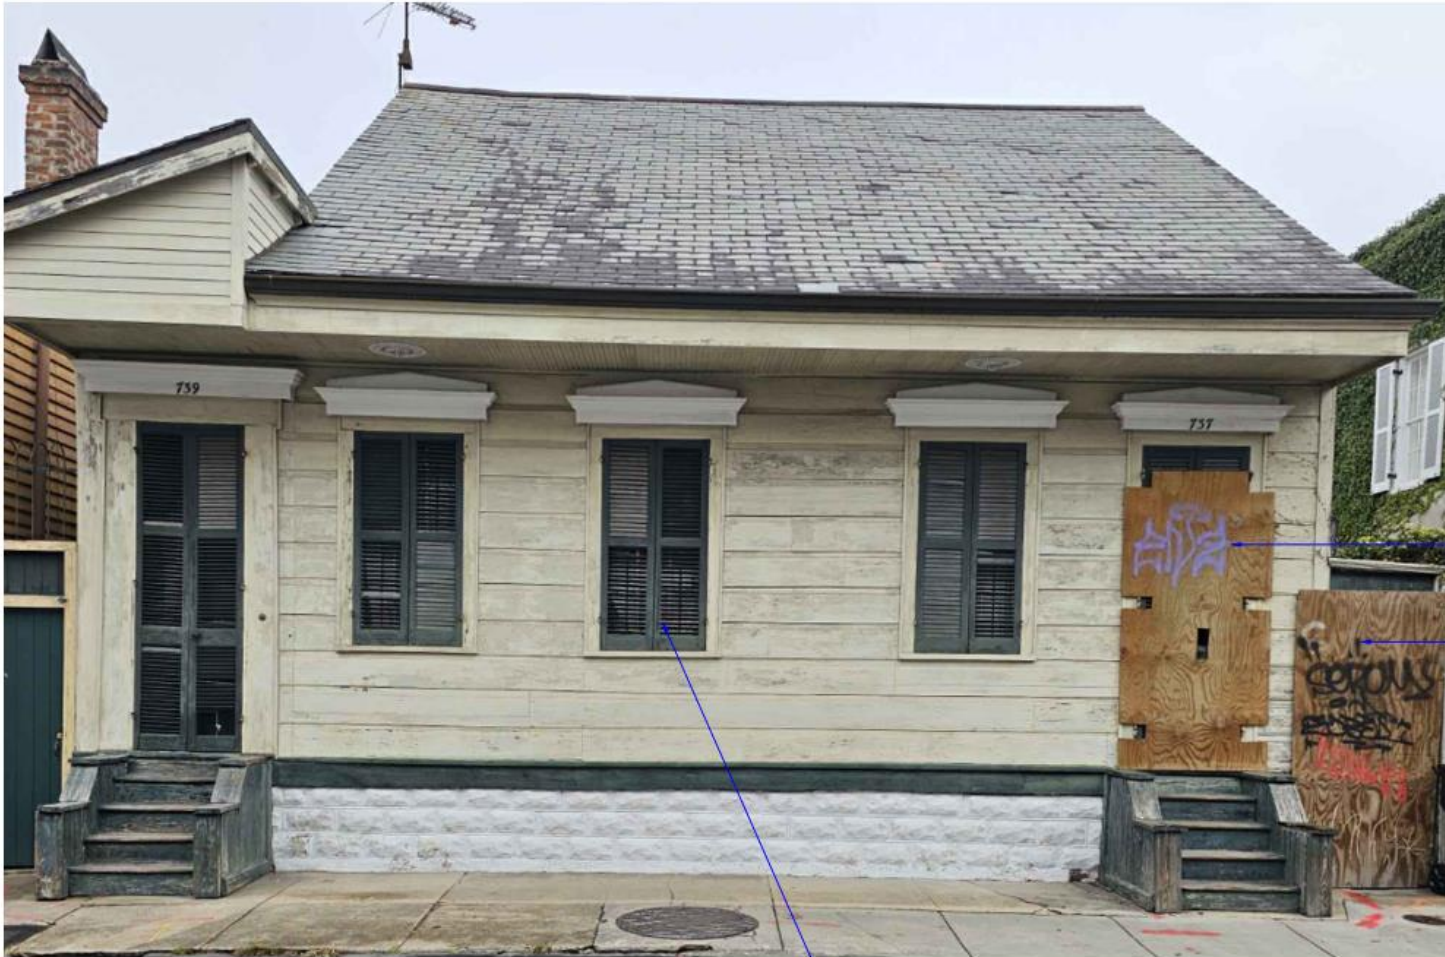
Existing conditions/  
repairs

FABRICATE NEW ENTRY DOORS TO FIT IN EXISTING FRAMES - SEE SD2

NEW SIDE GATE UNIT TO REPLACE EXISTING DAMAGED BEYOND REPAIR

REMOVE FRONT WINDOW AND DOOR SHUTTERS AND REPAIR WITH MATERIALS IN KIND, PAINT AND REINSTALL. REPLACE HARDWARE TO MATCH AS NEEDED

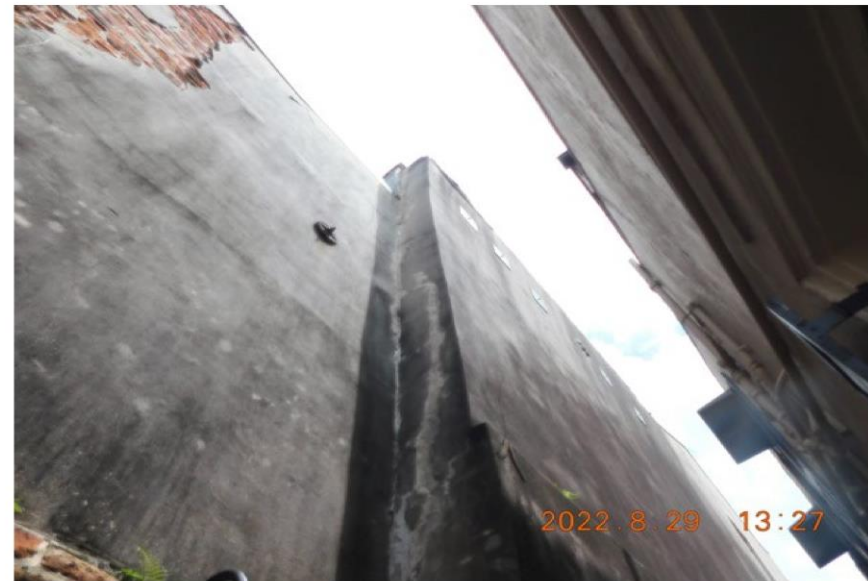
View of Exterior Wall from 1129 Burgundy Street

From the alleyway between 1129 and 1131 Burgundy Street, we observed the exterior of the masonry wall in question at the rear of 1004 Governor Nichols Street. This wall is approximately three-stories tall and does not adjoin the neighboring buildings. The brick masonry is clad in a smooth stucco finish. We observed brick tie anchors at the rear of this wall to be newer in appearance than the ties on adjacent walls. We understand from our conversation with the owner that these ties were added approximately ten to fifteen years ago in an effort to mitigate further movement of this exterior load bearing masonry wall.

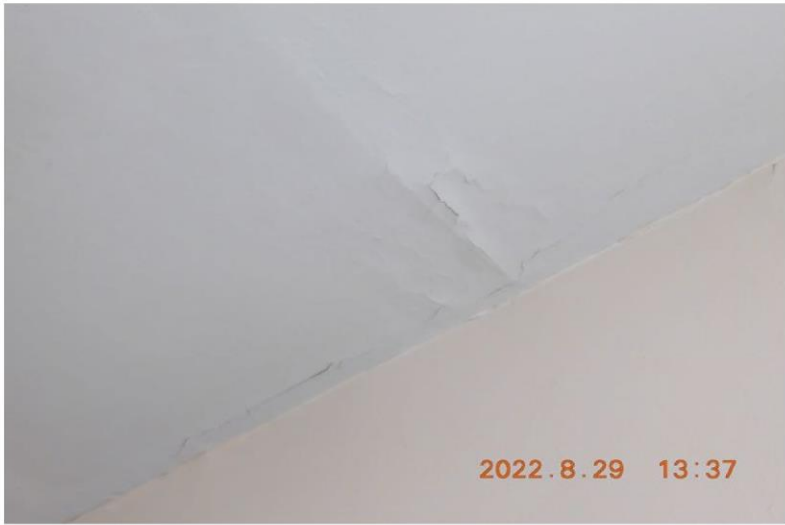
Water Damage and Cracks at Second Floor Unit

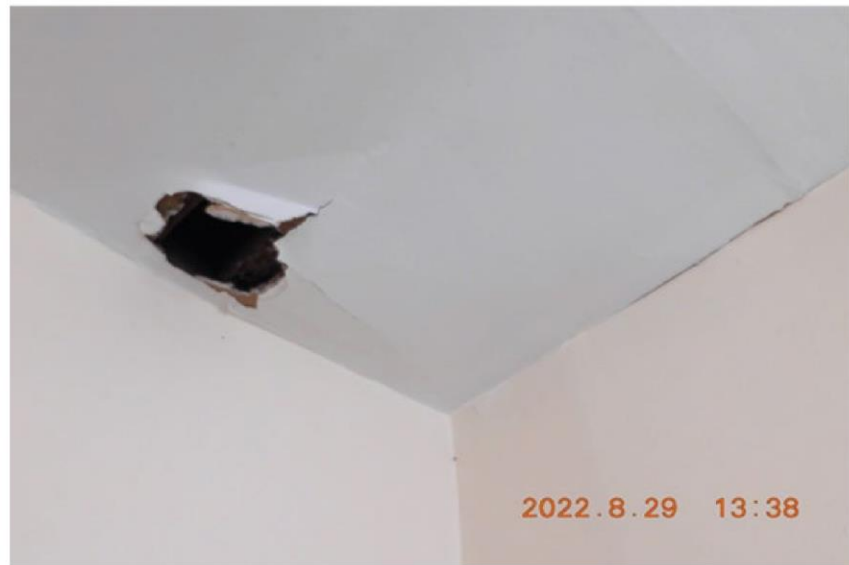
Puncture and Water damage at Second Floor Unit

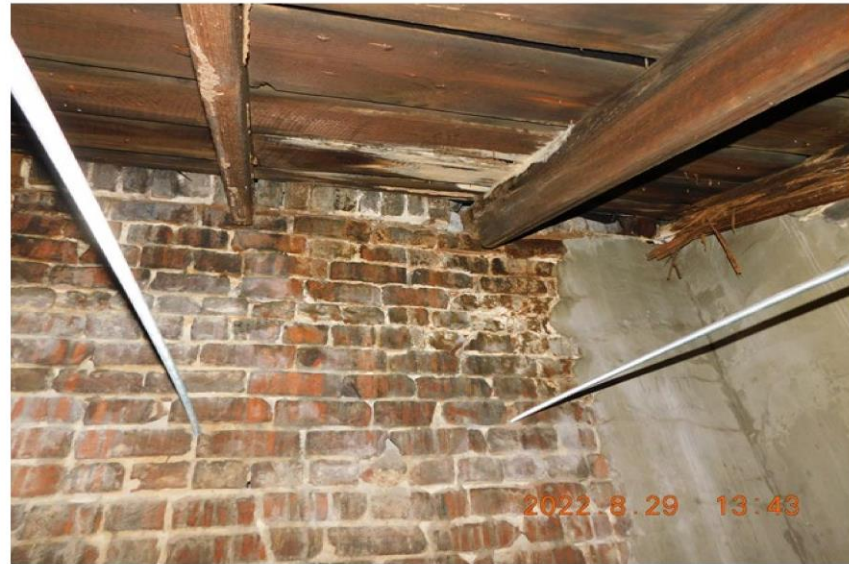
Missing Brick at Roof above Puncture

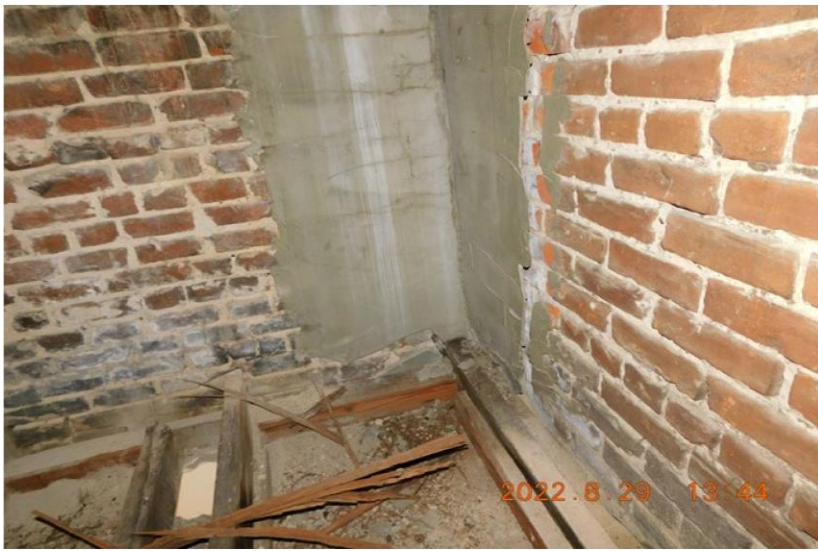
Cracks and Water Damage to Grout repair

We observed an obvious lean to the upper portion of this wall, as well as grout repairs that appeared to be made to the cracks and voids this displaced wall created between the neighboring masonry walls. We observed cracks in these repair locations that appear to have resurfaced from the original displacement described.

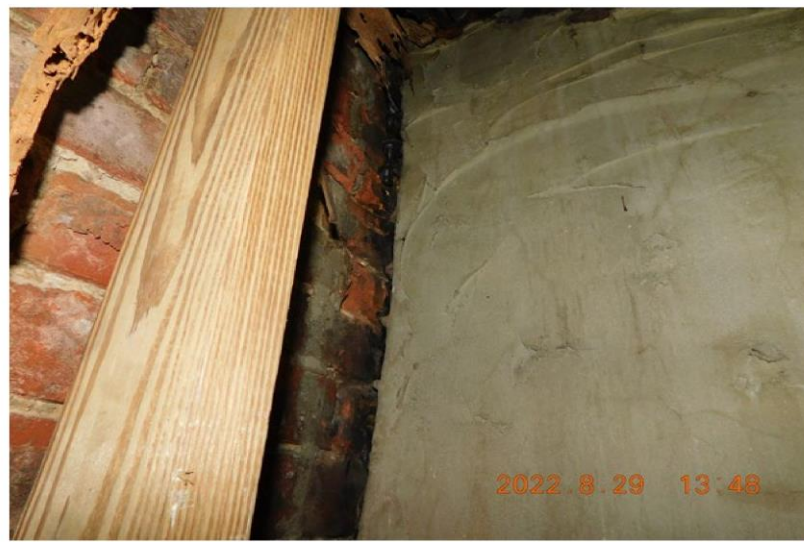
Signs of Movement at Grout Repair

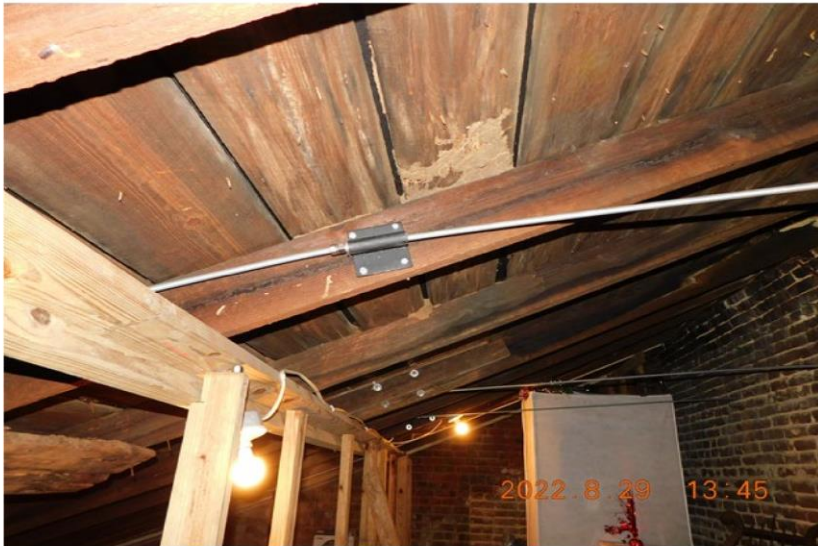
Typical Condition of Brick Tie Rods

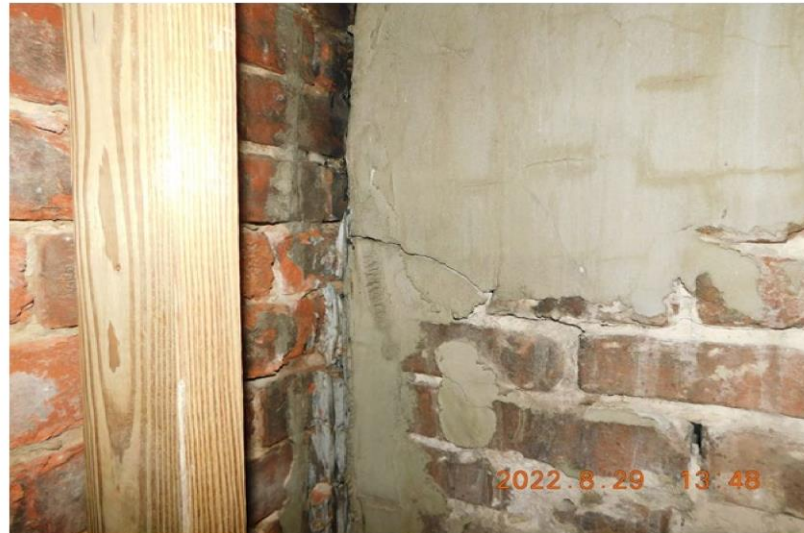
Cracks and Separation at Grout Repair

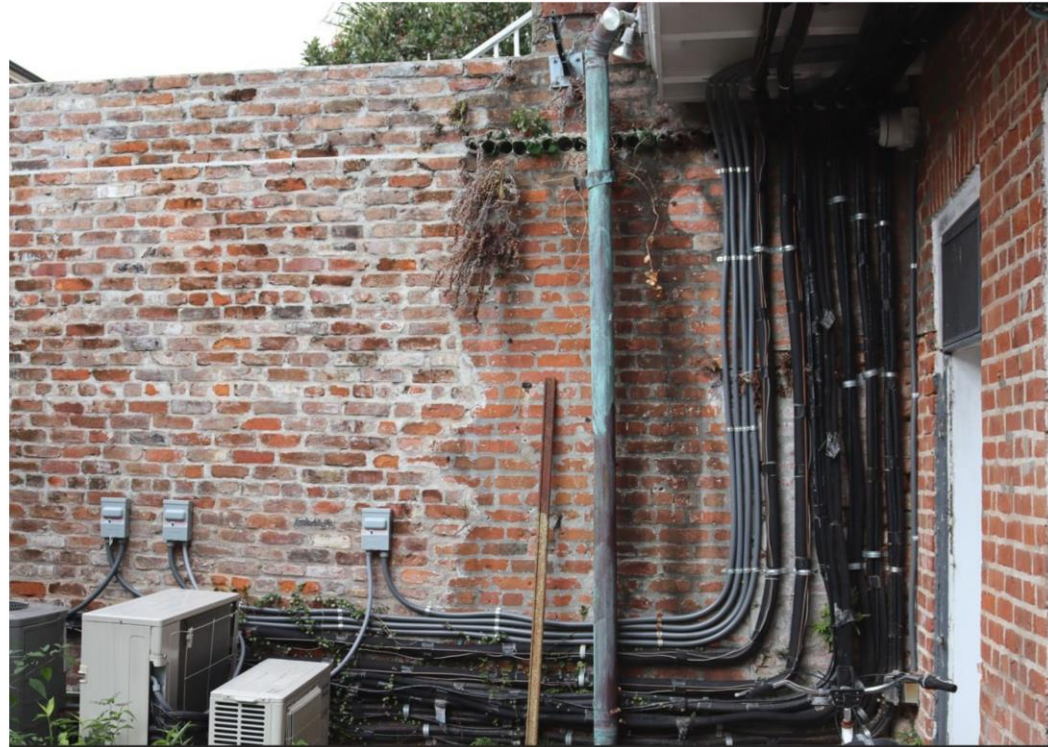
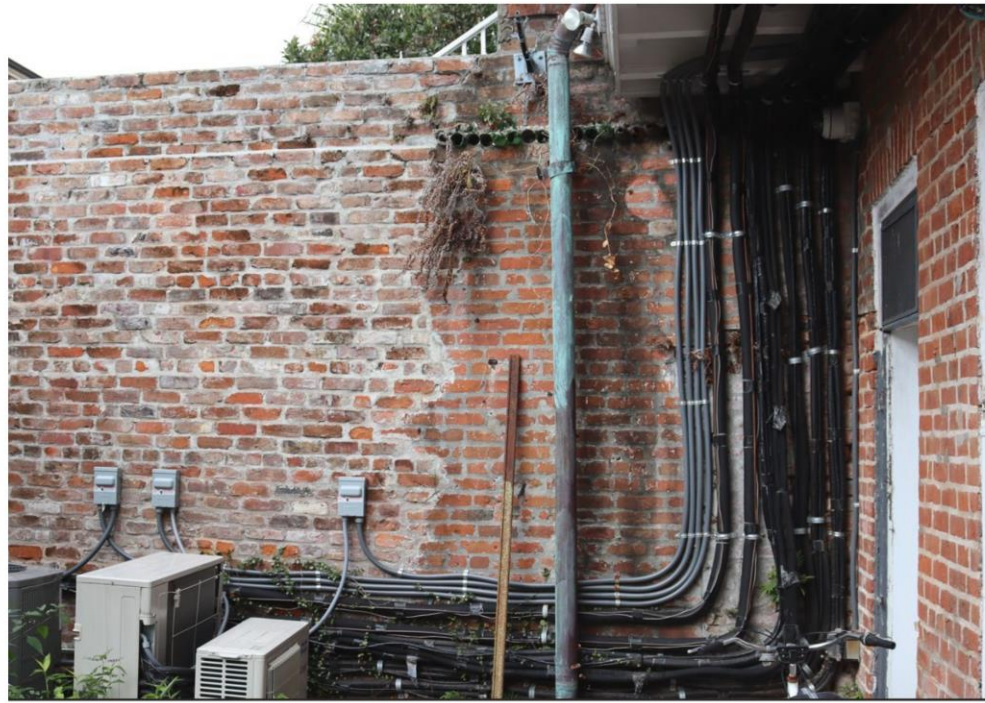
### Existing Condition

There are a total of six condenser lines and five electrical conduit lines running from the front (Bourbon Street) end of the dependency wing towards the rear masonry wall. These lines are currently attached to the underside of the balcony where the joists intersect with the masonry wall. There are also four condensers located along the rear masonry wall. The visual impact of this mechanical equipment is most noticeable at the back of the courtyard. Currently, the condenser lines run along the exterior façade of the dependency, and then there is one, small penetration through the masonry wall for each line. The major pros and cons of this arrangement are as follows:

1. Pro: Penetrations through the historic masonry wall are as small as possible (about 2" round), and they are spread out. There is no significant impact to the integrity of the masonry wall.
2. Pro: The lines are up high and serviceable, which follows VCC guidelines for mounting equipment.
3. Pro: The highest concentration of equipment is located at the back of the property.
4. Pro: The condenser lines are flexible and can easily trace the height changes of the courtyard stairs.
5. Con: The lines are visible from inside the courtyard.
6. Con: The condensers are visible at the back of the courtyard.
7. Biggest Con: The "L" shaped concentration of conduit and condenser lines at the back wall is highly visible and intrusive.

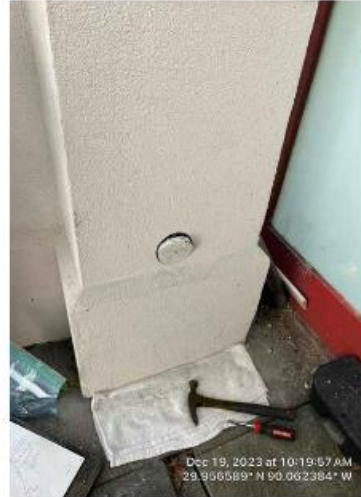
Sample #2 Overview

Sample #2 is installed over wood substrate covered with a felt paper water resistive barrier. The sample was taken at a finished part of the 2023 renovation. Sample #2 is comprised of a diamond metal lath that supports a brown coat, a scratch coat and a finish coat. This installation technique would be consistent with 20th-century stucco repairs and additions. We suspect that the column was constructed around 2010 and perhaps painted around 2013. It is possible that the columns were not painted as the stucco was newer in 2013. The most recent finish coat was added in 2023.

At coring, we bagged the Sample #2. At our office, we then drilled multiple holes in the Sample #2 to create small pieces weighing 77-grams for the deformation sample. The samples were in our possession from coring to Fed Ex. The sample was sent via Fed Ex to RQM+/Jordi Labs for a deformation sample.

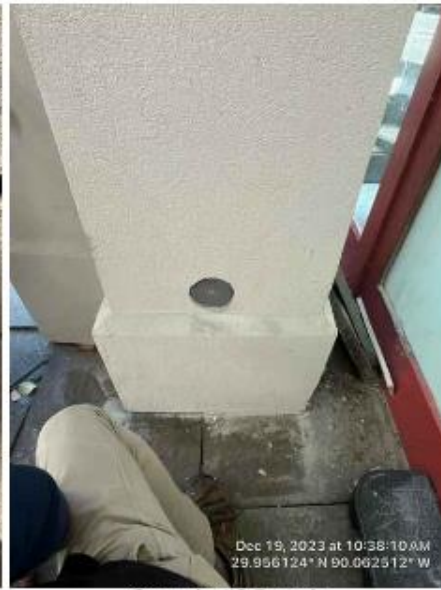
Showing Approximate Depth of Sample #2

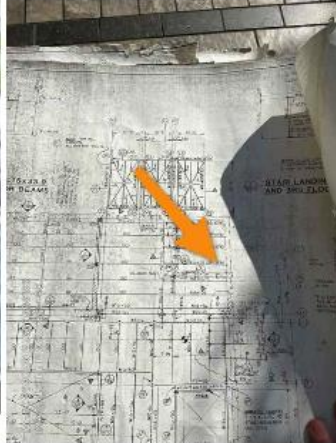
Sample #3 location on the 1999 building plans

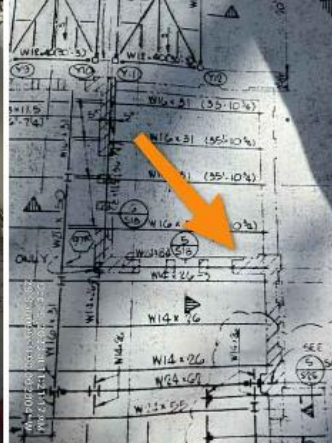
Sample #3 location as a close-up on the 1999 building plans

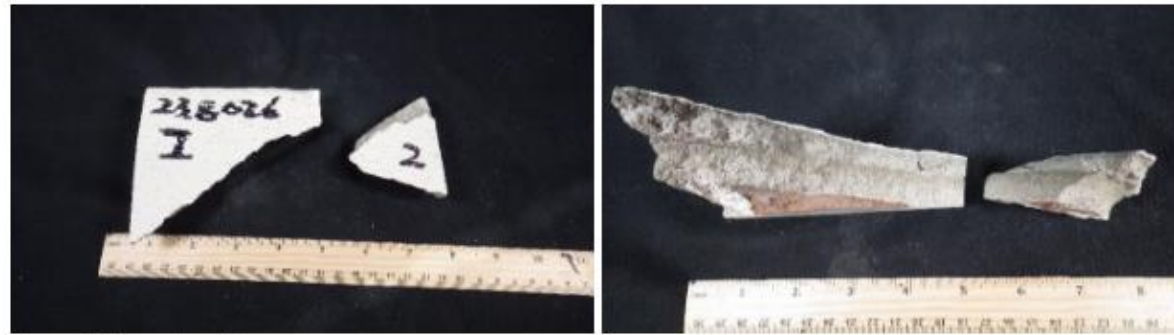
Figure 1. As-received stucco samples.

Received for the petrographic examination were two saw-cut stucco samples without identification (Figure 1). For convenience, WJE identify the samples as Sample 1 and Sample 2. Sample 1 measured approximately 4-1/4 inches x 3-1/2 inches x 7/8 inch. Sample 2 measured approximately 2-1/2 inches x 2 inches x 13/16 inch. Both samples appeared triangular in shape and appeared to contain two coats of stucco. The top surface of the stucco was painted, and the bottom surface contained an adhered brick piece. No metal lath was detected.

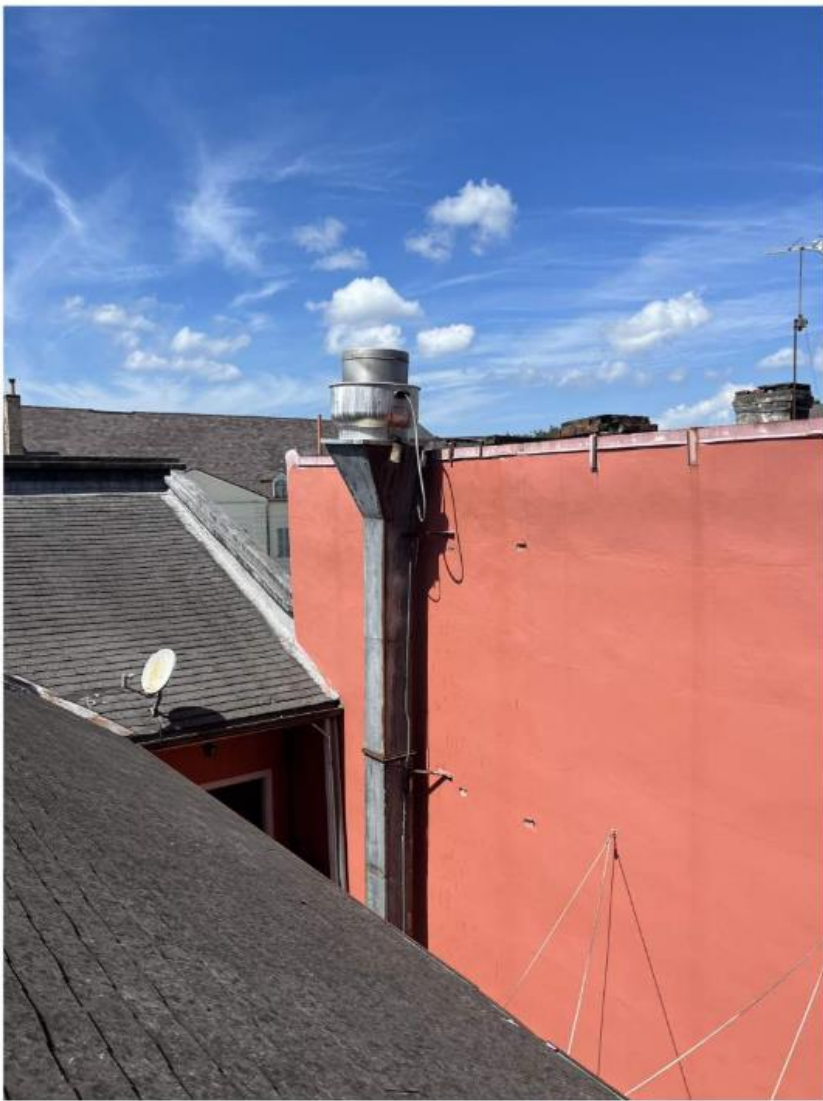
EXISTING HOOD TO BE REPLACED

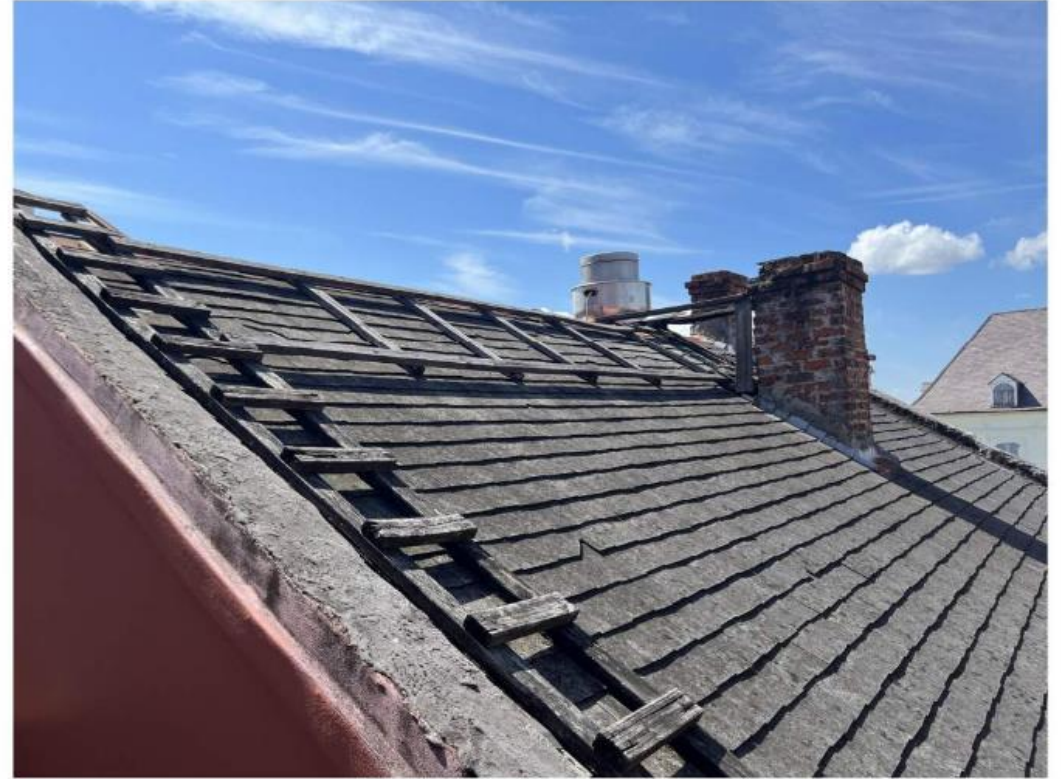
EXISTING ROOF

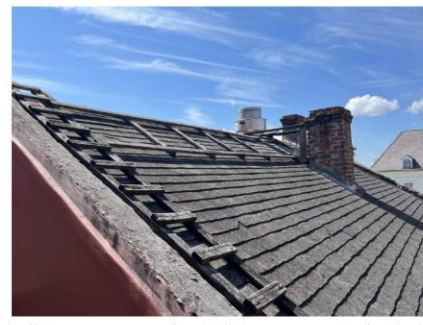
EXISTING ROOF

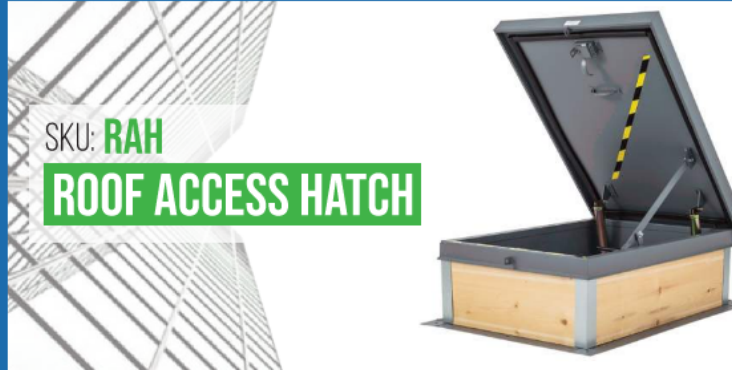
SKU: RAH  
**ROOF ACCESS HATCH**

## DIMENSIONS AND APPEARANCE

NOMINAL DOOR SIZE (W x H)	FRAME INNER DIMENSION (W x H)	FRAME OUTER DIMENSION (W x H)	ROOF OPENING DIMENSION (W x H)	WEIGHT
E-24" x 24" -RAH-W	24" x 24"	31" x 31"	24" x 24"	84 lbs.
E-24" x 30" -RAH-W	24" x 30"	31" x 37"	24" x 30"	103 lbs.
E-24" x 36" -RAH-W	24" x 36"	31" x 43"	24" x 36"	124 lbs.
E-30" x 30" -RAH-W	30" x 30"	37" x 37"	30" x 30"	129 lbs.
E-30" x 36" -RAH-W	30" x 36"	37" x 43"	30" x 36"	155 lbs.
* E-30" x 54" -RAH-W	30" x 54"	37" x 61"	30" x 54"	233 lbs.
* E-30" x 96" -RAH-W	30" x 96"	37" x 103"	30" x 96"	413 lbs.
E-36" x 36" -RAH-W	36" x 36"	43" x 43"	36" x 36"	185 lbs.
E-36" x 48" -RAH-W	36" x 48"	43" x 55"	36" x 48"	248 lbs.
E-48" x 48" -RAH-W	48" x 48"	55" x 55"	48" x 48"	330 lbs.

\* "W" or "H" greater than 48". The hinge will be positioned onto the larger side.
