# Vieux Carré Commission Architecture Committee Meeting

Tuesday, January 10, 2022

# FACADE REPAIRS

**FACADE REPAIRS**  
815 SAINT ANN ST.  
NEW ORLEANS, LA 70116

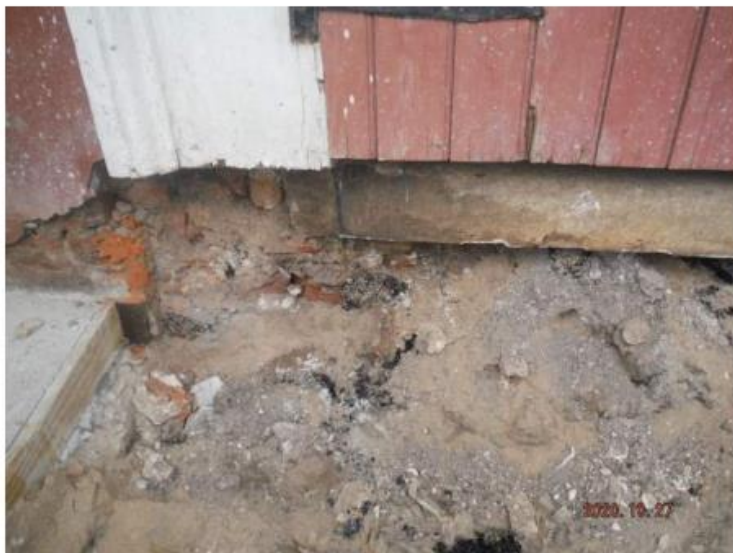
Photo 1: DAMAGED FOOTING

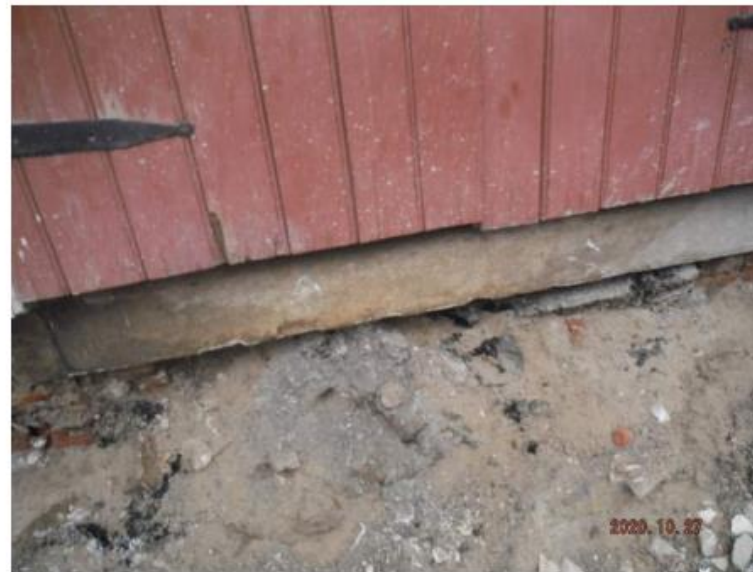
Photo 3: DAMAGED/MISSING FOOTING

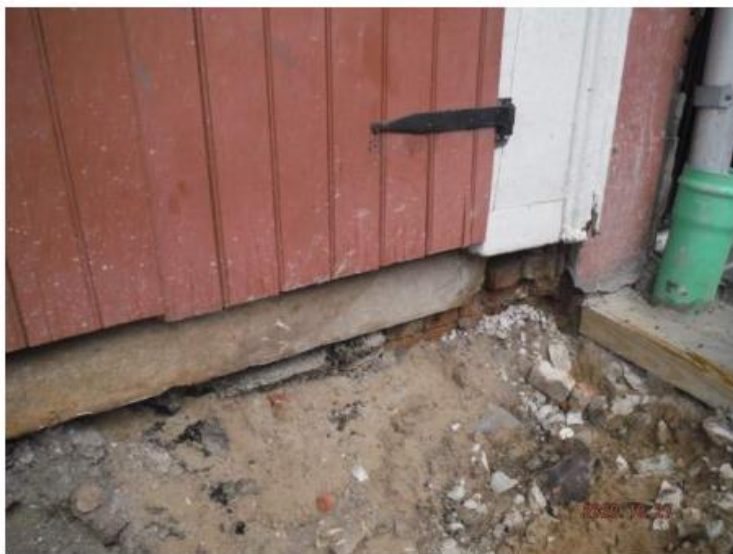
Photo 2: DAMAGED/MISSING FOOTING.

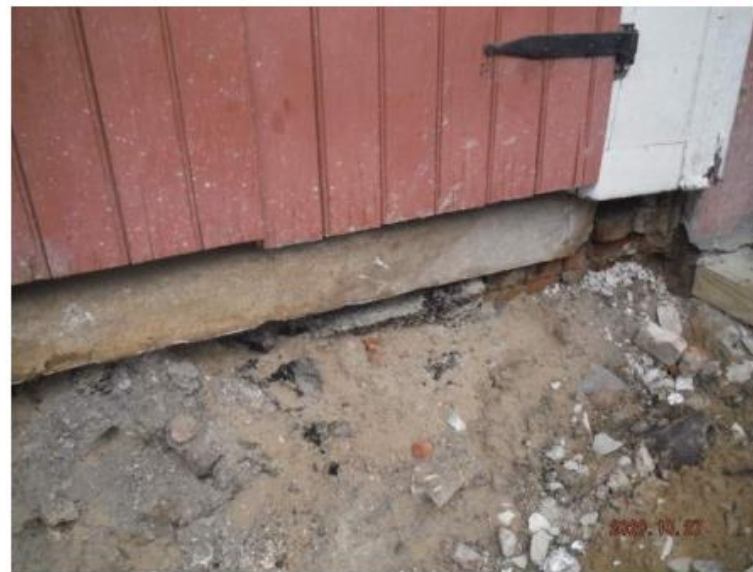
Photo 4: DAMAGED FOOTING.

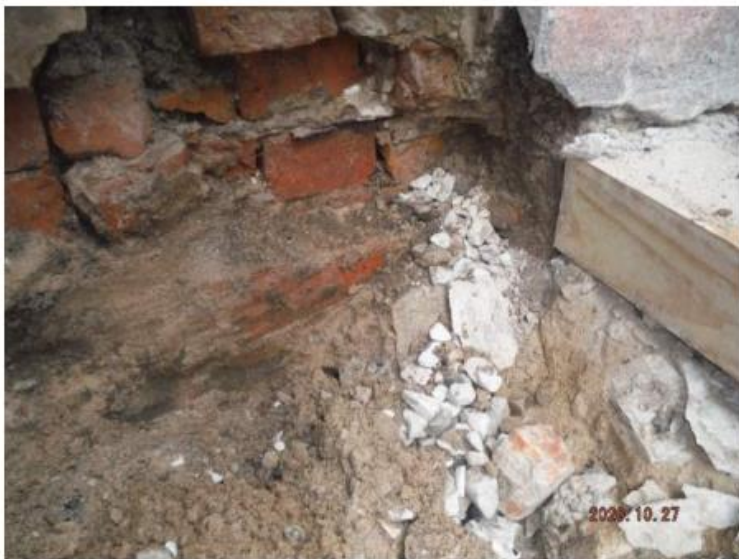
Photo 5: CLOSE UP OF DAMAGED BRICK OF FORMER FOOTING.

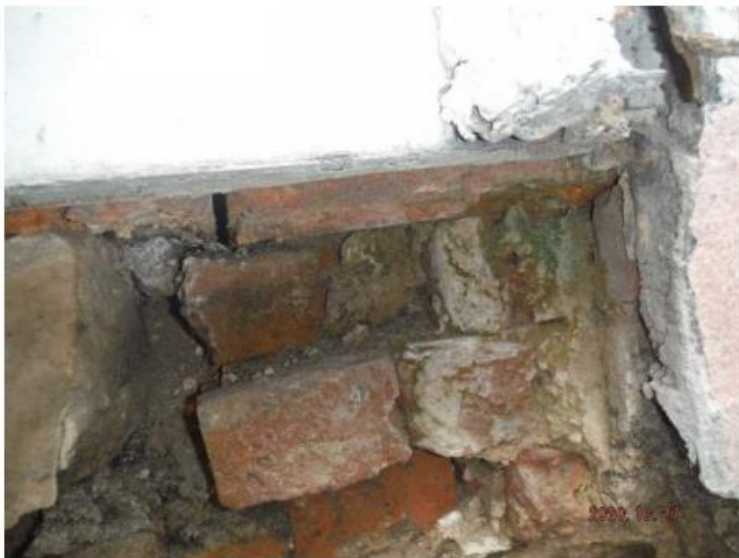
Photo 6: CLOSE UP OF DMAGED BRICK IN FORMER FOOTING.

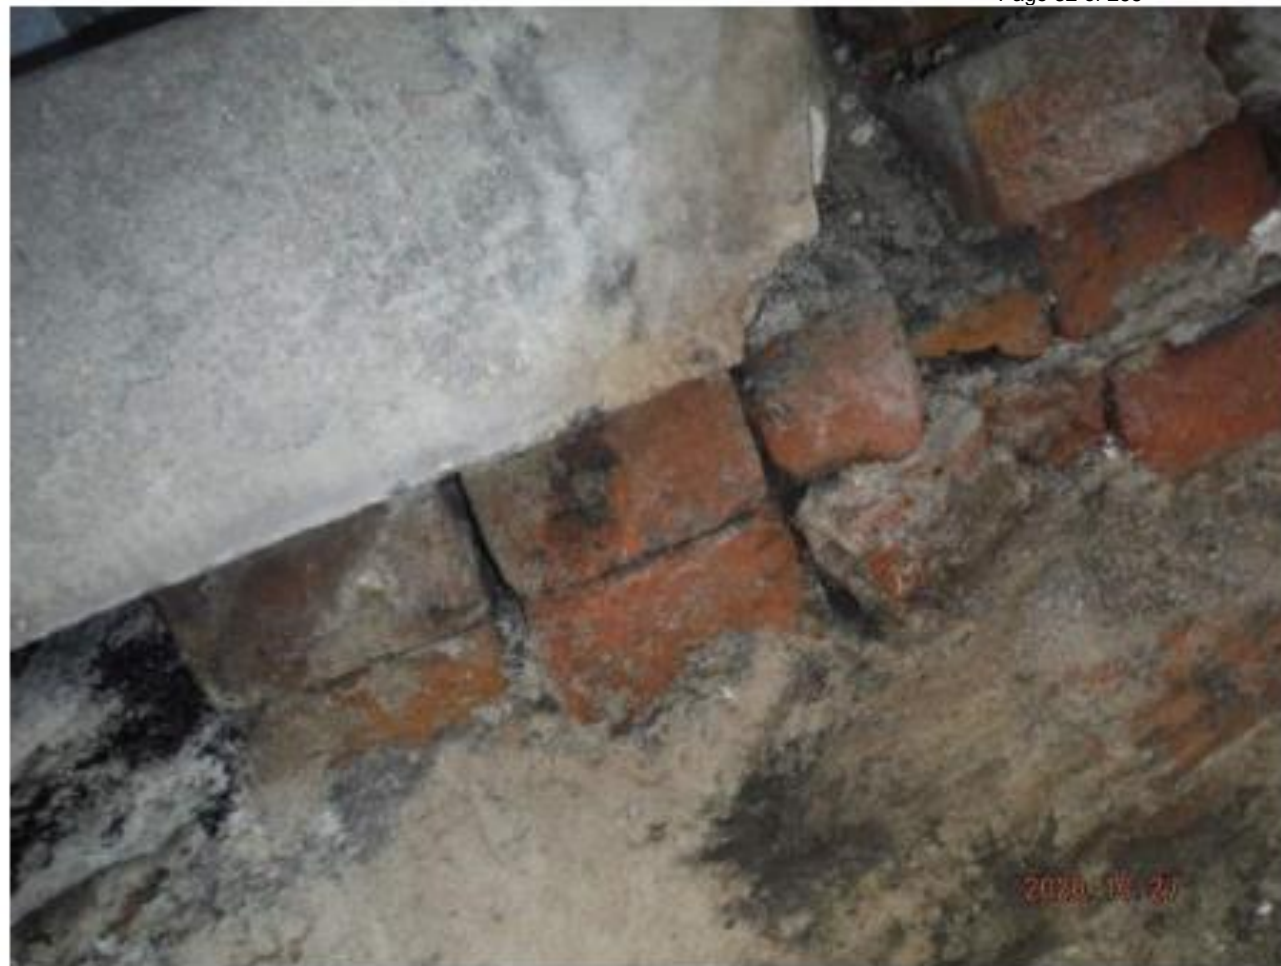
Photo 7: CLOSE UP OF DAMAGED AND DISPLACED BRICK IN FOOTING.

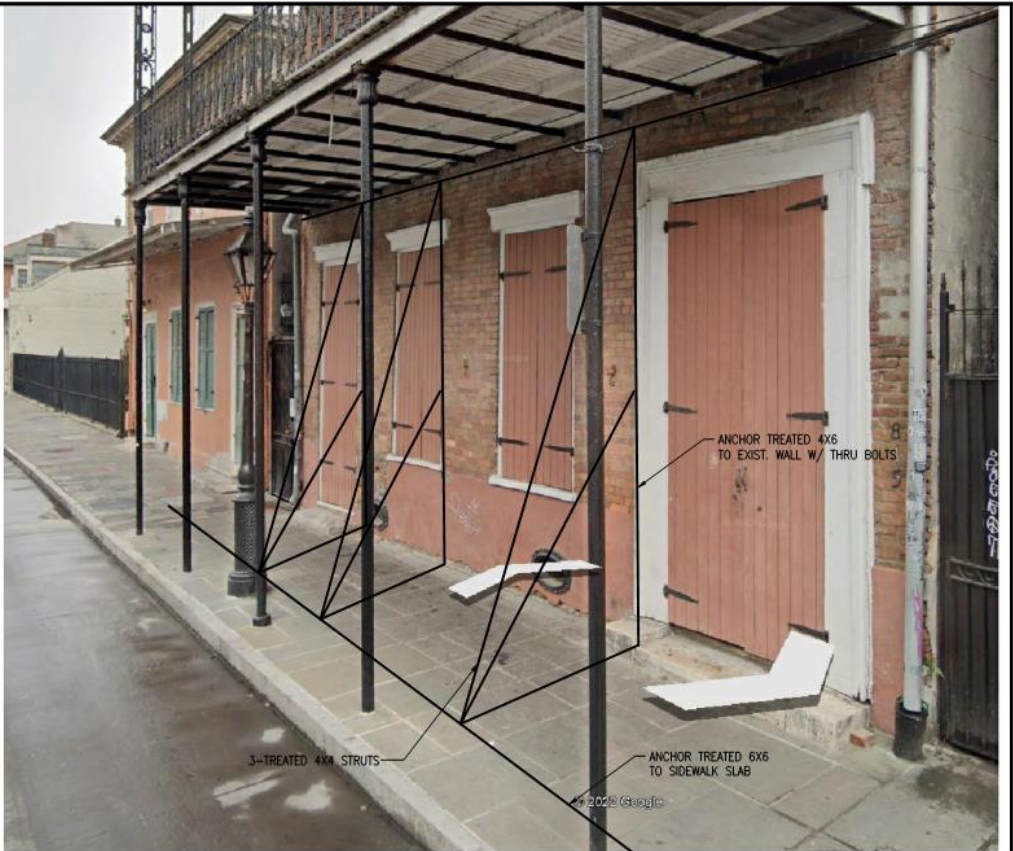
1 FRONT ELEVATION  
SKS1 NTS

Temporary shoring approved by VCC for a time frame of 60 days. Additional approvals needed from Safety & Permits and Department of Public Works.

NOTE:  
PROVIDE ABOVE WALL SHORING EACH  
SIDE OF EACH WINDOW AND DOOR.  
SHOWN ONE SIDE FOR CLARITY ONLY.

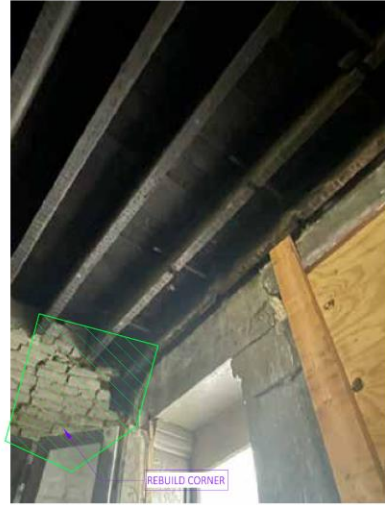
PHOTO 7

PHOTO NOTES:  
1. PHOTOS PROVIDED FOR CONTEXT ONLY. REFER TO DRAWINGS AND GENERAL NOTES FOR SPECIFIC REPAIR INSTRUCTIONS.  
2. NOT ALL AREAS OF REPAIR MAY BE SHOWN.  
3. ALL REPAIRS TO BE REMOVED BY MASCONRY WALLS AND CLEANED PER ARCHITECT.  
4. IF DAMAGED, COST LOCATION IS UNCLEAR, NOTIFY ENGINEER.

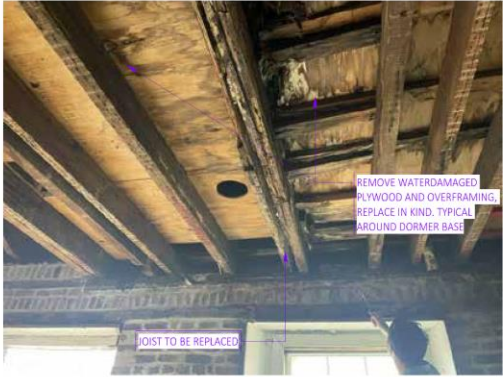
PHOTO 10

PHOTO NOTES:  
1. PHOTOS PROVIDED FOR CONTEXT ONLY. REFER TO DRAWINGS AND GENERAL NOTES FOR SPECIFIC REPAIR INSTRUCTIONS.  
2. NOT ALL PHOTOS OR REPAIRS MAY BE SPECIFIC.  
3. ALL ROOFING TO BE REMOVED BY MASONRY WALLS AND CLEANED PER ARCHITECT.  
4. IF DAMAGED JOIST LOCATION IS UNCLEAR, NOTIFY ENGINEER.

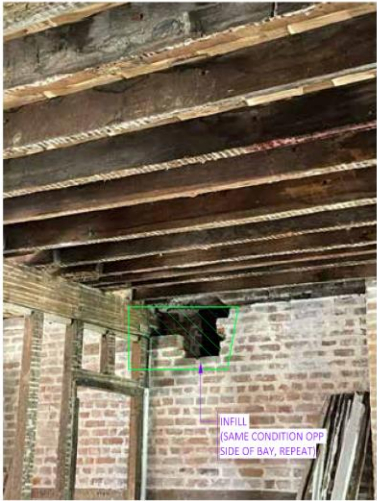
PHOTO 13

PHOTO NOTES:  
1. PHOTOS PROVIDED FOR CONTEXT ONLY. REFER TO DRAWINGS AND GENERAL NOTES FOR SPECIFIC REPAIR INSTRUCTIONS.  
2. NOT ALL AREAS OF REPAIR MAY BE SHOWN.  
3. ALL VESTIBULATION TO BE REMOVED BY MAINTENANCE WALLS AND CLEANED FOR ARCHITECT.  
4. IF DAMAGED JOIST LOCATION IS UNCLEAR, NOTIFY ENGINEER.

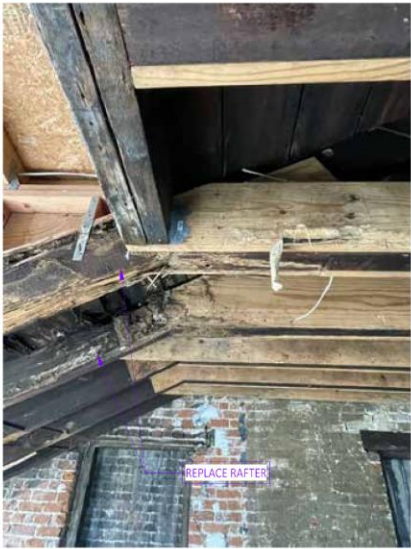
PHOTO 16

PHOTO NOTES:  
1. PHOTOS PROVIDED FOR CONTEXT ONLY. REFER TO DRAWINGS AND GENERAL NOTES FOR SPECIFIC REPAIR INSTRUCTIONS.  
2. NOT ALL AREAS OF NOLA-X MAY BE SHOWN.  
3. ALL VENTILATION TO BE REMOVED FROM MAISONRY WALLS AND CLIMATO PER ARCHITECT.  
4. IF DAMAGED JOIST LOCATION IS UNCLEAR, NOTIFY ENGINEER.  
5. AREAS OF DAMAGED JOISTING AT ROOF AND FLOORS SHALL BE REPLACED WITH RATED SHEATHING PER GENERAL NOTES.

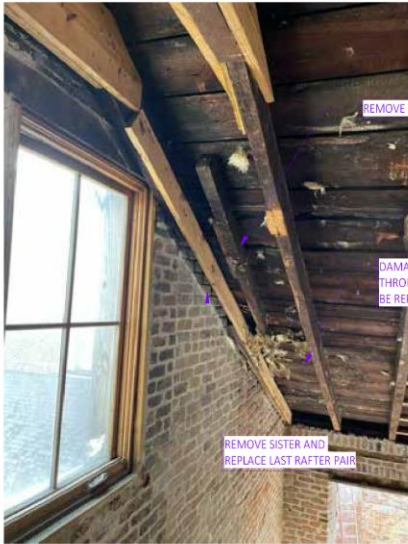
PHOTO 19

PHOTO NOTES:  
1. PHOTOS PROVIDED FOR CONTEXT ONLY. REFER TO DRAWINGS AND GENERAL NOTES FOR SPECIFIC REPAIR INSTRUCTIONS.  
2. NOT ALL AREAS OF REPAIR MUST BE SHOWN.  
3. ALL VEGETATION TO BE REMOVED FROM MASONRY WALLS AND CLEANED PER ARCHITECT.  
4. IF DAMAGED JOIST LOCATION IS UNCLEAR, NOTIFY ENGINEER.  
5. AREAS OF DAMAGED/DECKING AT ROOF LINE IN THIS SHALL BE REPLACED WITH KATIE SHEA WINGS PER GENERAL NOTES.

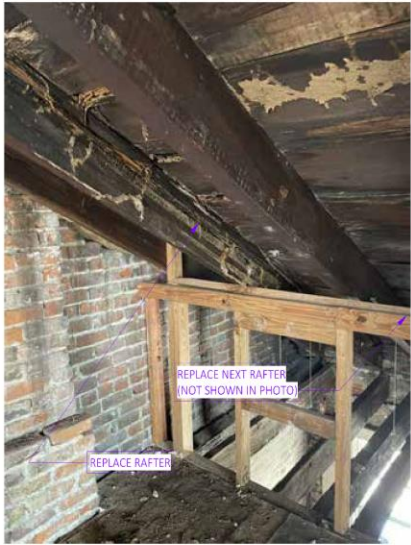
PHOTO 22

PHOTO NOTES:  
1. PHOTOS PROVIDED FOR CONTEXT ONLY. REFER TO DRAWINGS AND GENERAL NOTES FOR SPECIFIC REPAIR INSTRUCTIONS.  
2. NOT ALL AREAS OF REPAIR MAY BE SHOWN.  
3. ALL REPAIRS ARE TO BE FINISHED FROM MASONRY WALLS AND CLEANED PER ARCHITECT.  
4. IF DAMAGED JOIST LOCATION IS UNCLEAR, NOTIFY ENGINEER.  
5. PAIRS OF DAMAGED COLLAR TIES (POC) AND J/TCS SHALL BE REPLACED WITH RAISED SHEATHING PER GENERAL NOTES.

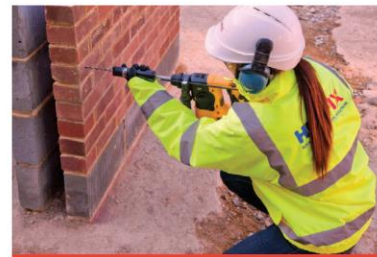
DryFix tie being power-driven into pilot hole

1. Mark the position for the DryFix tie on the facade.
2. Drill an appropriate diameter pilot hole (depending on density of backup material) through the facade and into the backup substrate, to predetermined depth, using a rotary percussion drill (3-jaw-chuck-type).
3. Fit the special DryFix PDA insertion tool to an electric hammer drill (SDS type).
4. Load the DryFix tie into the insertion tool.
5. Power-drive the tie into position until its outer end is recessed below the face of the mortar joint by the insertion tool.
6. Repair the entry hole with matching materials.

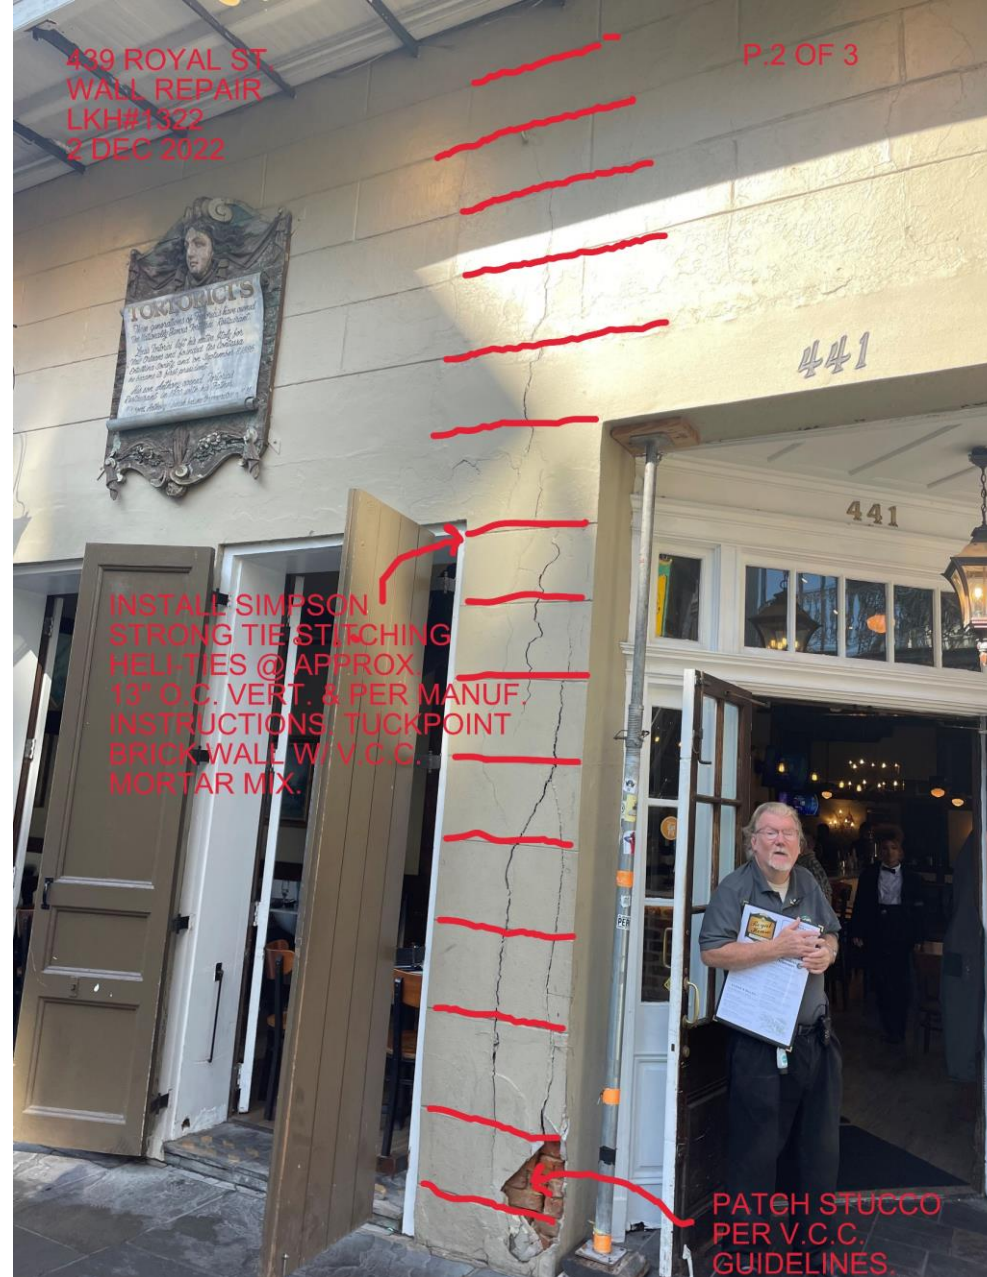
INSTALL SIMPSON  
STRONG TIE STITCHING  
HELL-TIES @ APPROX  
13" O.C. VERT. & PER MANUF  
INSTRUCTIONS. TUCKPOINT  
BRICK WALL W/ V.C.C.  
MORTAR MIX.

PATCH STUCCO  
PER V.C.C.  
GUIDELINES.

- NOTES:
1. REFER TO DETAIL 3/HT-1 FOR ADDITIONAL INSTALLATION INFORMATION.
  2. TO ACCOMMODATE WALL CORNER CONDITIONS, HELI-TIE STITCHING TIE MAY BE BENT 90 DEGREES WITH A MIN. BEND RADIUS OF  $\frac{1}{4}$ "

The Simpson Strong-Tie® Heli-Tie helical stitching tie provides a unique solution to the preservation and repair of damaged brick and masonry structures. Ties are grouted into existing masonry joints to repair cracks and increase strength with minimum disturbance. Made of Type 304 stainless steel, the Heli-Tie stitching tie features radial fins formed on the steel wire via cold rolling process, increasing the tensile strength of the tie.

- Chase bed joint 20" on either side of the affected area to a depth of approximately 1 1/4" with a rotary grinding wheel. Vertical spacing of installation sites should be 12" for red brick or "every other course" for concrete masonry units.
- Clear bed joint of all loose debris.
- Mix non-shrink repair grout or mortar per product instructions and place into the prepared bed joint, filling the void to approximately two-thirds of its depth.
- Embed the tie at one-half the depth of the void. Trowel displaced grout to fully encapsulate the tie.
- Fill any remaining voids and vertical cracks with non-shrink repair grout or other repair mortar to conceal repair site.

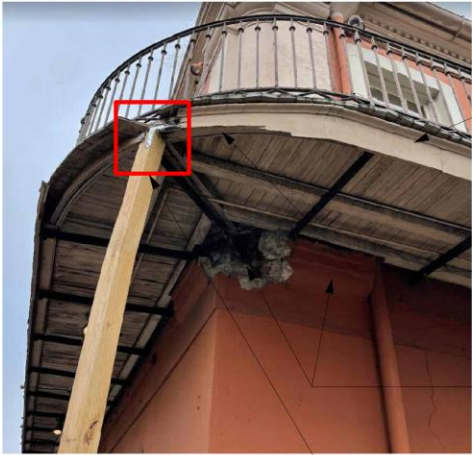
NEW WOOD FASCIA AND UPPER TRIM PEICE AT UNDERSIDE OF DECKING TO BE REPLACED WHERE DAMAGED. MATCH EXISTING PROFILES IN LIKE AN KIND.

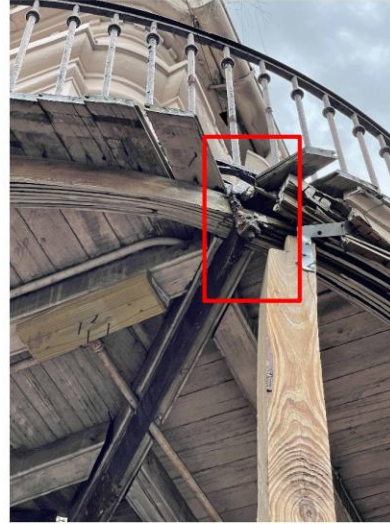
STEEL OUTRIGGER END  
CONDITION

CONNECTION POINT TO RAILING

EXISTING GUARDRAIL

SQUARE VERTICAL STUB UP  
WELDED TO EXISTING GALLERY  
GUARDRAIL BOTTOM

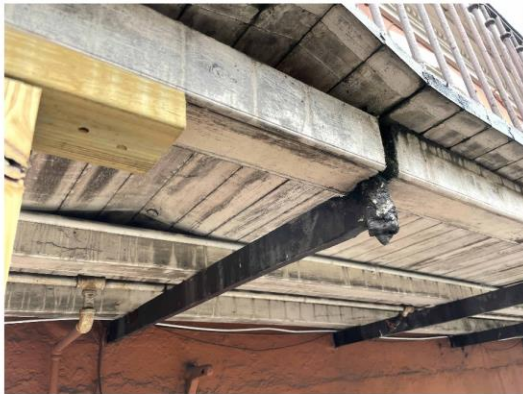
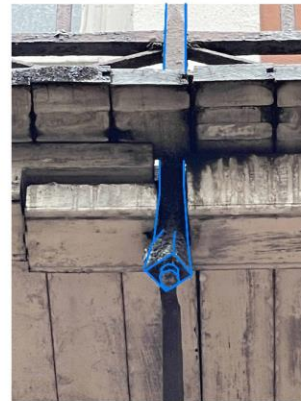
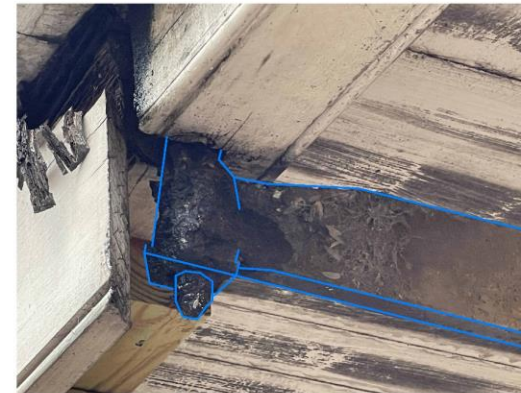
CORNER REPAIR - DAMAGED CORNER OUTRIGGER

ADJACENT OUTRIGGER

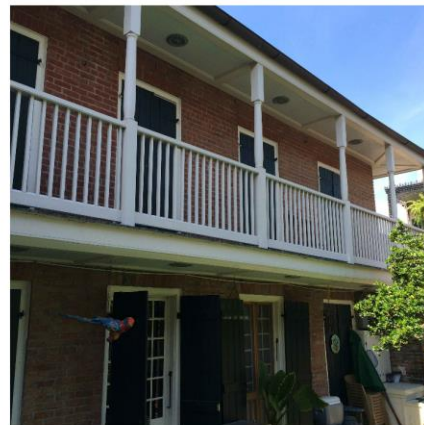
1 Inappropriate Balcony Columns

ACTION: REMOVE ALL (8) EXISTING COLUMNS AND REPLACE WITH NEW PER DETAIL 1A.

- The columns of the rear dependency have been inappropriately replaced.
- The masonry wall has been altered and an iron hedgehog has been installed, without VCC permit.

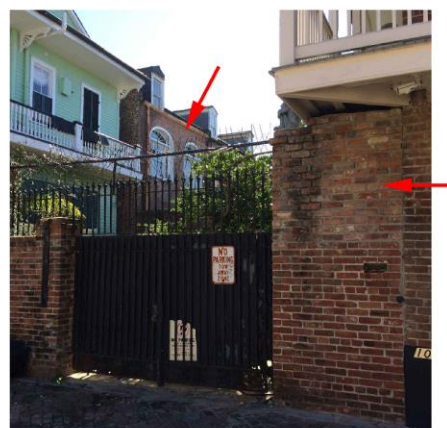
2 Altered Masonry Wall without Benefit of Permit  
Hedgehog Installation without Benefit of Permit

ACTION: REQUEST RETENTION OF ALTERED MASONRY WALL AND HEDGEHOG FOR SECURITY REASONS.

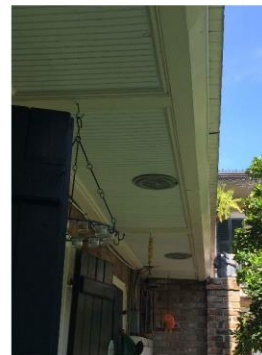
3 Inappropriate Balcony Underside Enclosure  
Recessed Lighting Installed without Benefit of Permit

ACTION: REQUEST RETENTION OF ENCLOSURE AND RECESSED CAN LIGHTS.  
NOTE: UNDERSIDE OF BALCONY ALONG ST. PHILIP STREET IS UNENCLOSED.

- The soffit has been inappropriately replaced and the balcony underside has been improperly enclosed without VCC permits. The second floor soffit should be enclosed using beaded board, contrary to the coffered ceiling in place. Historically, the balcony underside was not enclosed.

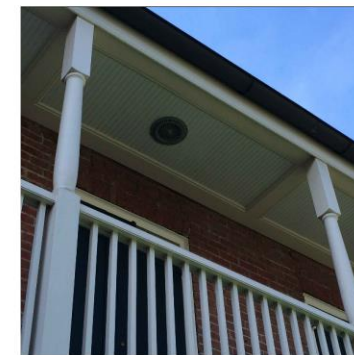
4 Inappropriate Coffered Balcony Ceiling  
Recessed Lighting Installed without Benefit of Permit

ACTION: REQUEST RETENTION OF COFFERED CEILING AND RECESSED CAN LIGHTS.

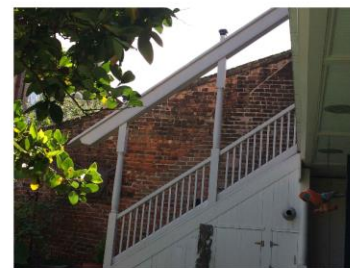
5 Inappropriate Handrail with Lights Installed

ACTION: DEMOLISH AND REMOVE EXISTING LIGHTING, BEAMS AND COLUMNS DOWN TO THE HANDRAIL.

- Existing columns to be removed and replaced with columns to match previously existing
- Demolish existing lighting, beams, and columns above the balcony stairs down to the handrail
- Relocate exhaust from gas water heater to N Rampart side of enclosure
- Demolish existing column and board installed below balcony
- Repoint as necessary throughout property using VCC approved mortar recipe below
- Modify underside of balcony as per detail submitted 03/23/15

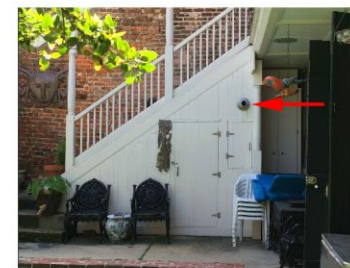
6 Underside of Stair Enclosed without Benefit of Permit  
Installation of Exhaust Vent without Benefit of Permit

ACTION: REQUEST RETENTION OF ENCLOSURE. RELOCATE EXHAUST FROM GAS WATER HEATER TO BACK SIDE OF ENCLOSURE.

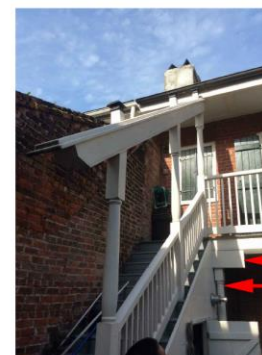
7 Inappropriate Column and Board beneath Balcony

ACTION: DEMOLISH AND REMOVE EXISTING COLUMN AND BOARD.

***Rear dependency colonettes and railing improperly replaced without benefit of application or permit; white painted wooden member attached to 2<sup>nd</sup> floor rear dependency colonette and located above stair rail, with attached metal projections, installed without benefit of application or permit.***

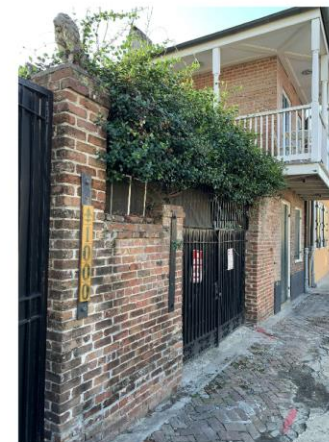
**Vegetation on Ironwork --  
Request To Retain**

Scale: NTS  
Potted vegetation secured to iron trellis & fence ironwork

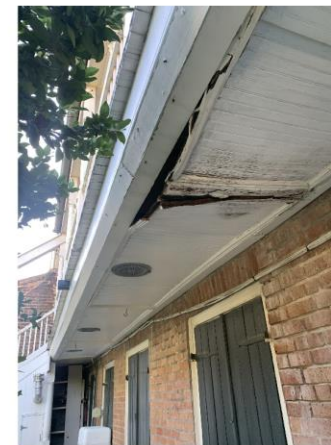
**Inappropriate Ceiling & Trim--  
To Be Removed**

Removal of existing finished ceiling and trim; repair any moisture damage to balcony structure and paint.

New can light flush mount fixtures per VCC requirements installed at underside of balcony structure and centered over each door.

Loose wiring to be removed and/or secured in new conduit
