Vieux Carré Commission Meeting

Wednesday, May 27, 2020

Conti Street Reconstruction (Bo St. to Chartres St.)

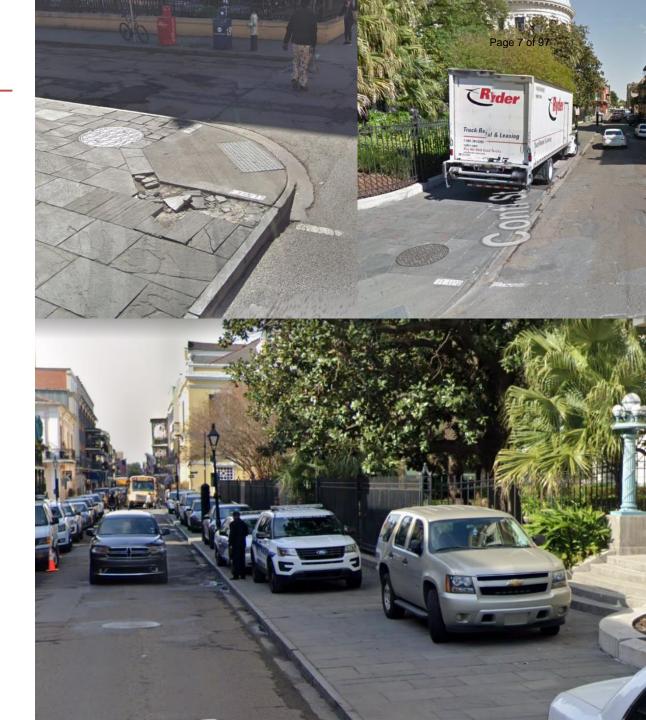
Conti Street (Royal St. to Chartres St.):

Mott MacDonald is recommending the use of the R-7530 Decorative Bollard or an approved equal to prevent vehicles from parking on the northern sidewalk in the 600 block of Conti Street.

Overview

- R-7530 bollards include a unique design featuring a narrow body made from versatile ductile iron with decorative fluting and spherical top castings that blends into the historical New Orleans French Quarter.
- Mott MacDonald recommends designing the bollard spacings to be approximately 55 inches apart and 18 inches from the back of curb to ensure accessibility for all pedestrians, motorized chairs and wheelchairs while also not compromising the bollard's ability to protect against smart cars or other vehicles from fitting in between each post.
- Street scaping is also an option that can be incorporated into the bollard layout throughout the block to provide additional green space. Mott MacDonald will be coordinating with DPW as it relates to specific plants desired in planters spaced throughout the block.

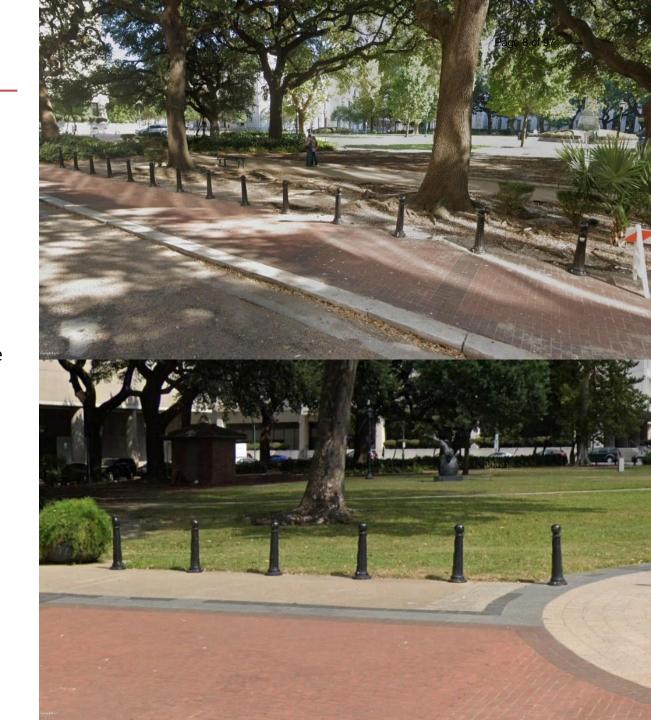
Conti Street (Royal St. to Chartres St.):

R-7530 Decorative Bollards may also be installed as a fixed or removable system through different mounting options. These options will be coordinated with both DPW and Entergy Electric for the area's bollards need to be placed atop electrical vaults.

Mounting Options

Fixed

The R-7530 Decorative Bollard may be anchored permanently by imbedding the internal steel rod into a 1' x 1' concrete foundation. The bollard decorative casting may still be removed/replaced if damaged or vandalized without having to replace the concrete foundation and internal steel rod. This option may be used for the majority of the 600 block except for areas effected by Entergy Electric's vault tops.

- Removable

By using anchor castings for removal mounts, a bollard can be detached by unlocking a padlock and removing a pin that runs through the center of the bollard's base. Mott MacDonald proposes installing removable bollards or an approved equal when placed atop Entergy's electrical vault and any other areas desired by DPW.

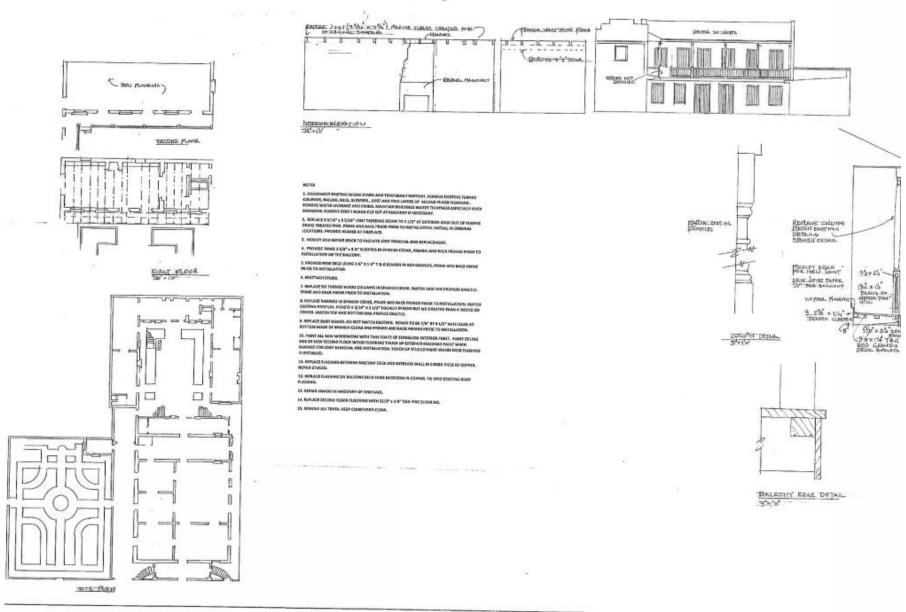
NOTES

- 1. DISCONNECT EXISTING WOOD STAIRS AND TEMPORALLY SUPPORT, REMOVE EXISTING TURNED COLUMNS, RAILING, DECK, SLEEPERS, JOIST AND TWO LAYERS OF SECOND FLOOR FLOORING. REMOVE WATER HYDRANT AND PIPING. MAINTAIN BUILDINGS WATER TIGHTNESS ESPECIALLY OVER BEDROOM, REMOVE EXIST I BEAMS CUT OFF AT MASONRY IF NECESSARY.

- 2. REPLACE 9 3/16" x 3 5/16" I DIST TAPERING DOWN TO 7 1/2" AT EXTERIOR EDGE OUT OF MARINE GRADE TREATED PINE, PRIME AND BACK PRIME PRIOR TO INSTALLATION, INSTALL IN ORIGINAL LOCATIONS, PROVIDE HEADER AT FIREPLACE.

- 3. MODIFY AND REPAIR BRICK TO FACILATE JOIST REMOVAL AND REPLACEMENT.
- 4. PROVIDE THREE 2 5/8" x 3 X" SLEEPERS IN SPANISH CEDAR, PRIMED AND BACK PRIMED PRIOR TO INSTALLATION ON THE BALCONY.

- S. PROVIDE NEW DECK USING 3 X* X 1 X* T & G BOARDS IN RED GRANDIS. PRIME AND BACK PRIME PRIOR TO INSTALLATION.
- 6. REATTACH STAIRS.
- 7. REPLACE SIX TURNED WOOD COLUMNS IN SPANISH CEDAR, MATCH EXISTING PROFILES EXACTLY. PRIME AND BACK PRIME PRIOR TO INSTALLATION.

- 8. REPLACE RAILINGS IN SPANISH CEDAR, PRIME AND BACK PRIMED PRIOR TO INSTALLATION. MATCH EXISTING PROFILES. PICKETS 1 3/16" X 1 1/2" EQUALLY SPACED BUT NO GREATER THAN 4 INCHES ON CENTER. MATCH TOP AND BOTTOM RAIL PRIFILES EXACTLY.

- 9. REPLACE SKIRT BOARD, DO NOT MATCH EXISTING. BOARD TO BE 7/8" BY 8 1/5" WITH BEAD AT BOTTOM MADE OF SPANISH CEDAR AND PRIMED AND BACK PRIMED PRIOR TO INSTALLATION.

- 10. PAINT ALL NEW WOODWORK WITH TWO COATS OF SEMIGLOSS EXTERIOR PAINT. PAINT CEILING SIDE OF NEW SECOND FLOOR WOOD FLOORING TOUCH UP EXTERIOR MASONRY PAINT WHEN DAMAGE FOR JOIST REMOVAL AND INSTALLATION, YOUCH UP STUCCO PAINT WHERE DECK FLASHING IS INSTALLED.

- 11. REPLACE FLASHING BETWEEN BALCONY DECK AND EXTERIOR WALL IN SINGLE PIECE OF COPPER. REPAIR STUCCO.
- 12. REPLACE FLASHING ON BALCONY DECK OVER BEDROOM IN COPPER. TIE INTO EXISTING ROOF FLASHING.

- 13. REPAIR CRACKS IN MASONRY OF FIREPLACE.
- 14. REPLACE SECOND FLOOR FLOORING WITH 51/2" x 1 X" T&G PINE FLOORING.
- 15. REMOVE ALL TRASH, KEEP COURTYARD CLEAN.

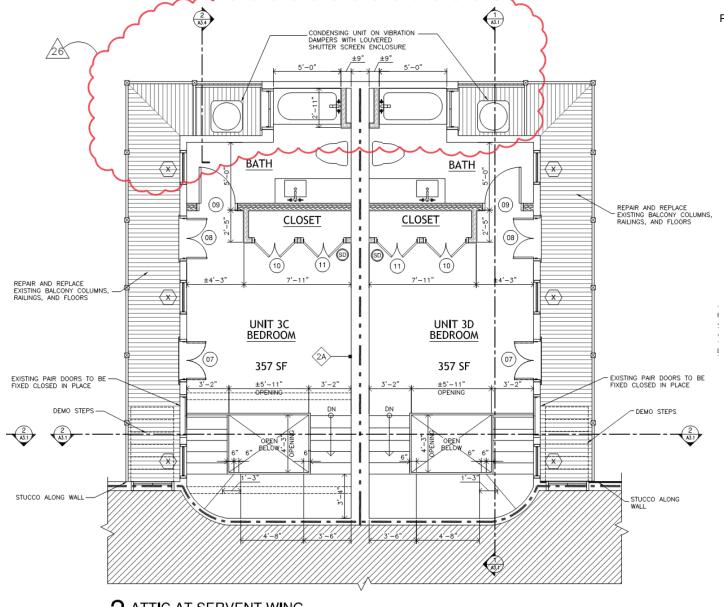
538 N. Rampart – Proposed Plans

$2_{\frac{\text{ATTIC AT SERVENT WING}}{\text{SCALE: } 1/4 \ = \ 1'-0"}}$

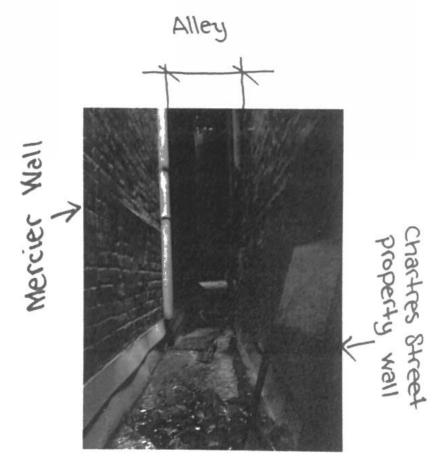
Alleyway between Mercier's free standing wall and rear wall of buildings facing Chartres St.

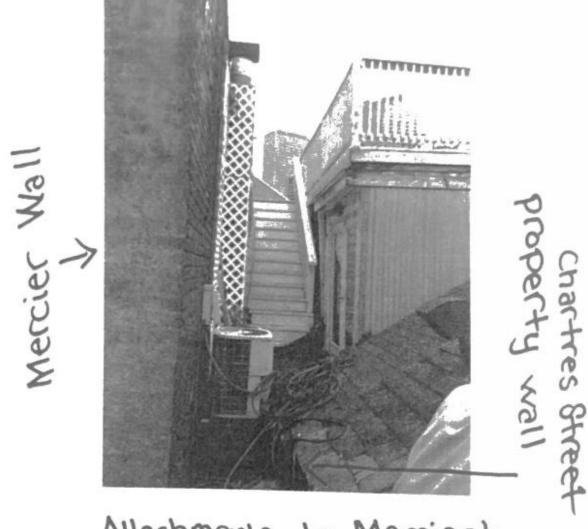
Attachments to Mercier's free standing wall

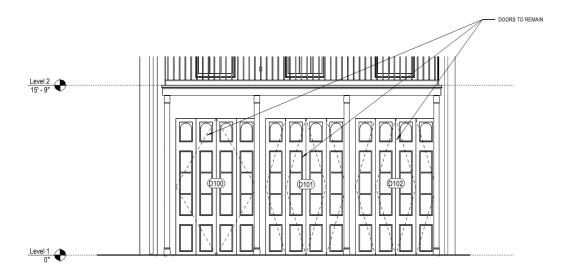
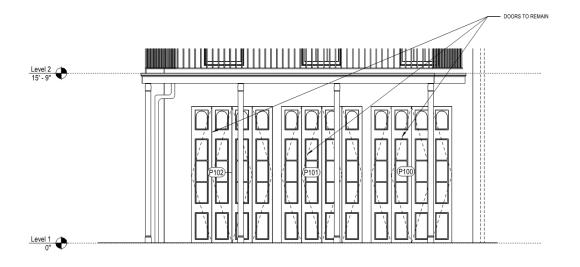
Proposed N. Peters St. Elevation

1/4" = 1'-0"
