CITY OF NEW ORLEANS Historic District Landmarks Commission

Guidelines for Roofing

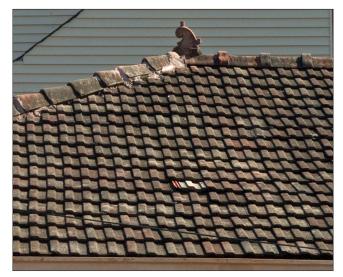
This concrete tile roof includes a finial and terra cotta ridge caps at the top of the main roof and along the roof hip.

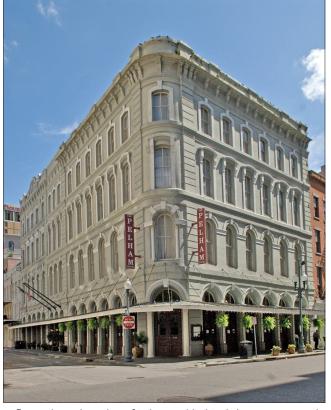
A flat or low-sloped roof is located behind the parapet and bracketed cornice.

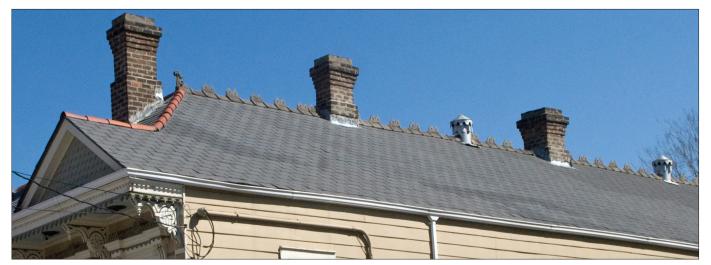
Ridge caps are located along the roof hips, cresting is along the top ridge and a finial is found at the end of the main roof gable. Chimney placement reflects the internal organization of the residence and Chinese caps provide roof ventilation.

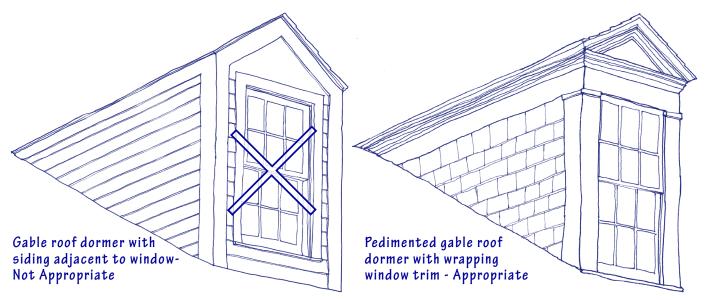
Both gable roof dormers have 6/6 double hung windows. However, the dormer to the left has simple wood trim along the eaves and rakes, with siding flanking the window at the face of the dormer and is inappropriate. The more traditional example at the right is more appropriate with a pedimented gable end with trim framing the window and wrapping to meet the slate at the cheek walls.
