CITY OF NEW ORLEANS Vieux Carré Commission

Guidelines for Masonry & Stucco

MASONRY & STUCCO

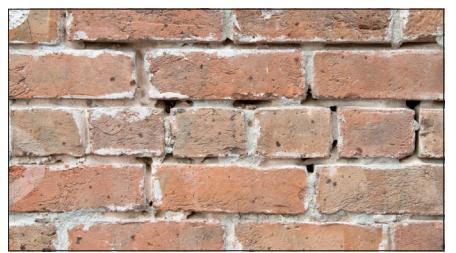
Local 19th Century Brick – A soft, firedclay, fairly regularly-shaped building component; locally known as lake or mud brick; often with color and surface variations; used primarily in walls, piers, foundations and exterior paving.

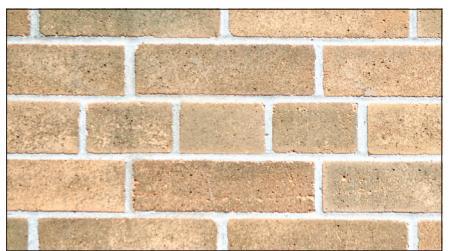
Yellow Brick – A hard, dense, fired-clay, regularly-shaped building component made from high lime content clay; typically extruded, sometimes with a glazed surface; used primarily in walls, piers, foundations and exterior pavers.

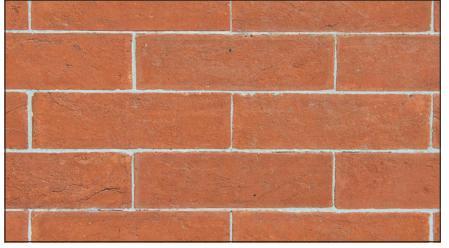
20th Century Brick – A hard, dense, fired-clay, regularly-shaped building component; typically extruded; sometimes with a glazed surface; used primarily in walls, piers, foundations and exterior paving.

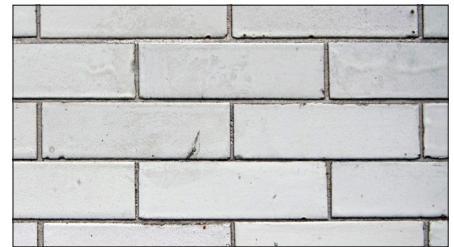
Glazed Brick – A hard, dense, fired-clay, regularly-shaped building component; typically extruded with a glazed surface; used primarily in walls.

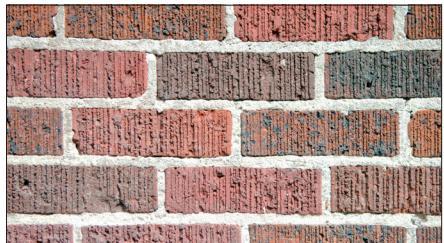
Wire Cut Brick – A dense, fired-clay, regularly-shaped building component; typically extruded with a ridged surface; used primarily in 20th century building walls.

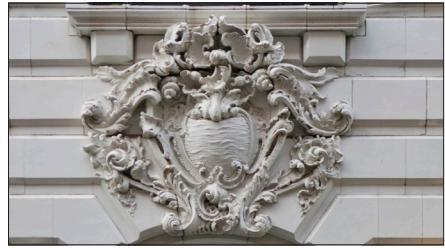
Terra Cotta – A fired-clay, non-structural building component; often with colored glaze; used for decorative, ornate details and wall finishes.

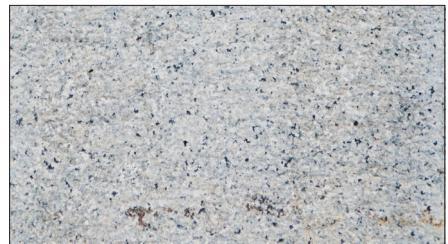
Granite – A hard rock, consisting of small, yet visible, grains of minerals; can be highly polished or textured; used for walls, piers, columns, stoops and street curbs; commonly gray, black or pink.

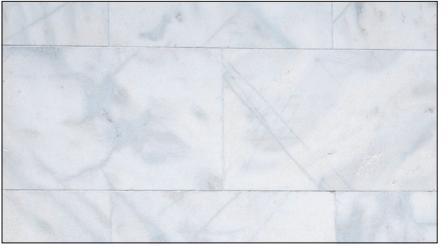
Marble – A fine grained stone able to be highly polished; has a wide range of colors and patterns; used for steps and stoops, statuary and fine masonry.

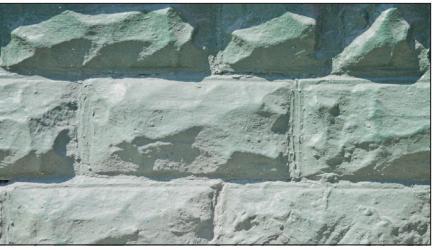
Textured Concrete Block – A structural building material made by mixing water, cement, sand and aggregate, placing it in a form and hardening; commonly used for foundations, walls and piers; popular in the early to mid-20th century.

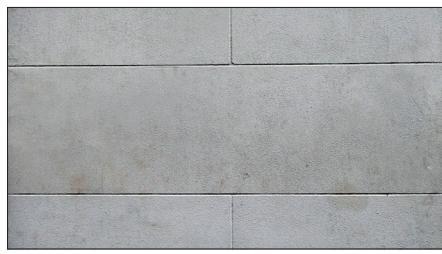
Scored Stucco – *Smooth finish with scoring to simulate stone joints.*

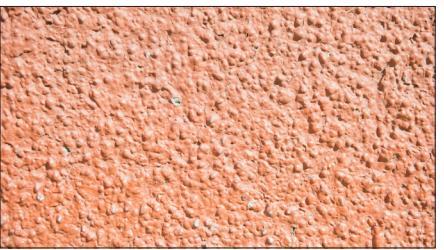
Dash Finish Stucco – Textured finish with pronounced aggregate at the surface.

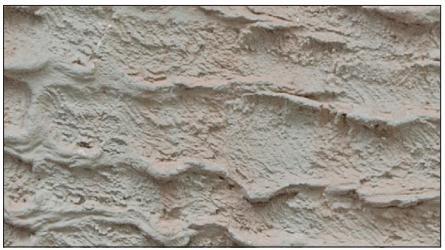
Textured Finish Stucco – Highly stylized finish with pronounced ridges and shadows from trowel application.

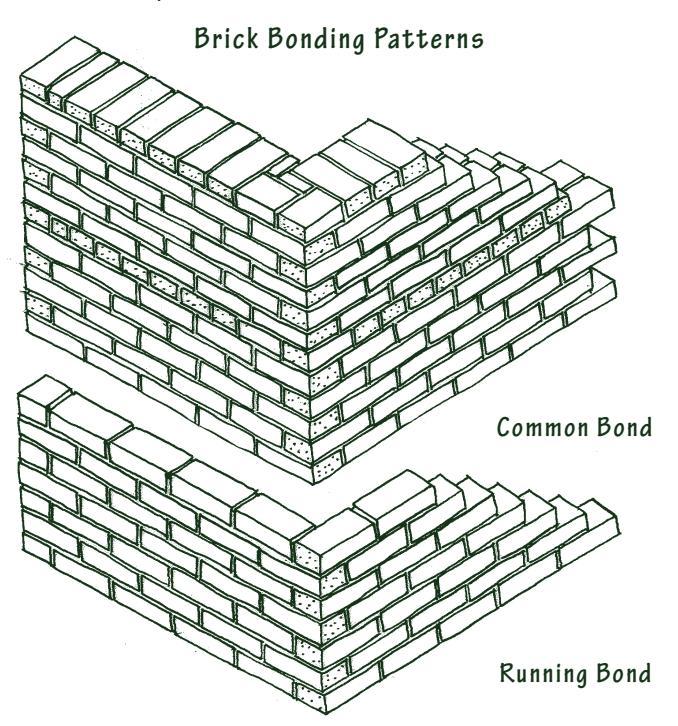
The most prevalent brick bonding pattern is common bond, which is built of stretcher courses with a header course every sixth row. Another familiar bonding pattern is running bond, comprised only of stretcher courses.

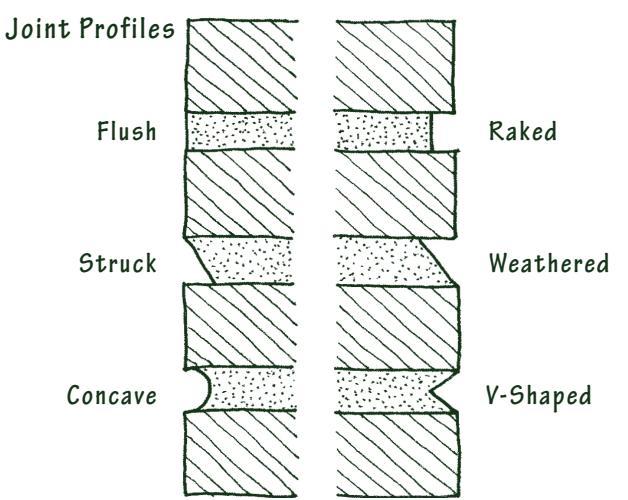
There are numerous joint profile types, or shapes, of mortar joints, each producing different shadow lines and highlights. When repointing an area of masonry, it is important to tool the mortar to match the existing joint profile for a consistent appearance.

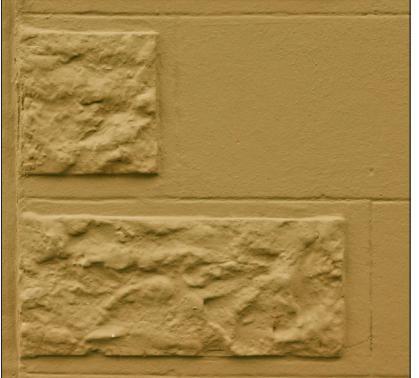
The appearance of finished stucco can vary based upon the desired effect and the skill of the craftsman. This example includes scoring and stucco quoins, or corner blocks.

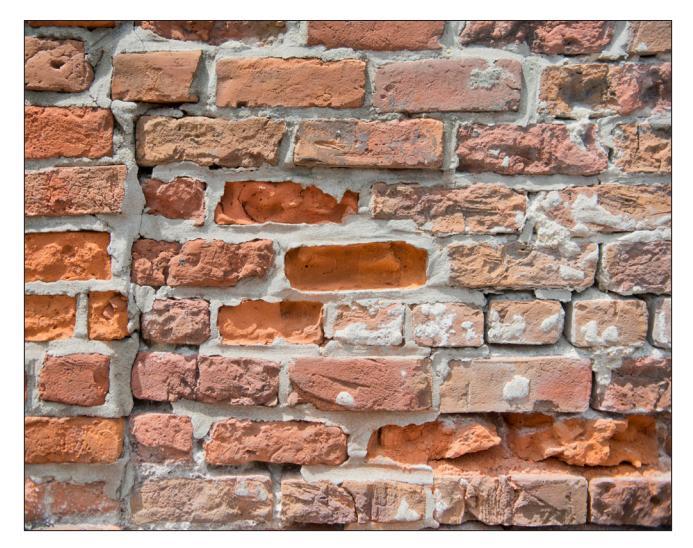
Deterioration of bricks and mortar – The surface of several of the lake bricks appear to be "powdered" or "melting," exposing their softer core. Some surrounding mortar remains in place, suggesting it is harder than the brick. Other mortar is eroding and cracks are present, increasing the potential for further moisture infiltration.

Deterioration of foundation – The brick foundation below is missing and collapsing, losing its ability to support the wall.

Recommendation – Most walls constructed from soft lake bricks should have a protective stucco coating. Replace deteriorated brick. Address all potential causes of moisture infiltration into wall including storm water and ground water. Repoint an open joint with compatible mortar, as soon as possible, to minimize storm water entering the wall. Apply compatible 3-coat stucco and appropriate painted surface to protect underlying brick. (Refer to Stucco, page 06-5.)

Recommendation – Rebuild foundation and provide hurricane fasteners to wood wall and floor framing. (Refer to Storm Preparedness, Guidelines for Exterior Woodwork, page 05-10.)

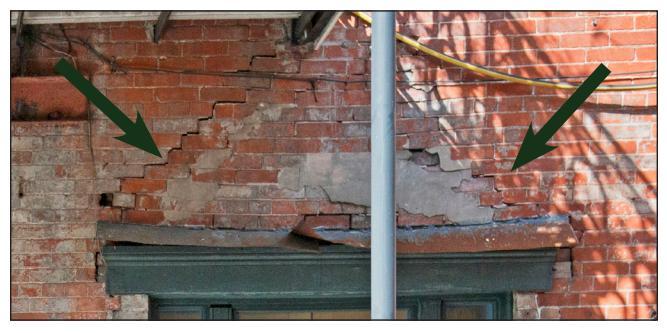
Failing window lintel – The window lintel is bowed down at the center and has multiple stepped cracks, along mortar joints at both sides leading to the gallery support above.

Recommendation – The extent of cracking at the window is severe. If the condition worsens, it could lead to collapse. Immediate consultation with an architect or engineer is recommended.

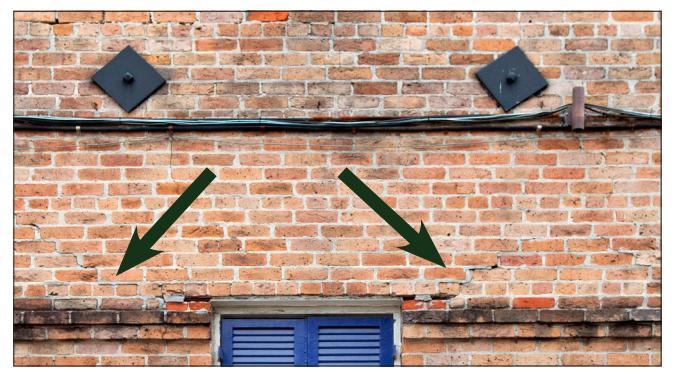
Step cracks at windows and bolted plates – Spalled brick and step cracks radiate up from both corners of the window. The flat plates on the wall above have threaded rods secured to the internal structure to stabilize or pull-back a bowing masonry wall. (Plain and decorative plates are available in different shapes.)

Recommendation – Replace spalled brick, repoint open step cracks and monitor condition regularly to see if they return. Remove abandoned wiring and associated anchors.

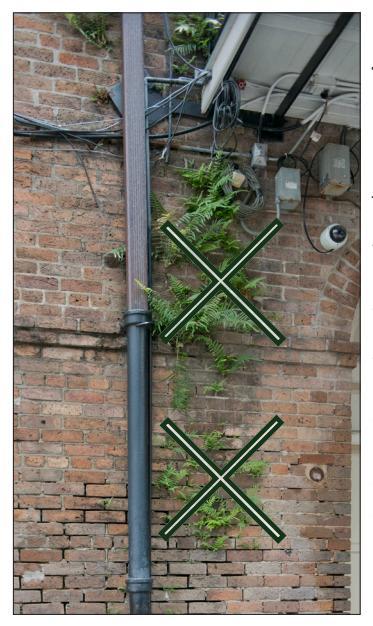
Plant growth and open joints at downspout – Plants are growing in the mortar joints around the downspout and open joints are visible below. Both conditions suggest the presence of moisture and saturation of the brick wall.

Recommendation – Verify the downspout is clear and draining, and its seams are well fastened. Remove abandoned electronic devices and wiring. Remove all plant growth. Repoint open mortar joints with compatible mortar.

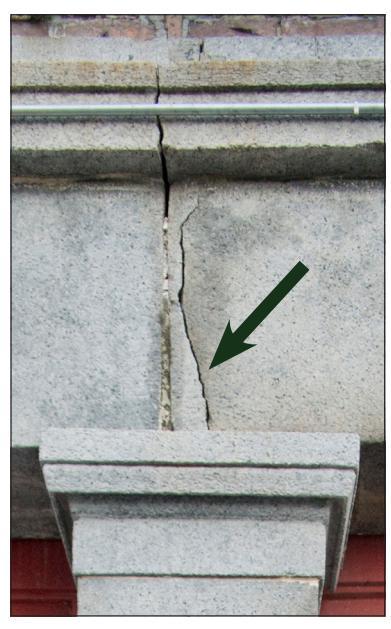
Cracked granite lintel – Granite lintel is cracked over structural support and through cornice.

Recommendation – Patch the open joint. Monitor the condition every two to three months to see if the crack re-opens. A crack over an unsupported area or near the edge of a support can be sign of a significant structural problem that requires immediate review by an architect or engineer.

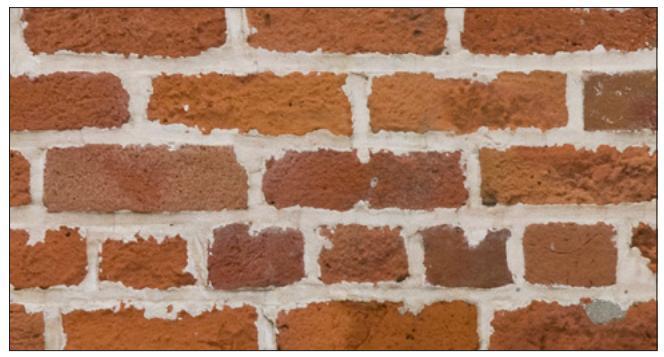
Spalled brick – Joints were widened and extended by a power tool to cut-out the joints during repointing. The joints are too large and extended vertically. The surface of the brick appears to have been damaged by removal of previous stucco and/or abrasive cleaning.

Recommendation – Cut back mortar joints to allow keying of new stucco wall finish. Apply compatible 3-coat stucco and appropriate painted surface to protect underlying brick. (Refer to Stucco Application, page 06-5.)

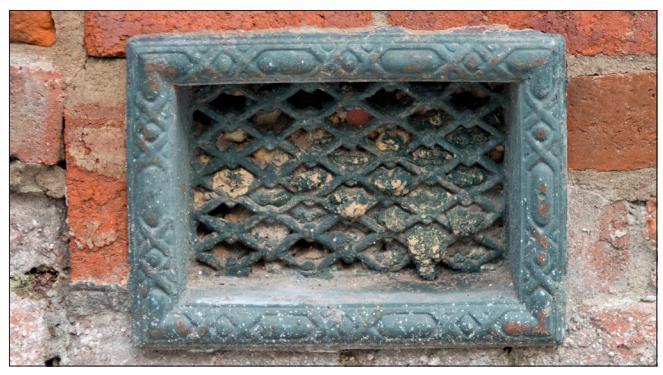
Obstructed foundation vent – The foundation vent is clogged with mortar, trapping damp, humid air in the crawlspace. Prolonged moisture in the crawlspace can deteriorate masonry and damage wood framing.

Recommendation – Remove obstructions from all vents and ensure there is sufficient airflow into the crawlspace.

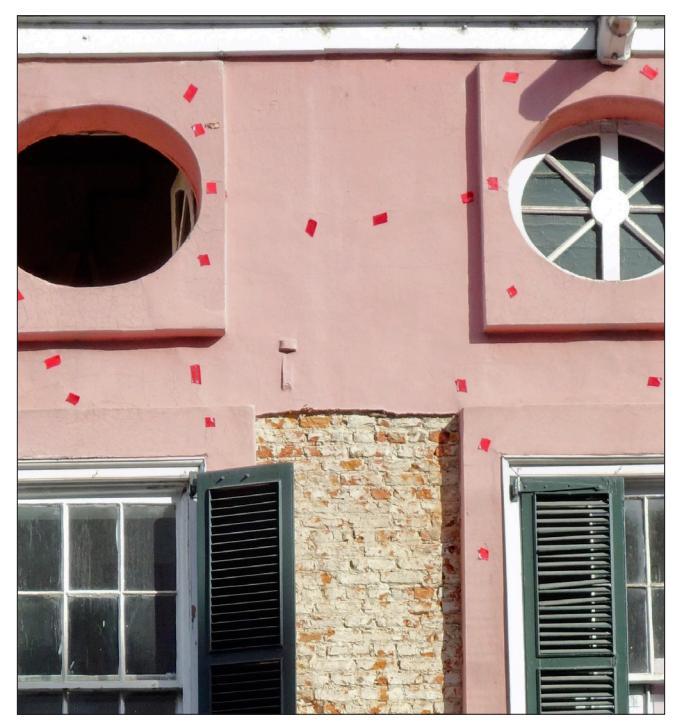
The stucco wall is in the process of repair. The loose stucco between the windows has been removed to the brick substrate to allow the new stucco to be installed. Red tape marks the locations of cracks to be repaired.

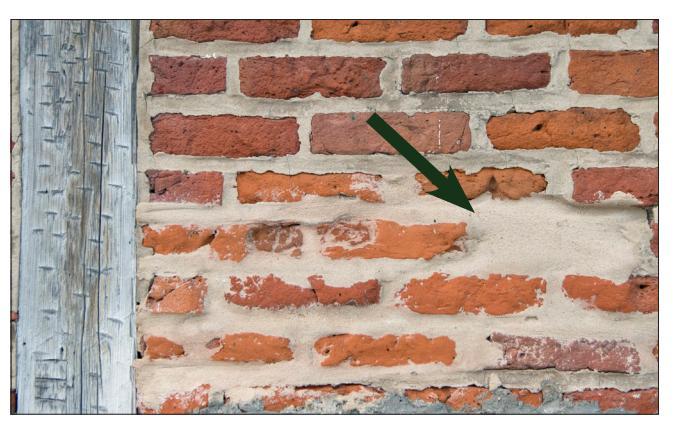
Stucco removed at brick-between-post construction – The removal of the stucco has exposed the soft, underlying brick and post. The brick is deteriorating quickly. Note the spalling and delamination of the brick, stucco patches in lieu of missing bricks and checking (cracking) of the wood post.

Recommendation – Remove inappropriate mortar and apply compatible stucco. Paint for a uniform appearance.

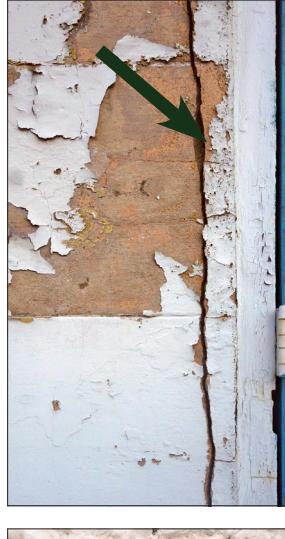
Crack through stucco – A significant vertical crack is located along the door jamb. There is loss of the paint finish. The crack could be the result of movement or a failure of the brick wall. The paint loss could be the result of moisture or improper preparation.

Recommendation – A long, deep crack can be an indication of a larger structural condition that should be evaluated by an architect or engineer.

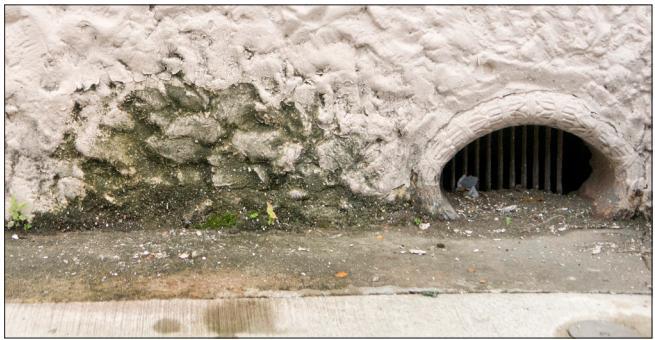
Algae growth at stucco foundation – The algae along the foundation suggests significant moisture in the ground immediately next to the building. Constant moisture can cause the stucco to delaminate and fall off the wall.

Recommendation – Divert water source away from the wall. Verify the slope of the ground next to the foundation is draining away from the wall and that no air conditioner condensate line or downspout is discharging in the area. Verify foundation vent is clear of debris. Clean stucco and, if required, apply mineral silicate paint for a uniform appearance.

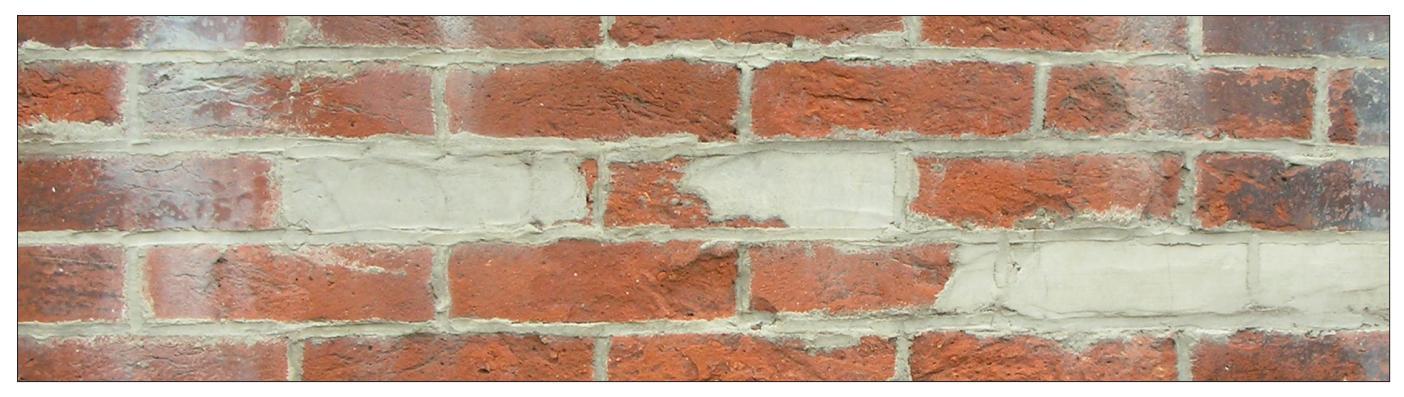
The rough texture and uneven surface suggest that an aggressive cleaning method was used. Stucco patches have replaced bricks and efflorescence, a white powdery substance, can be seen on the surface.

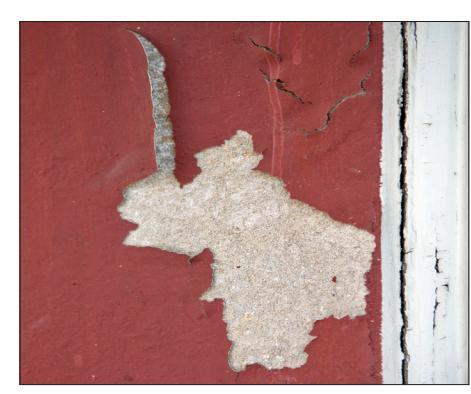
The peeling paint is likely incompatible with the stucco. If paint failure continues, complete removal and repainting with a masonry silicate paint should be considered.
