Historic District Landmarks Commission

Examples of appropriate camelback additions set two original rooms back

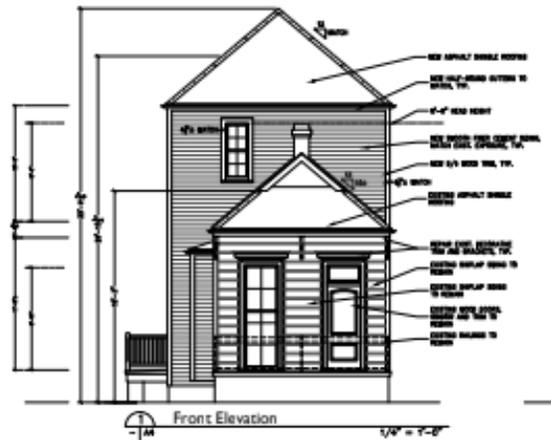
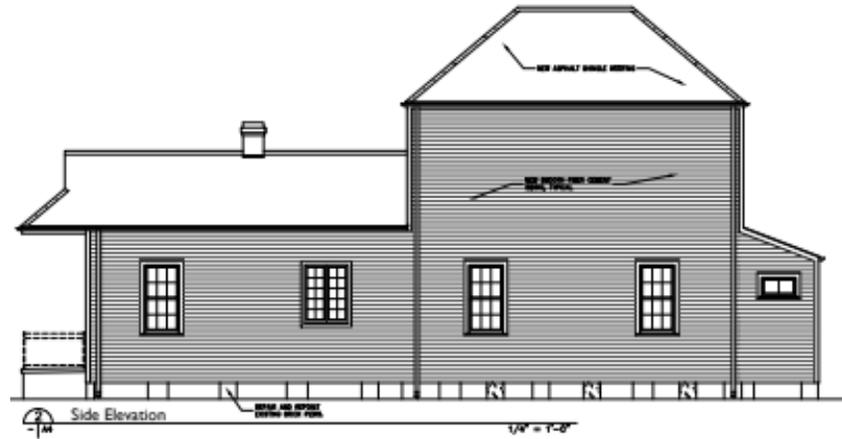
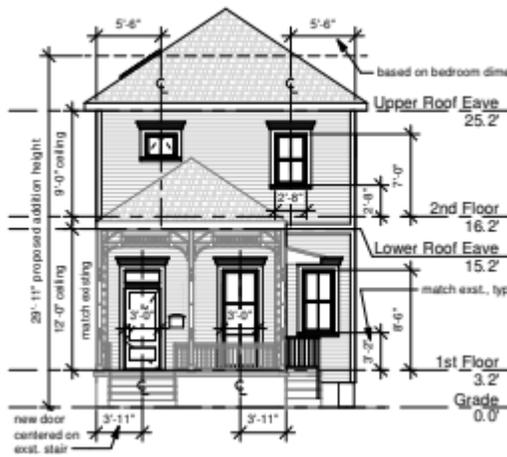
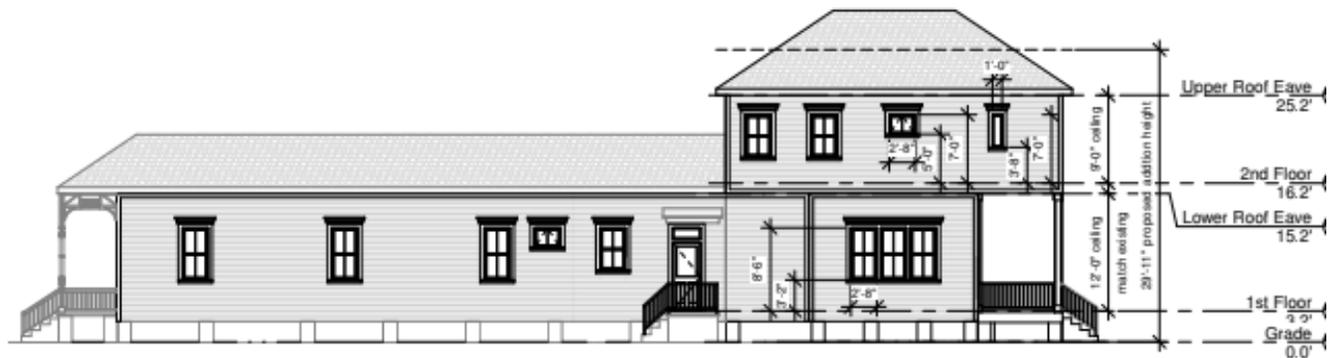
Single shotgun rear, two-story additions

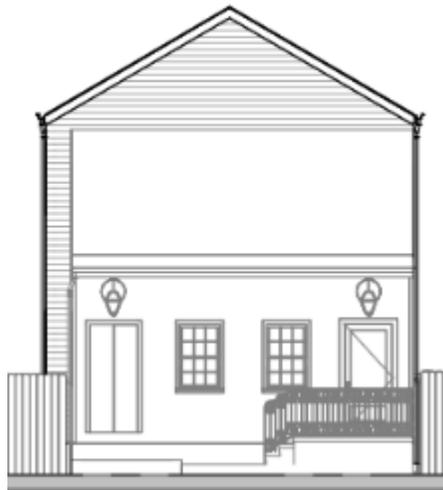
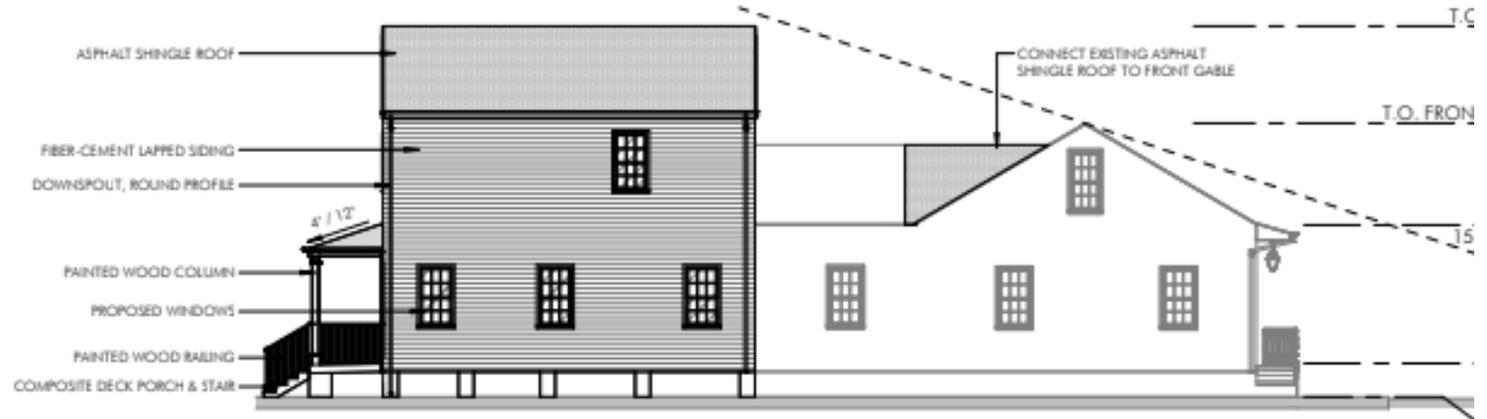
Creole cottage rear, two-story addition

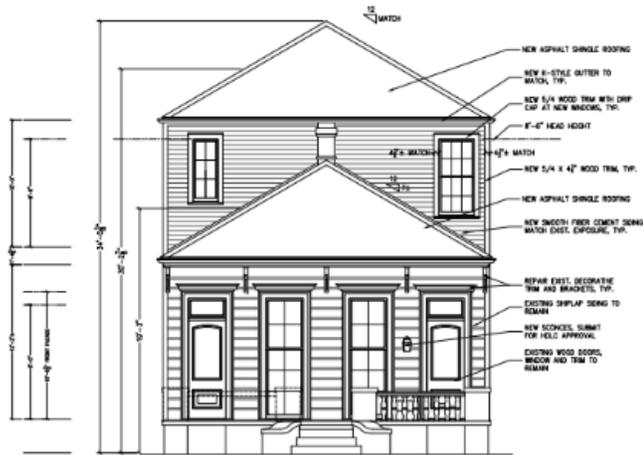
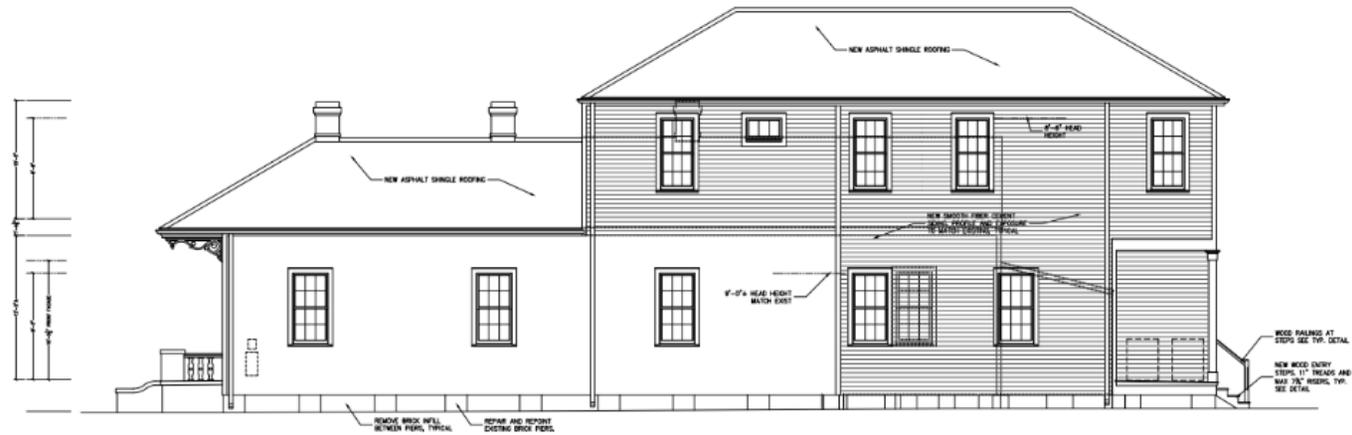
Double shotgun rear, two-story addition

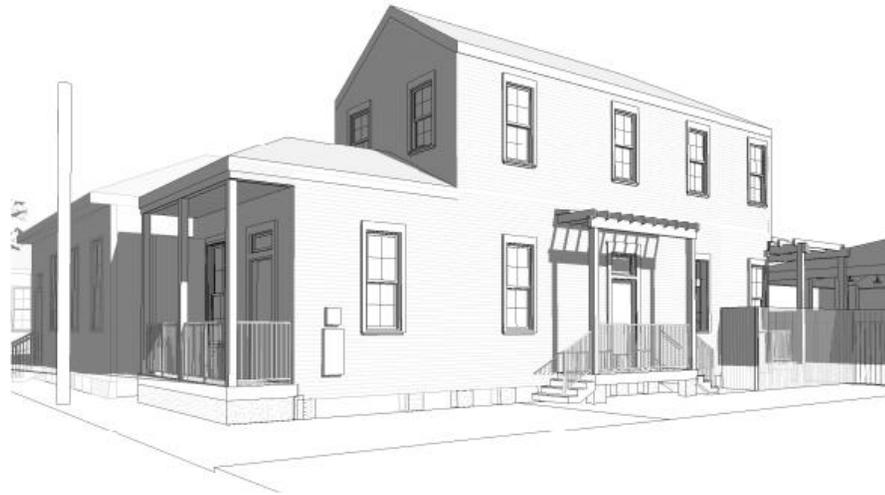
Two-story addition not set back far enough

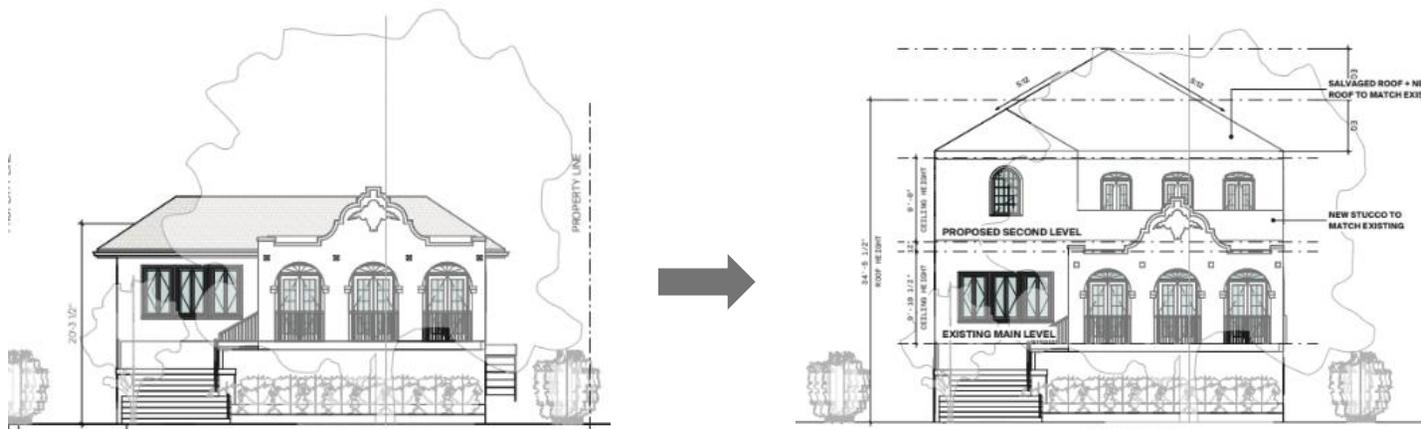
100% roof demolition and full floor addition above existing historic building

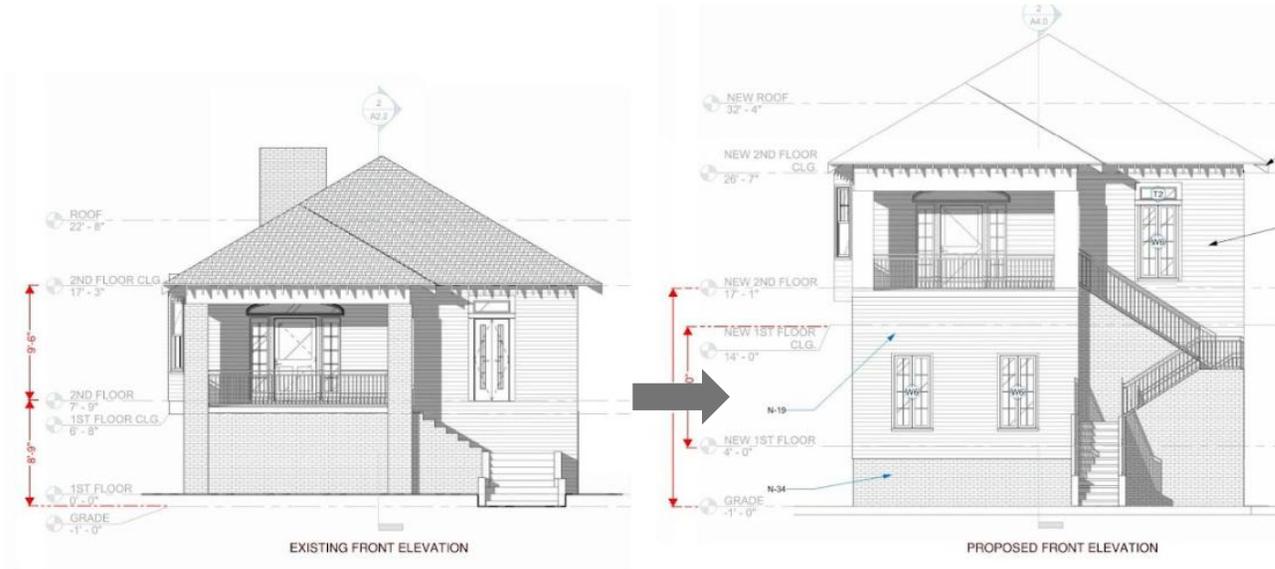
Raising a raised basement building and adding an additional floor underneath

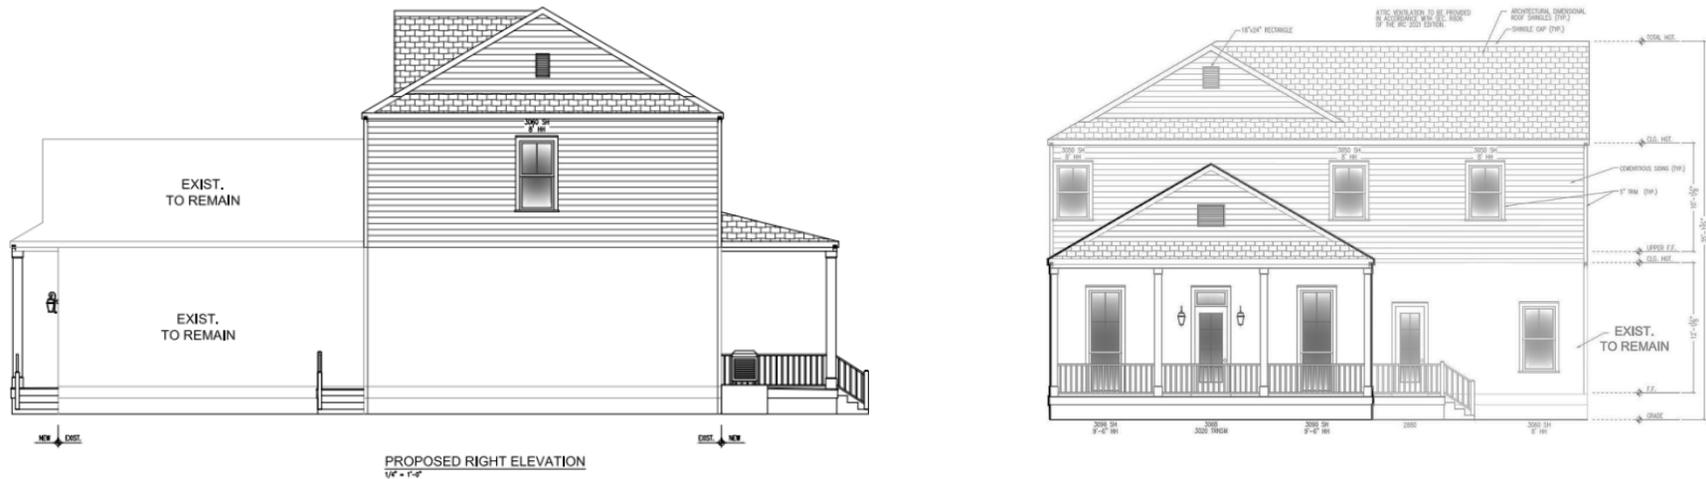
Rear addition set back far enough but is too wide
